# **An Additional Approach to Establishing the State of Operation of a Turbofan Engine During an Aircraft Accident**

**Douglas Zabawa**

Pratt & Whitney

## **Abstract**

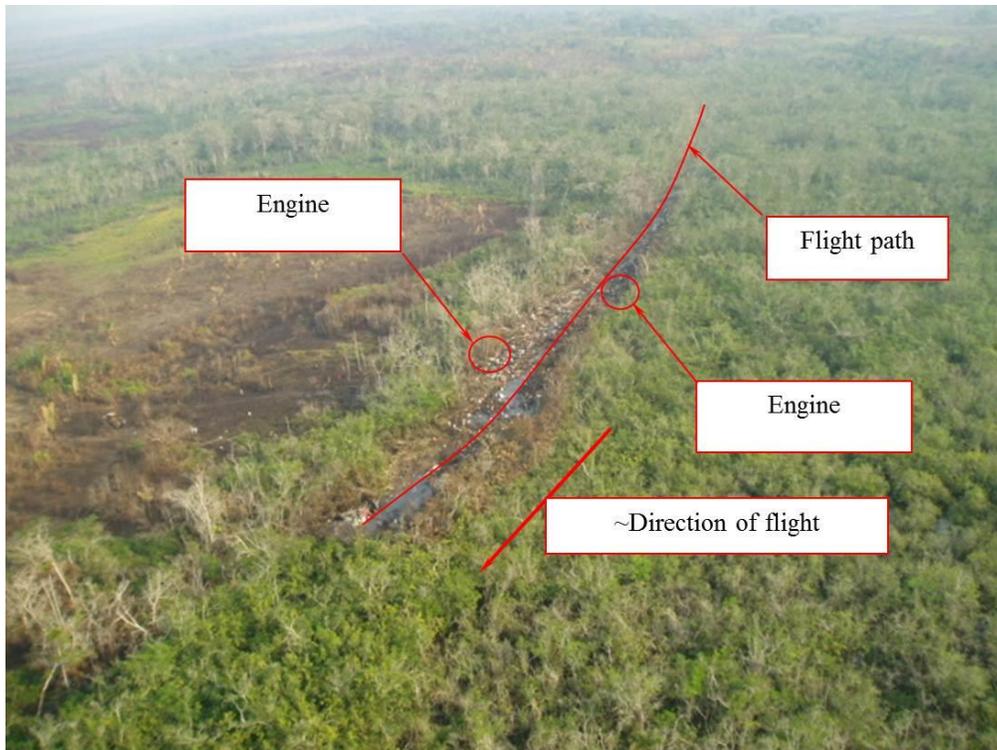
Based on observations both on the ground and from aerial surveys, it was determined that the aircraft came in at a shallow angle [see Figure 1] and at a significant bank angle with the right wing down [see Figure 2].

Figure 1: Aerial view of accident site depicting a shallow angle of impact (Photo Credit: CIAA Peru)

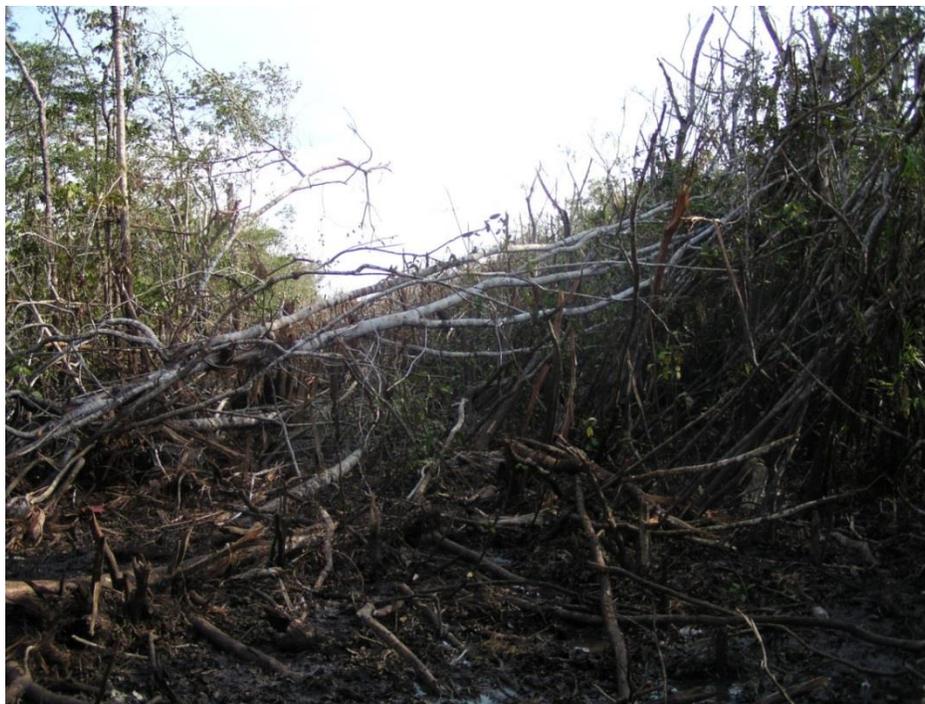
Figure 2: View looking against the direction of flight depicting aircraft bank angle with right wing down

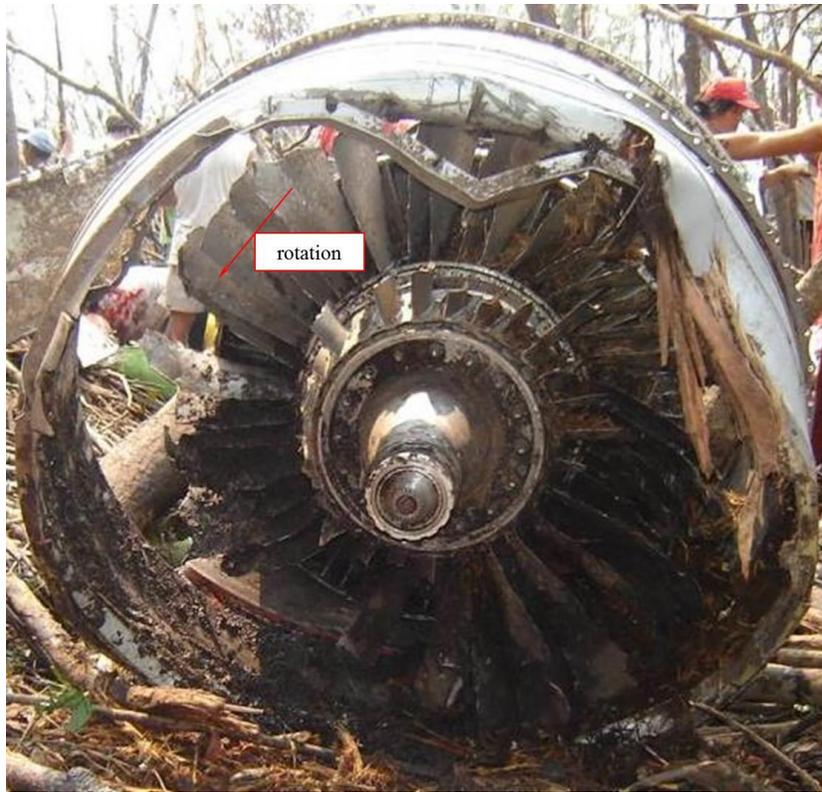
The detailed examination of the accident site identified both engines. Figure 3 is of the engine found on the left (1) hand side of the wreckage path while Figure 4 is of the engine found on the right hand side of the wreckage path. On-scene examination of both engines identified significant differences in the distress to the fan blades from one engine to the other with the engine on the right hand side of the wreckage path exhibiting very little distress to the fan blades and the engine on the left having just the opposite appearance. Further examination of the engine on the right hand side of the wreckage path identified the same lack of distress to the rear stage turbine blades.

Figure 3: Engine on left hand side of wreckage path (Photo Credit: CIAA Peru)

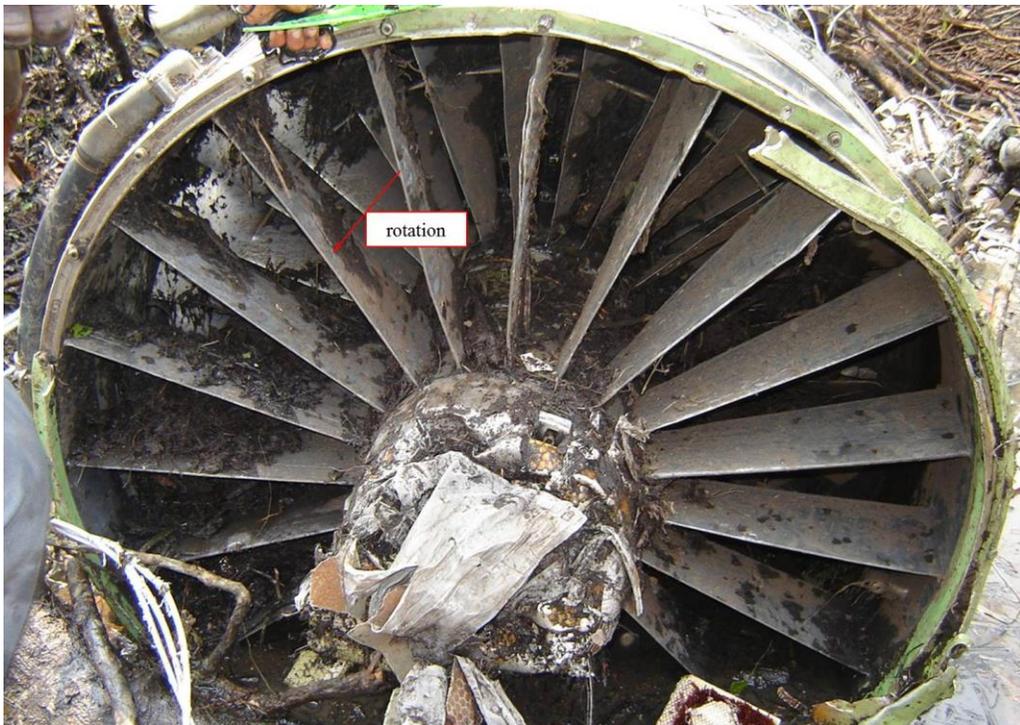
Figure 4: Engine on right hand side of wreckage path (Photo Credit: CIAA Peru)

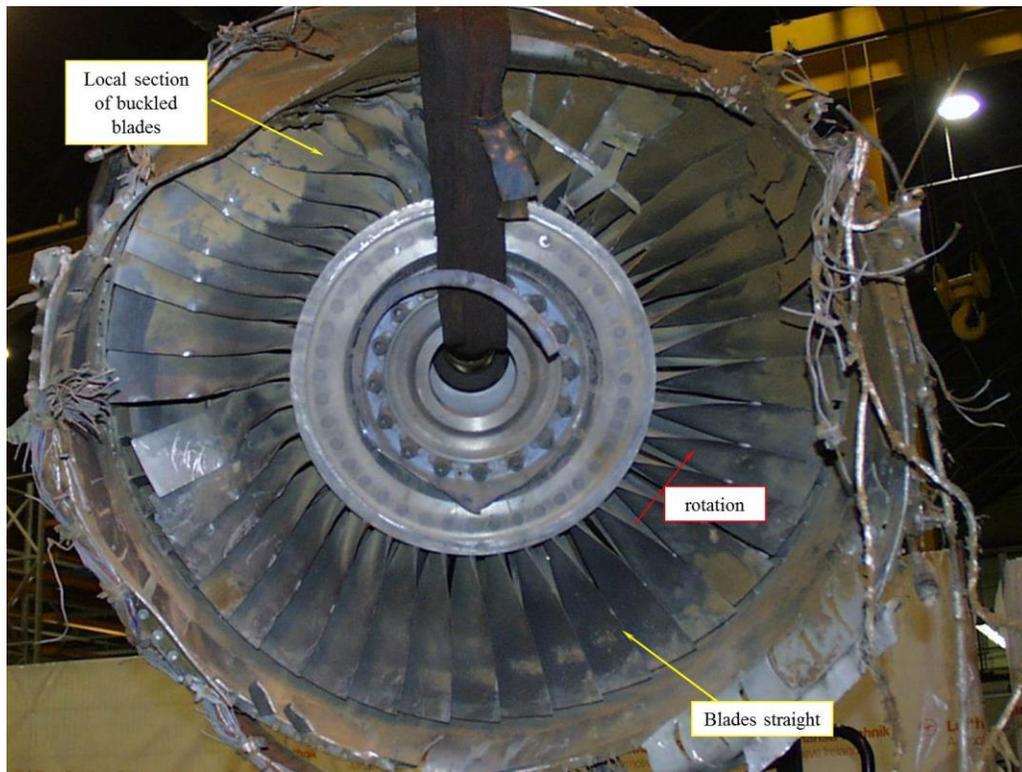
Figure 6 is an example of a fan rotor from an engine that was not rotating/windmilling (2) (i.e. an unpowered engine) at the time of impact. Note how the majority of the blades exhibit very little, if any deformation. They are straight and full length. Note also how a sector of the blades is buckled. This is interpreted as meaning that the rotor was not rotating at the time of its impact allowing only the blades that were in the area of the deformed case to become deformed.

Figure 6: Historical example of blade damage that occurs at impact with little (windmilling) or no rotor rotational speed

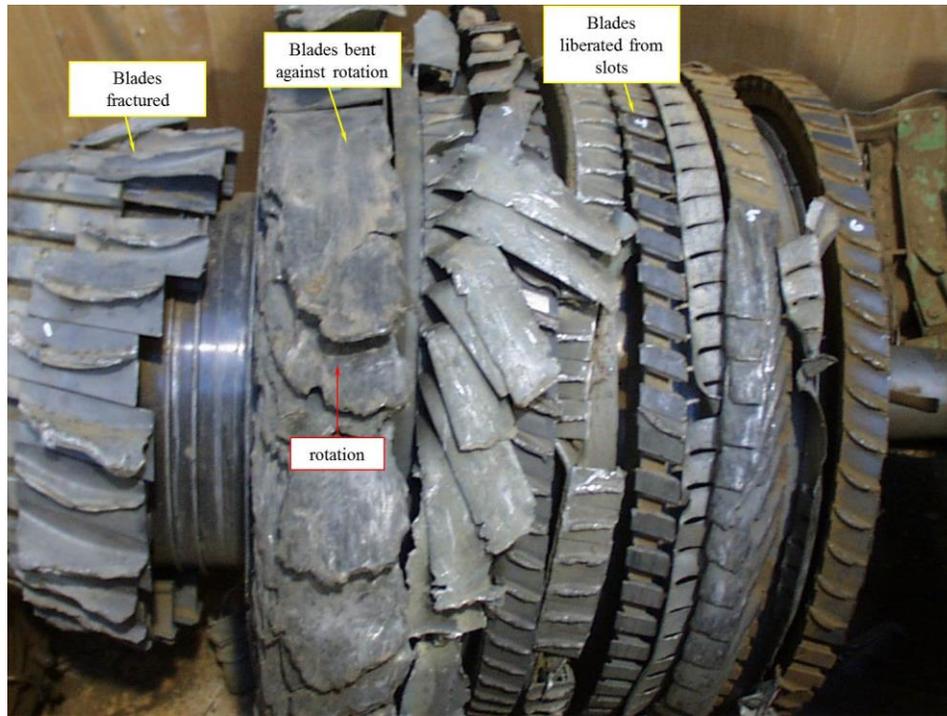
Figure 7 is an example of a compressor rotor from an engine that was rotating at high speed at the time of impact. The blade rows from this example have been liberated completely, folded over against the direction of rotation, or fractured off leaving only stubs of blades still attached to the underlying disk. The explanation for this is that the rotor, with blades attached, was rotating fast enough that all of the blades rotated past/into the deformed part of the engine case. Since all of the blades encountered this intrusion of the case into the rotor they all became distressed in a similar fashion.

Figure 7: Historical example of blade damage that occurs at impact with the rotor at a high rotational speed

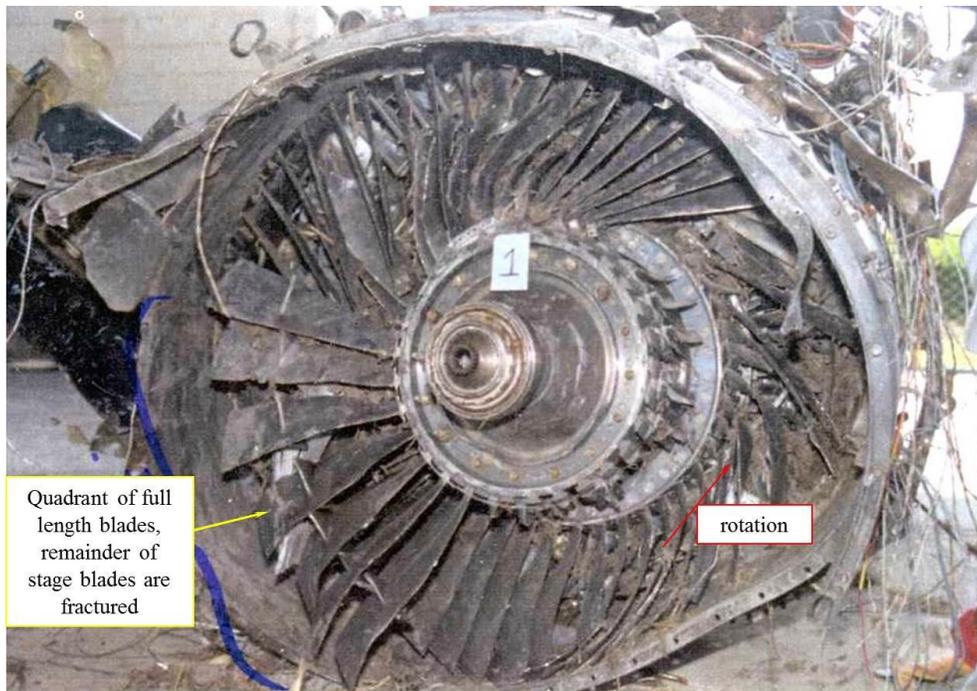
Levels of distress between the extremes depicted in Figures 6 and 7 can also be used to infer state of rotation. Figure 8 is an example where ~75% of the blades are fractured but the remainder are full length and straight/undeformed. The energy level of this impact was somewhere between no rotation of the engine and high-speed rotation. In this example the engine was rotating, but at the low (relative to high power take-off) rotational speed of idle.

Figure 8: Historical example of blade damage that occurs with rotor at low (~idle) rotational speed

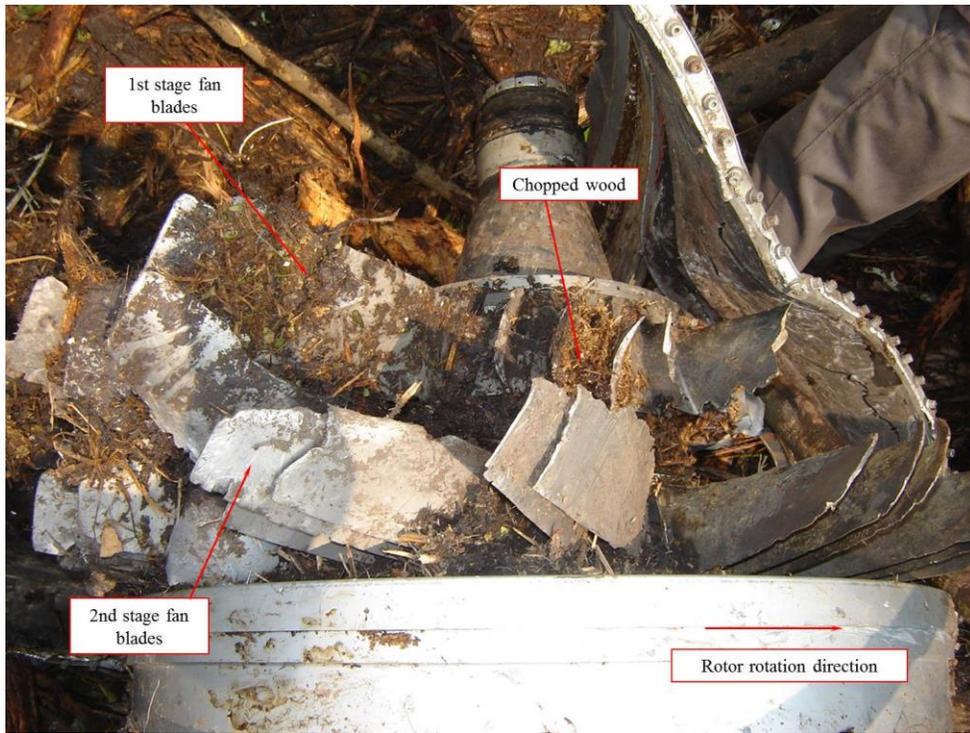
Examination of the No. 2 engine identified 1<sup>st</sup> stage fan blades that were both fractured and bent against the direction of engine rotation. Additionally, the 2<sup>nd</sup> stage fan blades that were observable were all bent against their direction of rotation. Splintered wood was also observed between the blades in both the 1<sup>st</sup> and 2<sup>nd</sup> stage fans. Figure 9 is representative of the condition of the fan stages of this engine.

The condition of the fan and compressor stage blades in the No. 2 engine were consistent with the rotors rotating at the time the engine received its impacts. Furthermore, the distress to the fan and compressor blades as compared to the lack of distress to the turbine blades indicated that the forward portions of the engine were where the initial engine impacts occurred which in turn arrested the rotation of the engine rotors.

Figure 9: Representative fan stage damage for the No. 2 engine (Photo Credit: CIAA Peru)

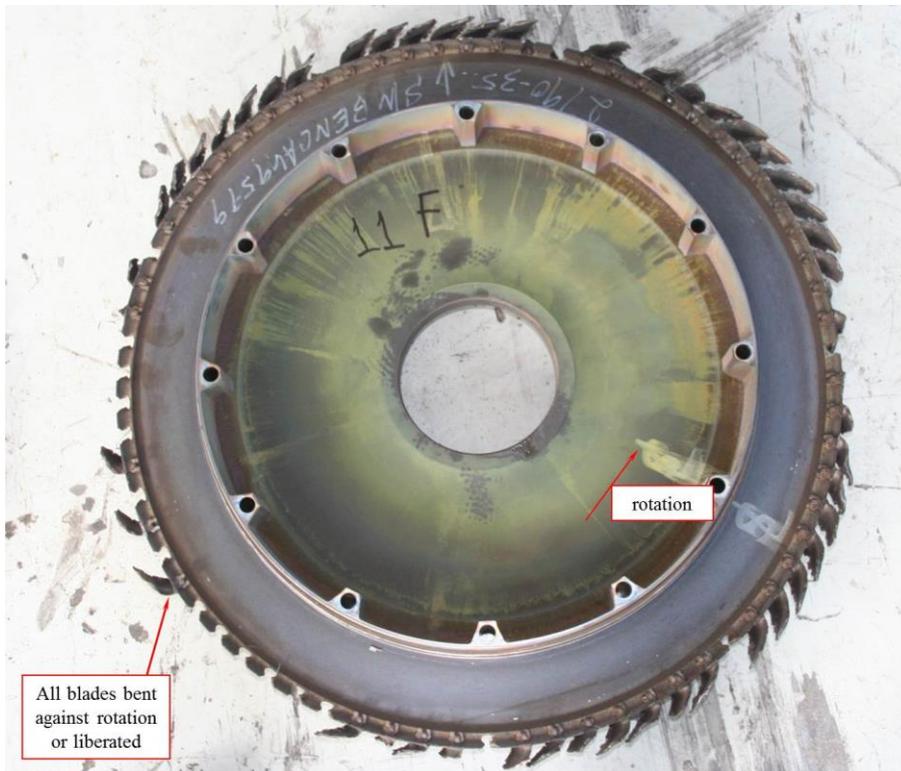
In general, it was observed that the blades in the High Pressure Compressor (HPC) were either fractured or exhibited damage against the direction of rotor rotation. This damage consisted of blade bending, leading edge and trailing edge breakouts and smearing, and tip curls. The distress within a given rotating stage was consistent around the entire circumference. Figure 10 is a picture of a typical compressor rotor from this engine.

Figure 10: Typical compressor rotor from the No. 2 engine

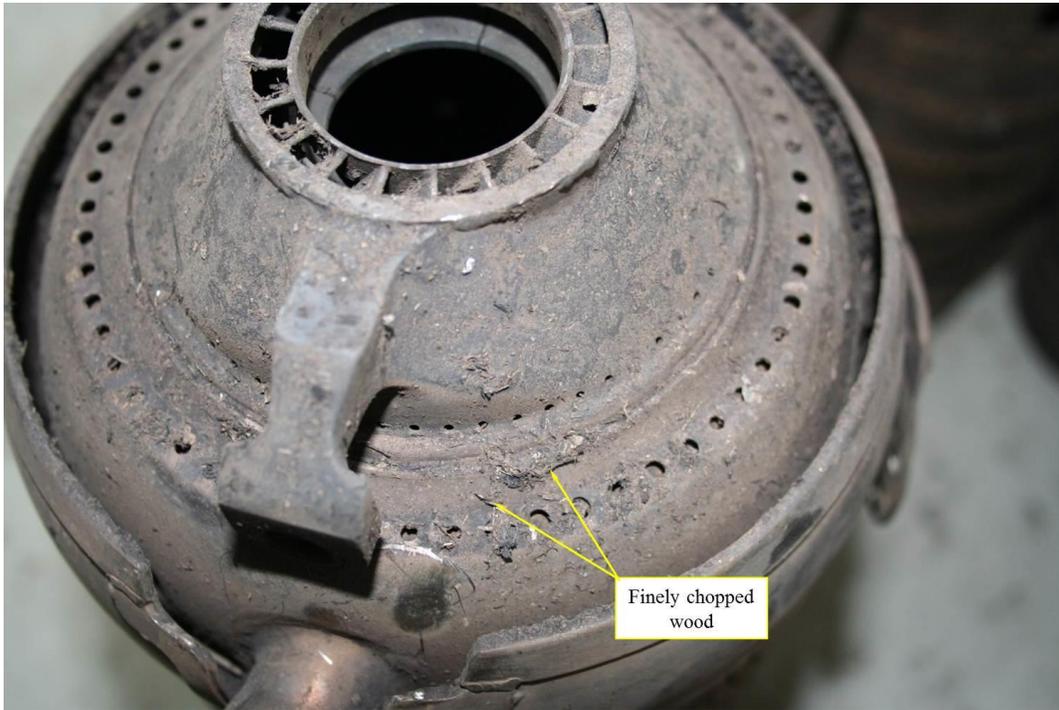
The domes of the burner cans exhibited a deposited coating of organic vegetation that consisted of dirt and finely chopped wood particles. Figure 11 depicts this debris.

Figure 11: Typical No. 2 engine burner dome with organic deposits included finely chopped wood fragments

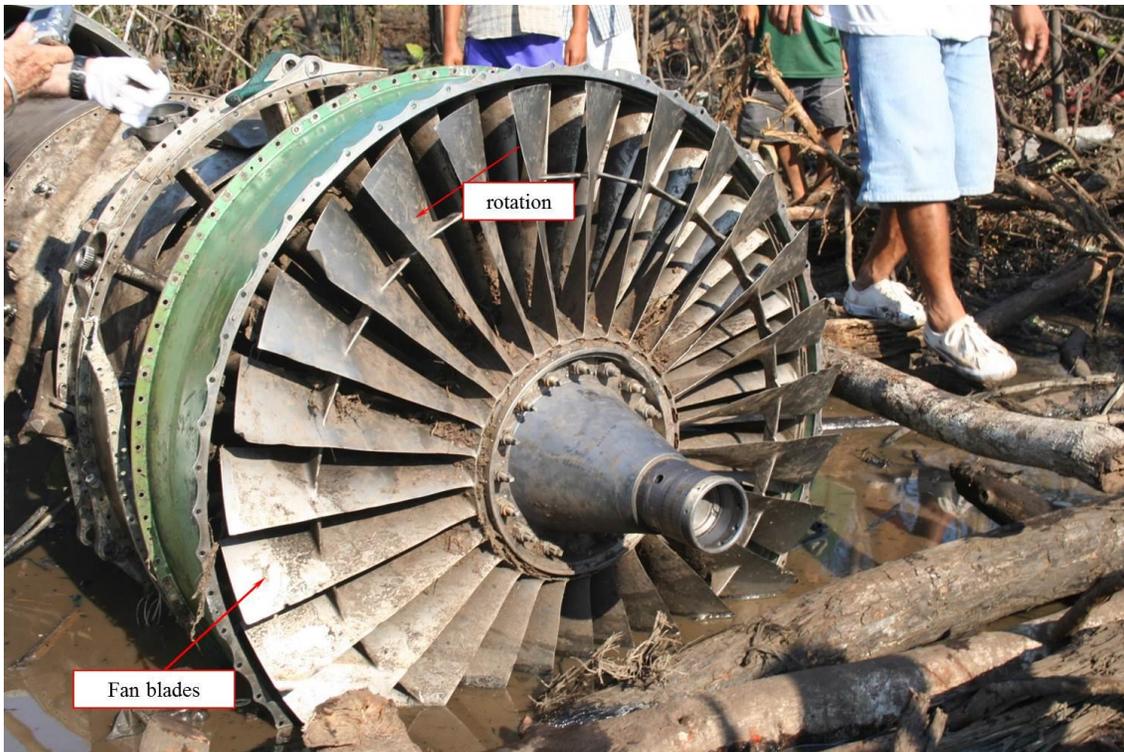
Examination of the No. 1 engine did not identify any significant distress to the blades of the 1<sup>st</sup> or 2<sup>nd</sup> stage fans. All of these blades were observed to be intact and straight with no significant deformation or distress. Figure 12 depicts the observed condition of the fan from the No. 1 engine on-scene.

The No. 1 engine did not exhibit the blade distress that is typically associated with an engine that is rotating at the time of its impacts during the accident sequence. The blades also did not exhibit a localized area of distress, such as a quadrant of buckled blades, which could be explained by an engine that was not rotating at the time of its impacts. Both of these points could be explained by the condition of the engine cases. The only significant deformation noted to the engine cases was to the Combustion Chamber Outer Case, which does not have any blades in close proximity to it to leave indications as to the state of rotor rotation.

Figure 12: No. 1 engine fan stage as observed at the accident site

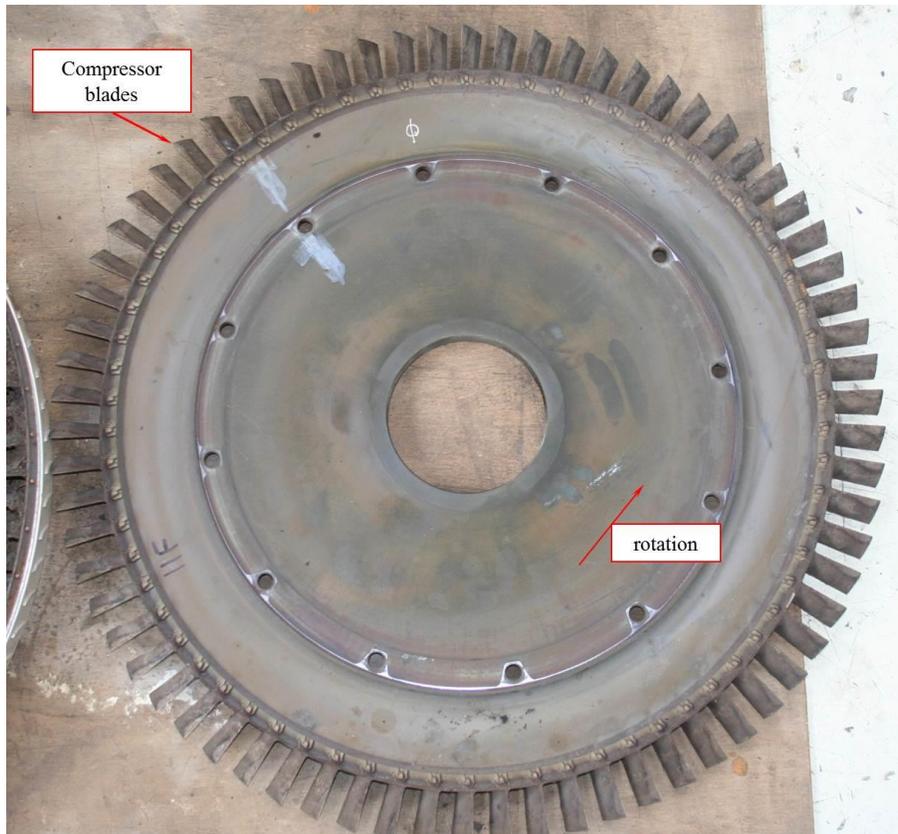
All of the HPC blades were observed to be in-place, intact, and straight. Figure 13 is a typical compressor rotor from this engine.

Figure 13: Typical compressor rotor from the No. 1 engine

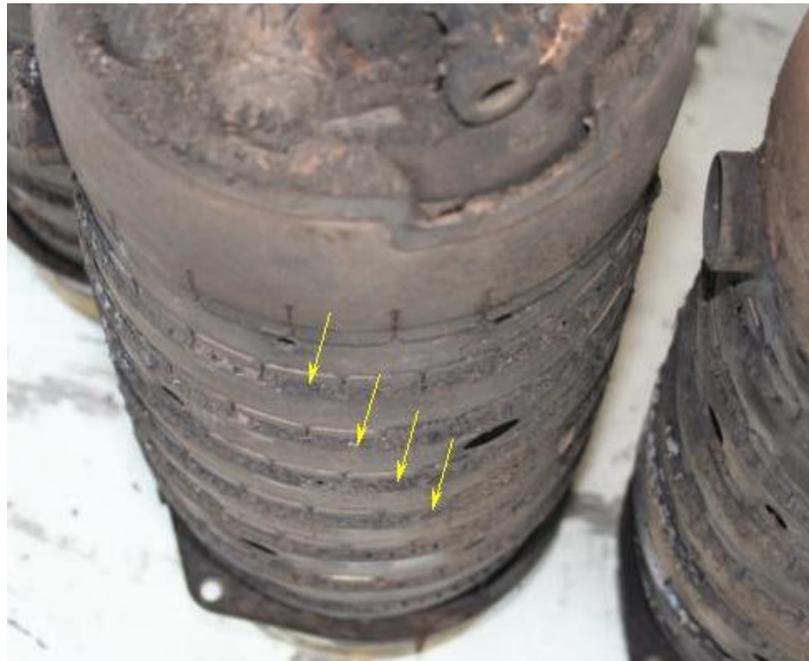
Organic vegetation consisting of a mixture of dirt and finely chopped wood particles was deposited on the largest diameters along the entire lengths of the individual burner cans. Figure 14 depicts the deposited debris on the burner cans.

Substantiating further that the engine was operating was the manner in which the debris was deposited on the raised surfaces of the burner cans. The debris was deposited in a manner that was consistent with it being entrained in airflow and then being caught on the high points of the surfaces that the airflow encountered. Again, this pointed to the engine operating and pumping air at the time the wood was being ingested.

Figure 14: No. 1 engine burner cans exhibited deposited debris on high spots (largest diameters)

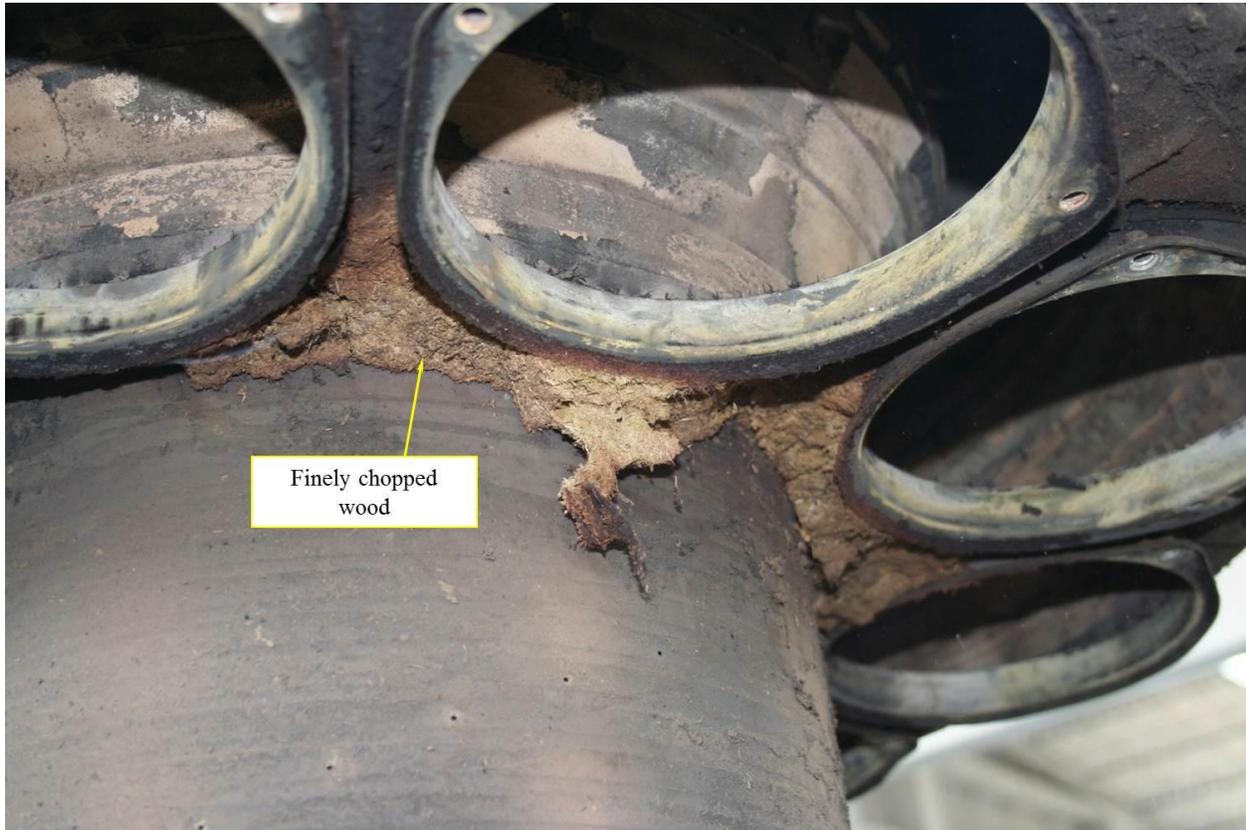
A significant amount of organic vegetation debris, consisting of finely chopped wood particles, was caked around the holes for the burner cans in the combustion chamber support assembly. Figure 15 depicts this debris.

With the lack of blade damage to help establish the state of rotor rotation, the investigation focused on understanding the organic debris deposits in the engine. As noted, the debris contained finely chopped wood that was found deep within the engine past all of the compression stages. It was determined that for the wood to have been chopped in the manner it was, something had to have done work on it, specifically the compressor blades. For this to have occurred, the engine rotors had to have been rotating at the time it encountered the trees. It is not feasible to have branches rammed into the front of the engine and still get chopped in the same manner as observed unless that engine was operating under power at the time it encountered the trees.

Figure 15: Deposited debris, including finely chopped wood fragments, deposited on combustion chamber support assembly
