Investigating a MD-88 Runway Excursion

Joshua Migdal

Air Safety Investigator, Delta Air Lines, Inc.

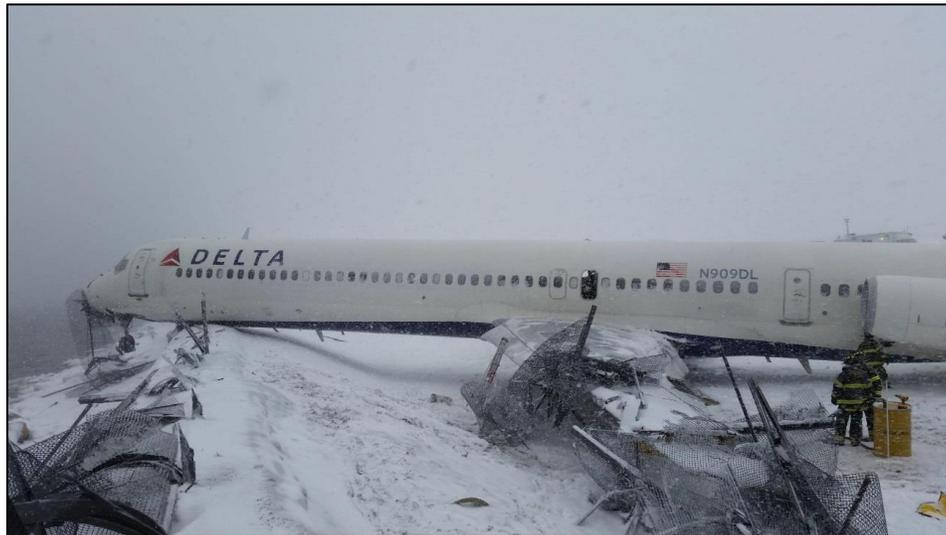
After departing the runway surface, the aircraft traveled across a grassy area before striking a seawall. The aircraft traveled parallel to the seawall, impacting the airport perimeter fence for approximately 1,000 feet before turning sharply to the left. The aircraft stopped with the nose suspended over Flushing Bay and fuel leaking from the left wing. *See Figure 1.* Subsequently, aircraft rescue and firefighting (ARFF) personnel arrived and an evacuation was initiated.

Figure 1: Photograph of the aircraft's final resting location (NTSB).

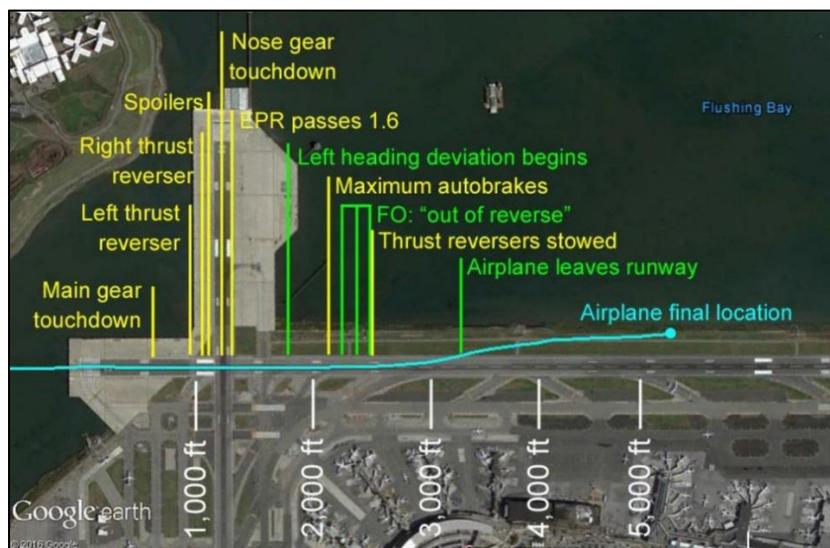
A performance study indicated that the aircraft touched down at 133 knots, approximately 600 feet from the runway threshold. Approximately 1,600 feet from the runway threshold, a left yawing moment began and the flight crew applied right rudder. During that time, the reverse thrust engine pressure ratio (EPR) exceeded 2.0 and 1.9 for the left and right engines, respectively. Subsequently, the thrust reversers were stowed and manual braking was applied. The aircraft exited the paved surface 3,200 feet from the runway threshold, approximately 14 seconds after main landing gear touchdown. See Figure 2.

Figure 2: Aircraft ground path (NTSB).

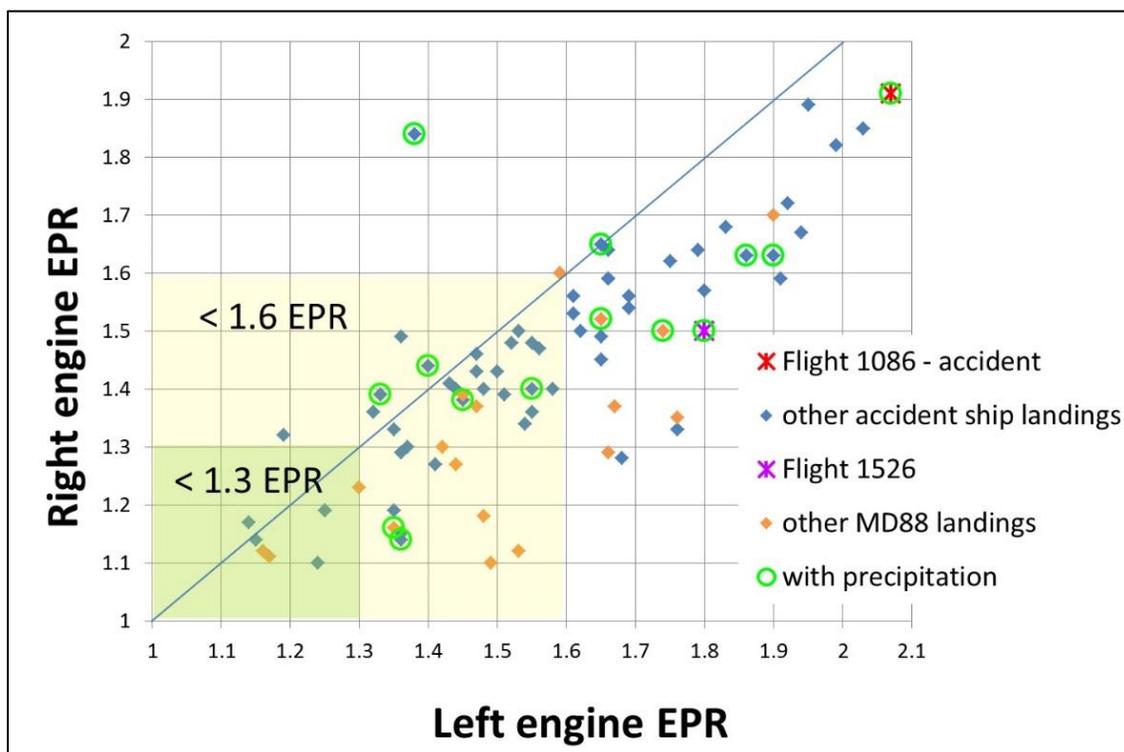
Following the accident, data from the quick access recorder (QAR) from the accident aircraft and the prior landing aircraft, Flight 1526 a MD-88, were analyzed. The analysis revealed that EPR values above 1.6 were common, including during times of reported precipitation. See Figure 3. It was noted that none of the 80 recorded landings exhibited a significant deviation in heading or resulted in a runway excursion. Additionally, of all of the landings analyzed, the accident landing had the highest recorded EPR, as well as the shortest time to rise from 1.3 EPR to 1.6 EPR. The data review demonstrates that aircraft routinely experience reverse thrust above 1.3 EPR without degradation of lateral control; this indicates that the conditions of the runway at the time of touchdown likely contributed to the loss of directional control and inability to recover.

Figure 3: Scatterplot graph of recorded QAR data (NTSB).

Following the accident in LGA, Delta conducted a Safety Management System (SMS) Safety Risk Assessment (SRA) to review reverse thrust usage on the MD-88. After completion of the SRA, a decision was made to limit reverse thrust to 1.3 EPR on dry runways (formerly 1.6). When landing on non-dry runways, flight crew initially select idle reverse thrust and after reverse thrust symmetry is verified with the aircraft aligned with the runway track, flight crews may gradually increase reverse thrust to no greater than 1.3 EPR.

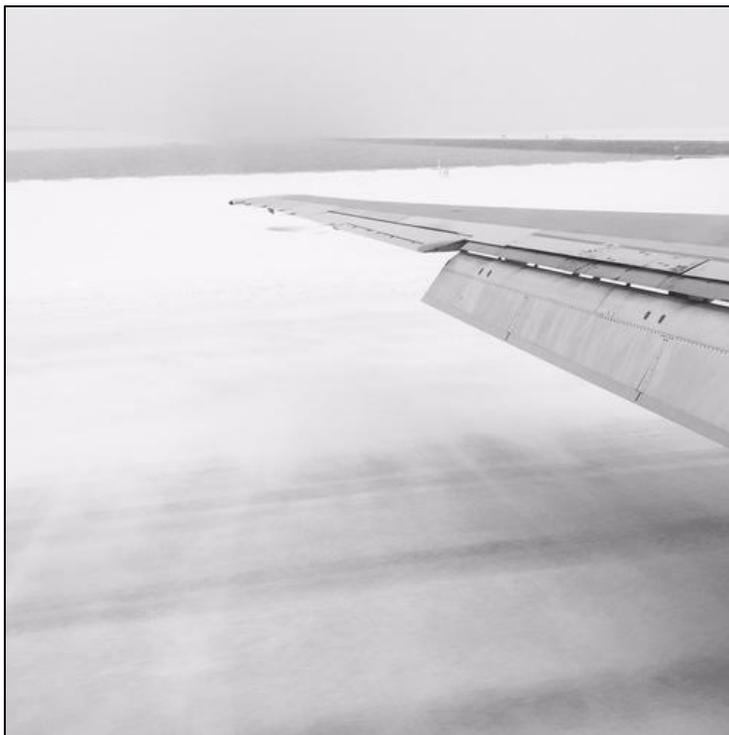
The investigation produced a timeline of events that revealed the runway was last cleared at 1035 EST and the last NOTAM was issued at 0903 EST. The investigation uncovered that the 0738 EST NOTAM indicated that the runway had been chemically treated, even though it had not been. See *Figure 4*. The LGA operations manager stated in an interview that NOTAMs will only be issued when conditions change and a new NOTAM will not be issued after clearing operations, if the runway conditions are comparable to the conditions previously reported. This practice is not in accordance with FAA Advisory Circular (AC) 150/5200-30C.

Figure 4: Passenger photograph of the runway during landing.
Photograph copyright Jason Aspès.
