## Air Safety Investigations Aircraft Incident/Accident Technical Report

Aircraft Incident/ Accident Information	Year: 2015	Make: Textron Aviation	Model: 680
	Serial number: 680A0010		Registration: N8JR
Location: Elizabethton, TN		Date: 08-15-19	Time: 1537 EDT
Aircraft Owner		Aircraft Operator	
JRM Air LLC PO Box 330 Mooresville, NC 28115-0330		Same as Aircraft Owner	
Report Information			
Air Safety Investigator: Peter J. Basile		Report #: ASI-19-CB-T	Report date: 01-21-20

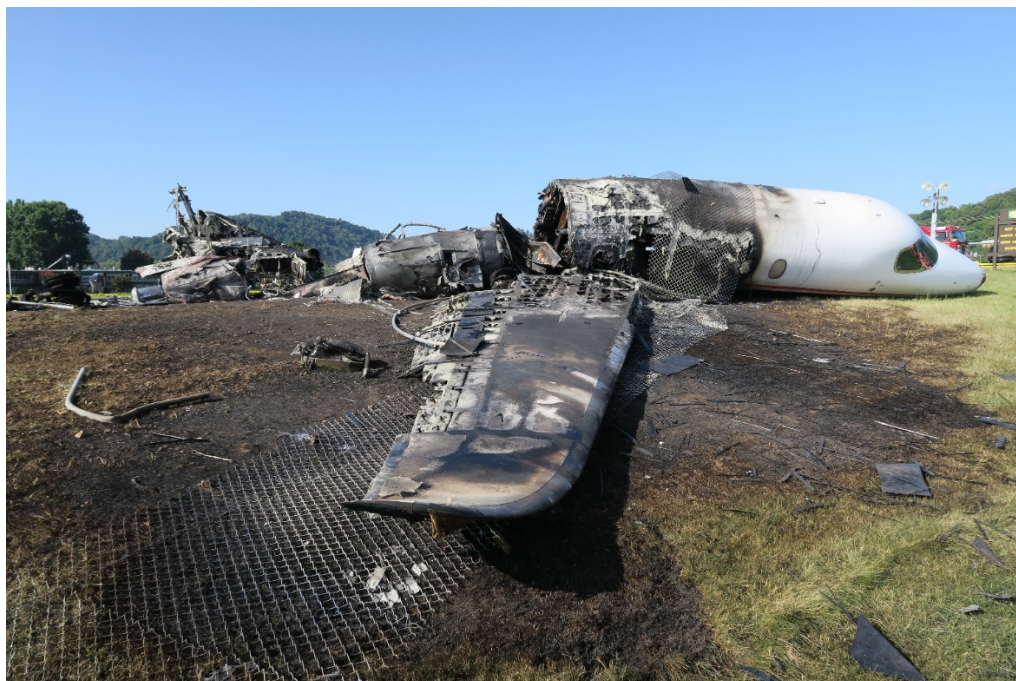
Per security video, the aircraft touched down on the runway and bounced. The aircraft appeared to climb back up to about 25' AGL before it descended rapidly and landed hard on the runway. The right main landing gear collapsed, and the right wing tip contacted the runway. Skid marks from the right main gear and right main gear door indicated the aircraft traveled slightly to the left before it turned back to the right. The aircraft departed the end of the runway on center line and traveled down a grass covered hill for approximately 400'. The aircraft traveled over an approximately 25' wide creek. The left main landing gear and nose gear separated from the aircraft when it struck the opposite creek bank. The aircraft traveled up a small grassy hill and came to rest next to the west bound lanes of Highway 91. The aircraft came to rest on a heading of 285° at an elevation of 1,551'. A post-impact fire consumed the aft portion of the fuselage and inboard wing areas.
