FORUM

JULY-SEPTEMBER 2019

Journal of the International Society of Air Safety Investigators

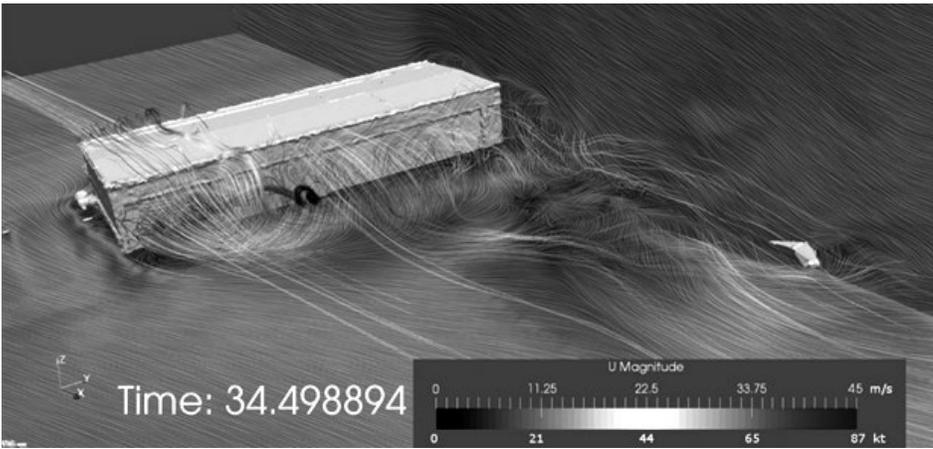
Figure 7. The 3-D visualization of wind simulation results for a discrete time showing turbulence generated downwind of the hangar. Note: The accident airplane's elevators can be seen on lower right side of image.

The wind simulation revealed that, at the accident airplane's parked location, the elevators could have been subjected to hangar-generated turbulent flow that included a small-scale 30+ meters-per-second (58+ knots) gust moving over the airplane. According to the simulation, another possibility included small-scale 15/+15 meters-per-second (-29/+29 knots) vertical vector couplets that moved horizontally toward the air-

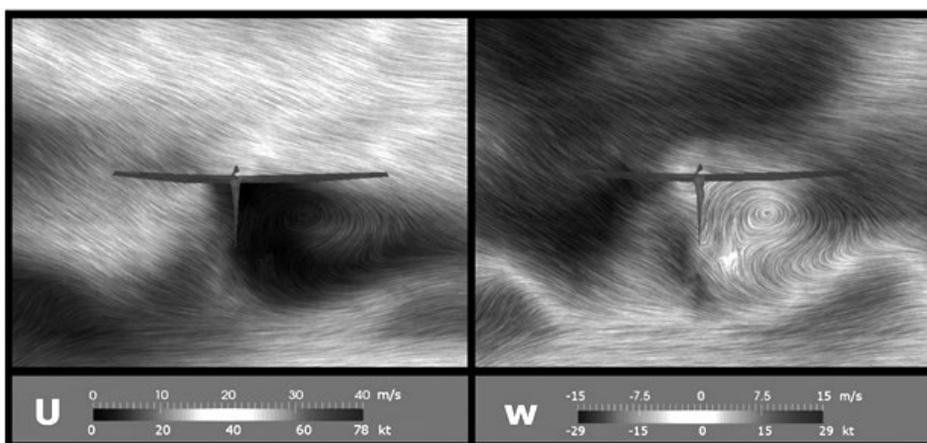
Figure 8. Vertical cross-section visualization of wind simulation results for a discrete time showing horizontal (“U”) and vertical (“W”) wind magnitudes in area of the accident airplane's elevators.

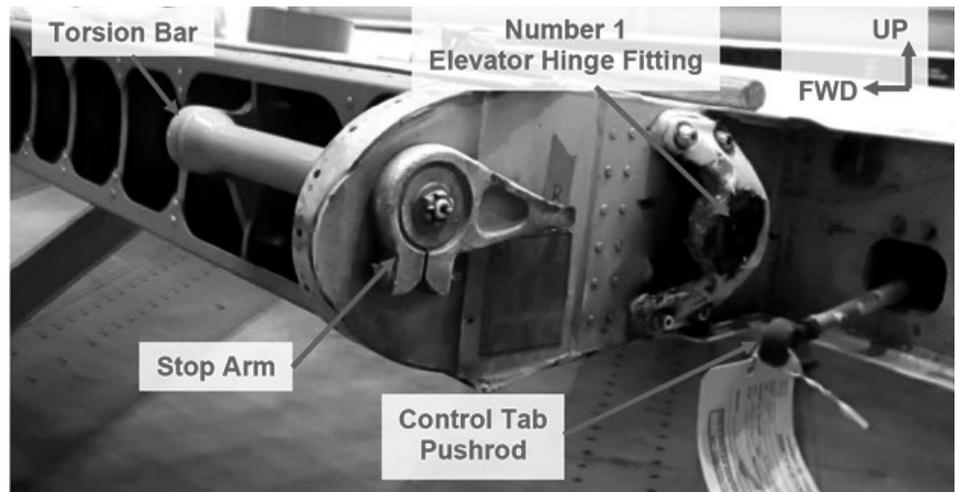
The CFD results assisted the NTSB systems investigator in designing a more representative test plan for the airplane's elevator system, more specifically the interaction with the elevator stops, which included a series of static and dynamic elevator load tests to determine what conditions, consistent with the CFD results and the known circumstances of the accident, could enable the geared tab linkage to move to an overcentered position and jam the elevator.

Figure 9. Elevator stop arm and torsion bar assembly.

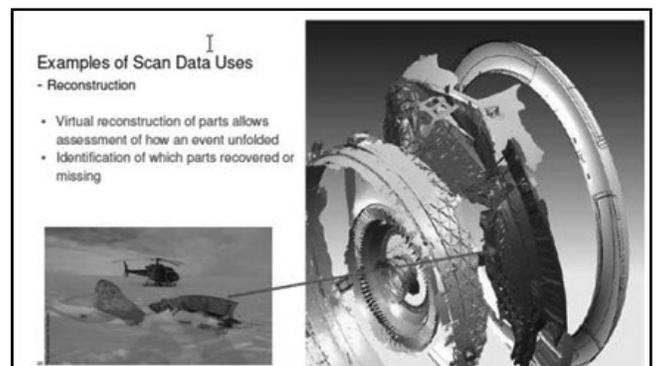
Figure 12. A 3-D reconstruction was produced, providing insight as to how the engine event may have occurred.

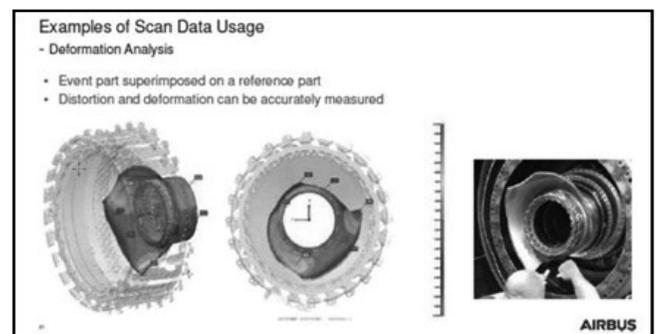
Figure 13: 3-D models can analyze how a part becomes distorted or deformed.

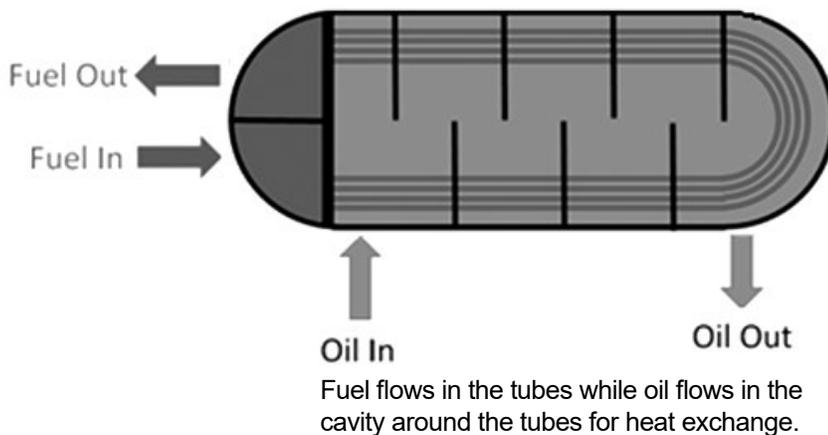
Figure 1. Schematic diagram of the main fuel oil heat exchanger.

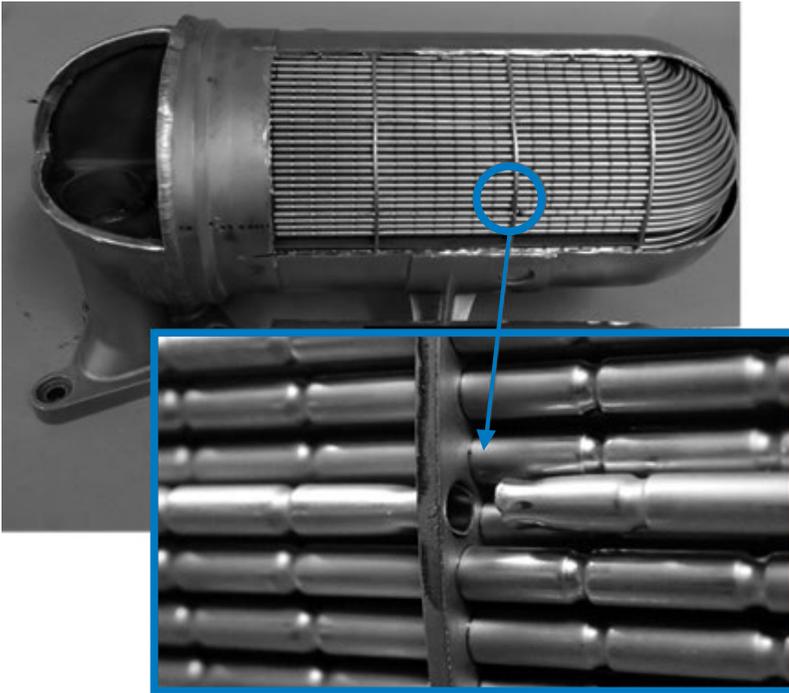
Figure 2. View of cracked tube in the main fuel oil heat exchanger.

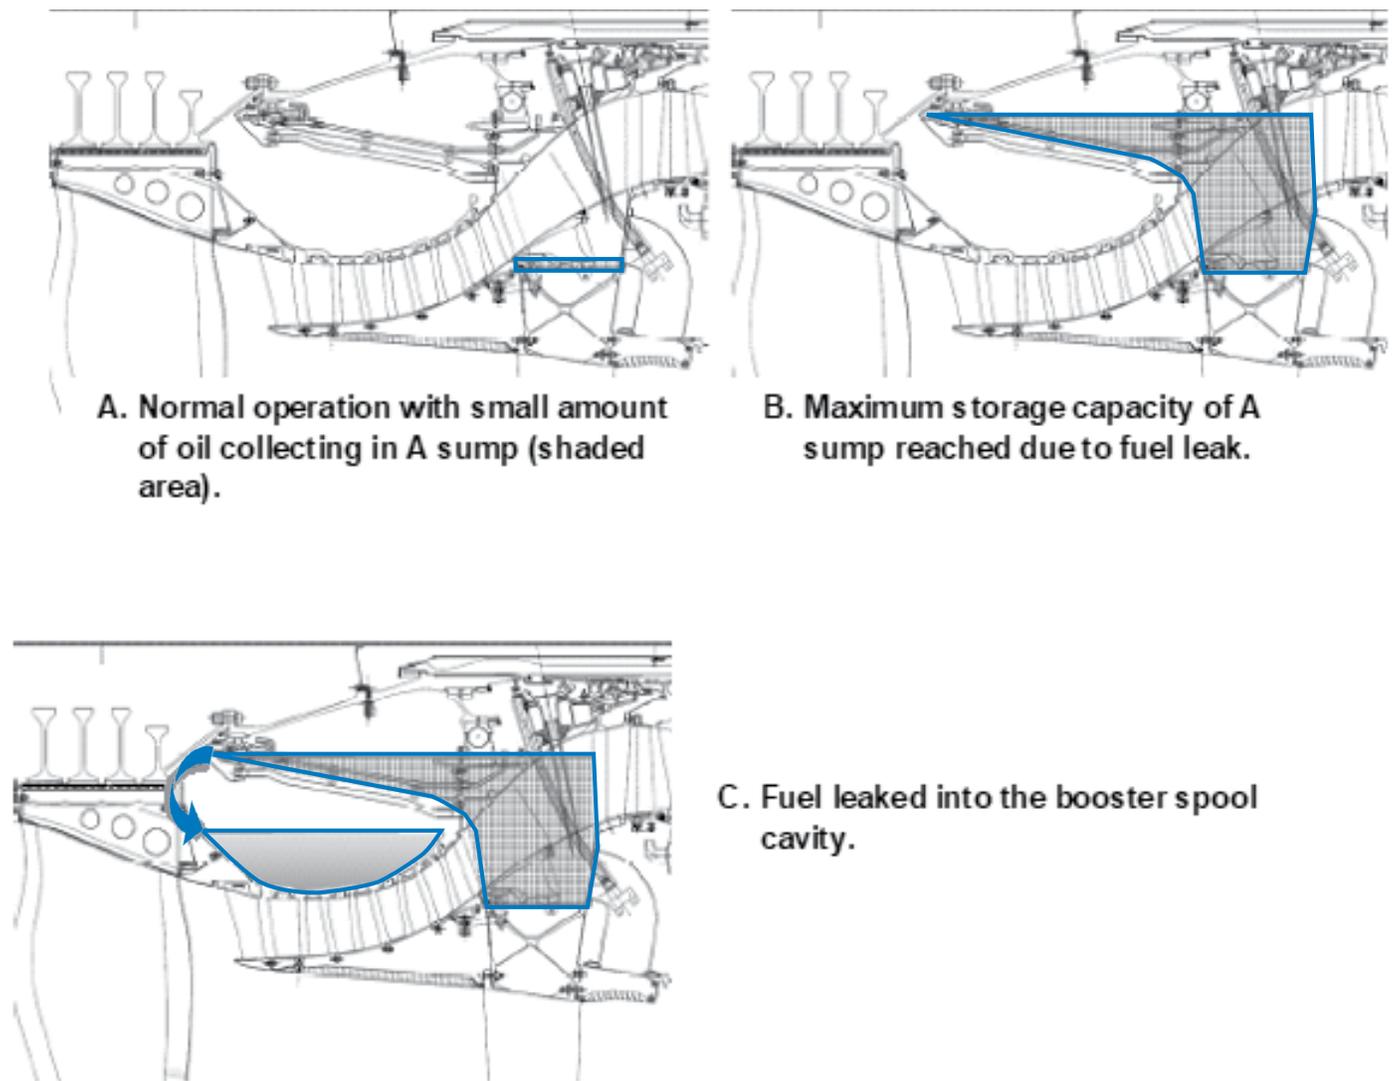
The oil tank and various engine drain points are areas in which one would usually expect to find only oil. Instead, fuel was found in those locations. Similarly, residual fuel was found in the various engine sumps. In addition, the gearboxes and the engine bearings, which are usually coated in oil, were dry. These observations suggest that engine oil was displaced from the engine and fuel, in place of oil, was distributed throughout the engine oil system.

Figure 3: Process of fuel filling the A sump and booster spool cavity.

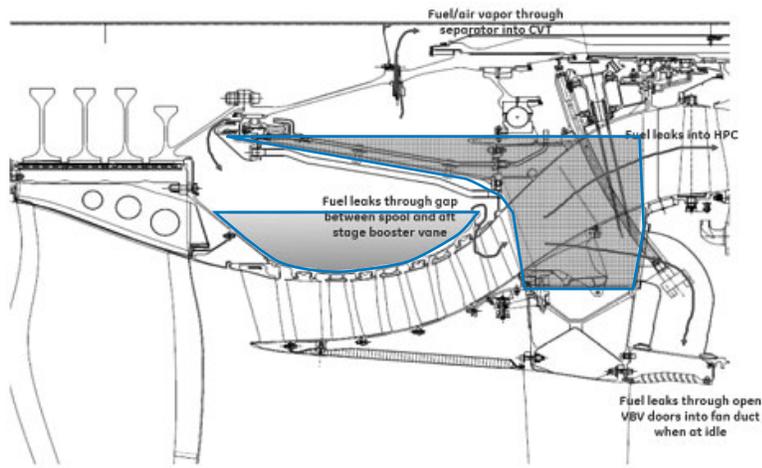
Figure 4: Leak path for fuel.

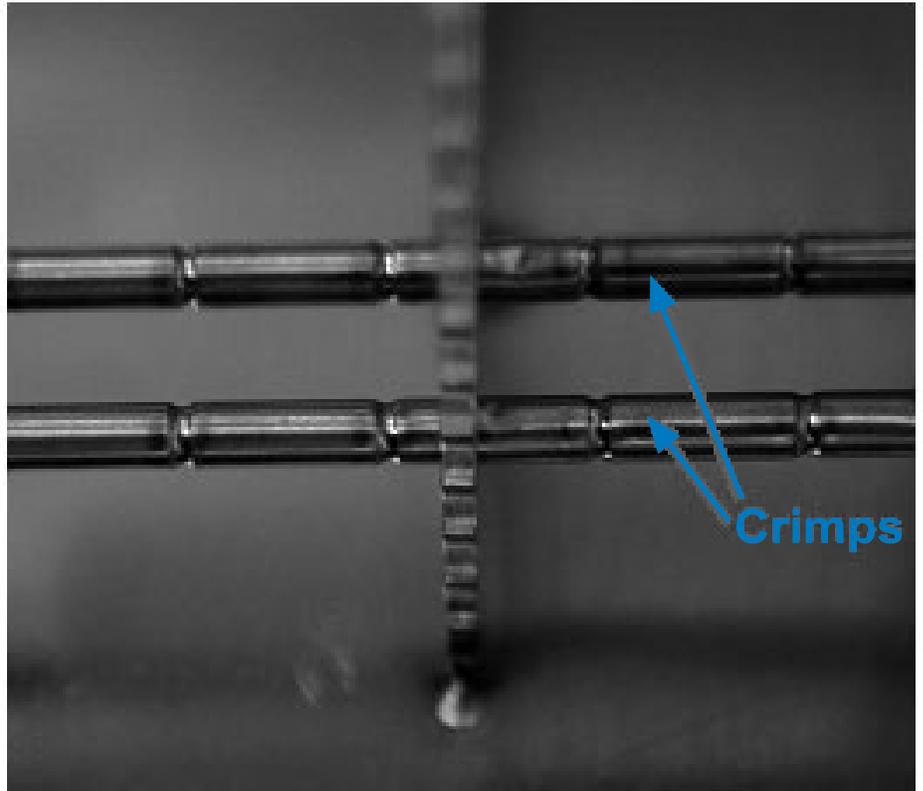
Figure 5. Crimps on tubes.
