# The Investigation of a Lithium-Ion Battery Fire Onboard a Boeing 787 by the US National Transportation Safety Board

*By Joseph M. Kolly, Joseph Panagiotou, and Barbara A. Czech of the  
National Transportation Safety Board*

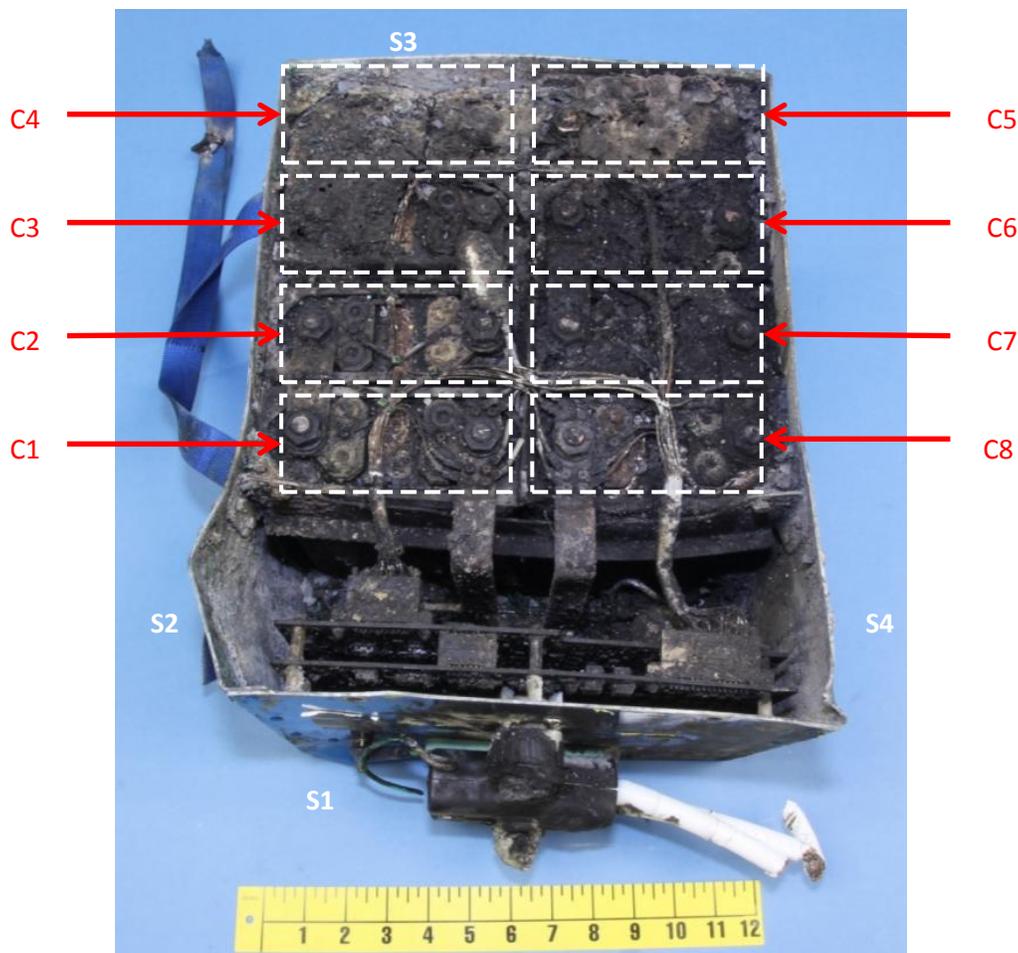
external sources such as electrical short circuiting and mechanical damage as an initiating event. The aluminum top (lid) of the case was bulged upward, exposing the internal components. The top was removed to reveal the upper surface of the battery assembly which exhibited severe thermal damage to the entirety of its internal components. Voltage measurements taken of each cell indicated the battery was completely discharged and electrical continuity measurements indicated each cell was shorted "open".

The thermal damage to the battery components, such as charring of materials and distortions of the cells, indicated areas of higher interest and probability of identifying an origin of the thermal event. However, this obscured clear distinction of the components and prevented immediate disassembly of the battery; a more deliberate disassembly process was necessary to avoid destroying any potential evidence that might indicate the root cause of the failure. Figure 4 shows the condition of the battery as received in the laboratory (with the top of the case removed).

**Figure 4.** Opened battery case showing approximate cell locations.

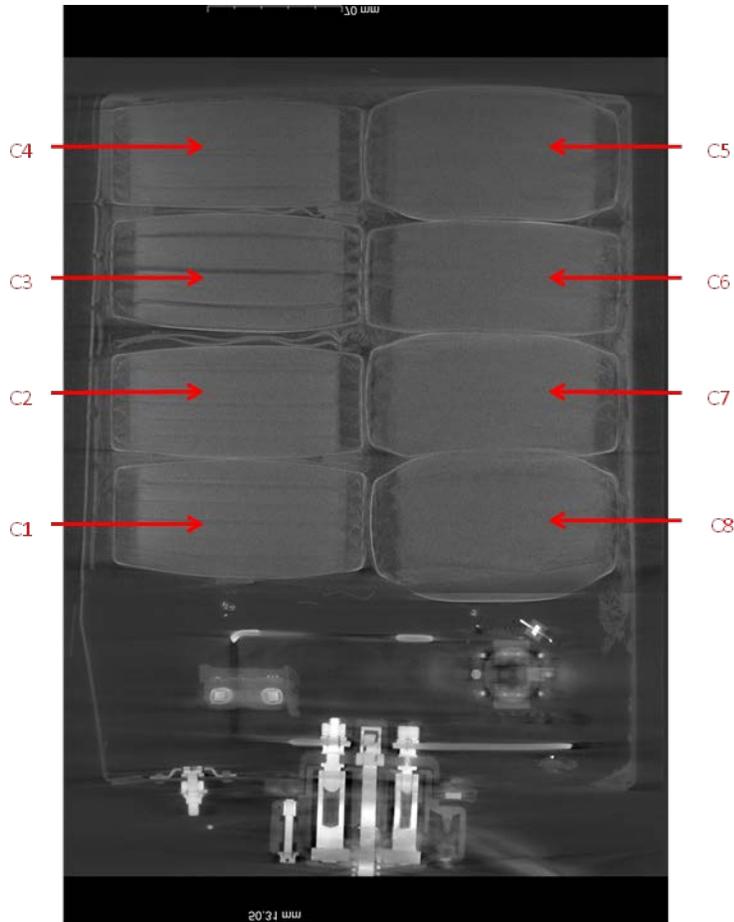
The results of the radiographic imaging work indicated that, although several of the battery cells had permanently deformed (bulged), they remained mostly intact. In the radiographic image below (figure 5), one can clearly see the bulging of the cells and the electrode windings that remained within each cell. Also evident was both cell-to-cell and cell-to-battery-case contact. The imaging revealed an absence of foreign materials within the battery, external to the cells.

**Figure 5.** Radiographic image of JAL APU battery indicating cell locations.

From this image, it is apparent that the cells on the right side of the figure (cells 5–8) experienced greater mechanical damage, in the form of bulging, than those on the left side. This pattern also corresponded to more severe thermal damage to the polymeric materials on the right side of the battery.

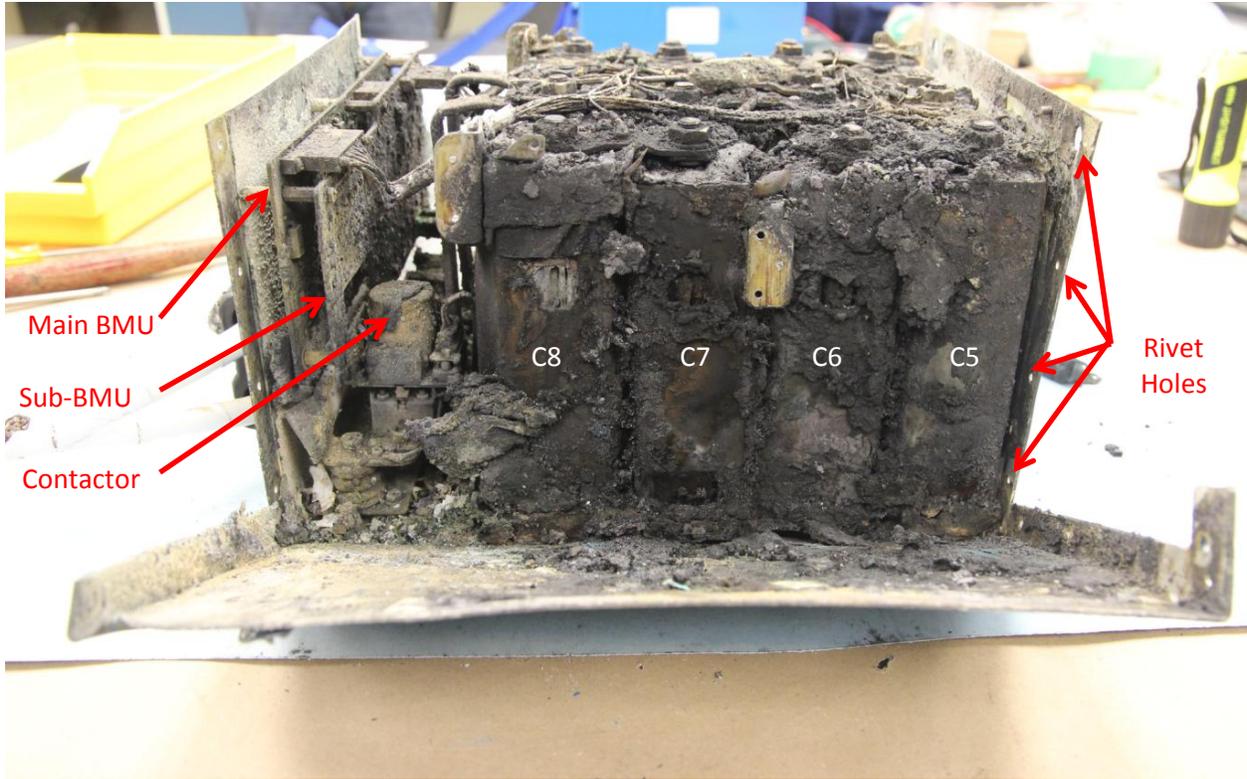
Disassembly began by removing the rivets along the seams of the aluminum battery case and folding down the sides. (See figure 6.) Figure 6 shows the side of the battery that experienced the greatest thermal and mechanical damage. When the sides of the cells were exposed, it was apparent that cells 5–8 had relieved pressure through their vent discs. Cells 1–3 also vented but with less deformation of their vent discs.

**Figure 6.** View of battery with battery case panel pulled back to reveal cells 5 through 8.

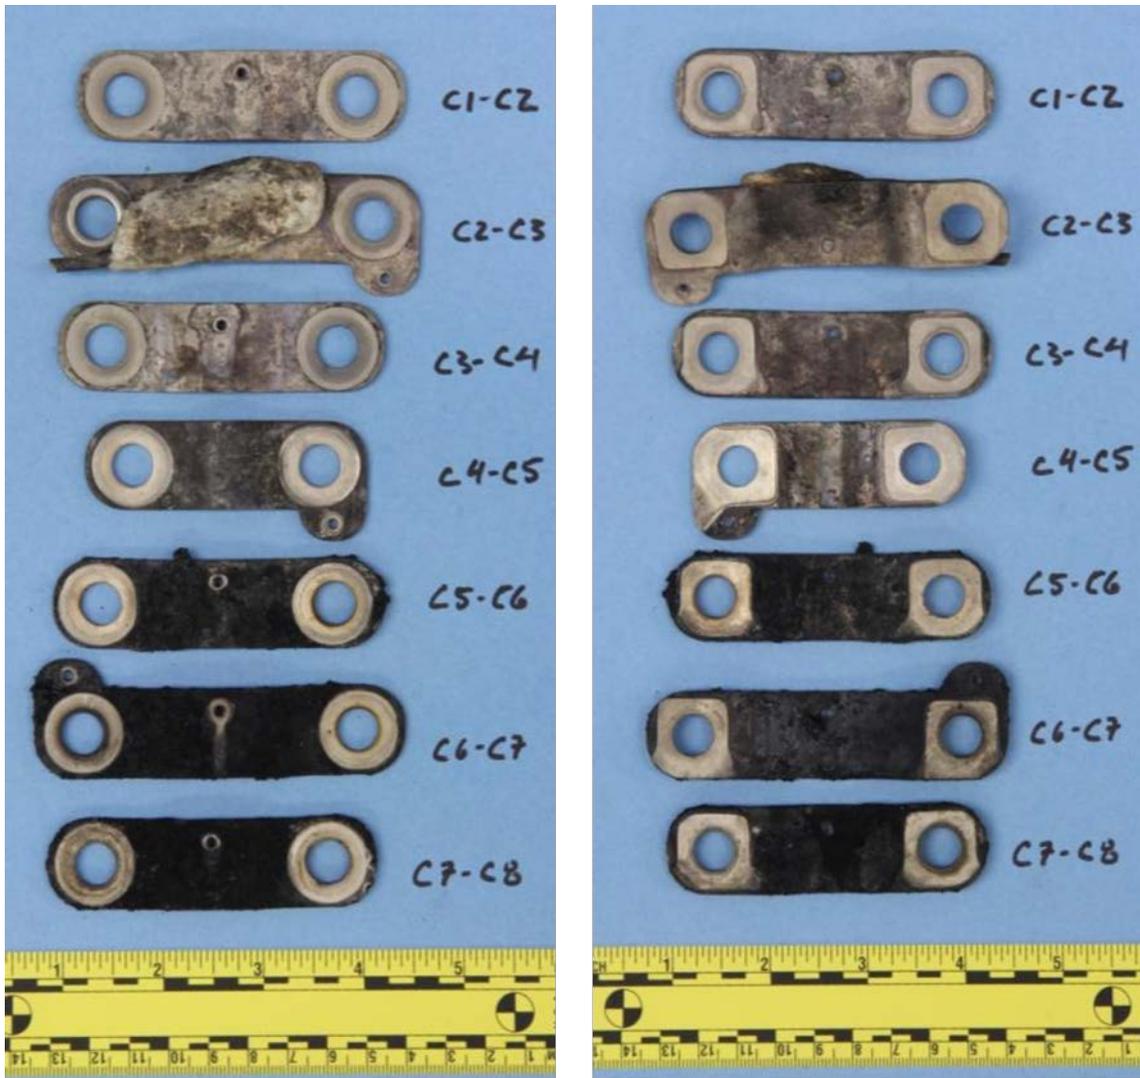
**Figure 7.** Views of bus bar contact surfaces. The photo on the left shows the contact surfaces facing the washer and the nut. The photo on the right shows the contact surfaces facing the battery terminal.

For each bolted connection, the condition of the faying contact surfaces was visually evaluated using a 5X to 50X zoom stereo microscope. No dark oxides or interference colors associated with high-temperature resistive heating were observed on the surfaces of the bus bars.

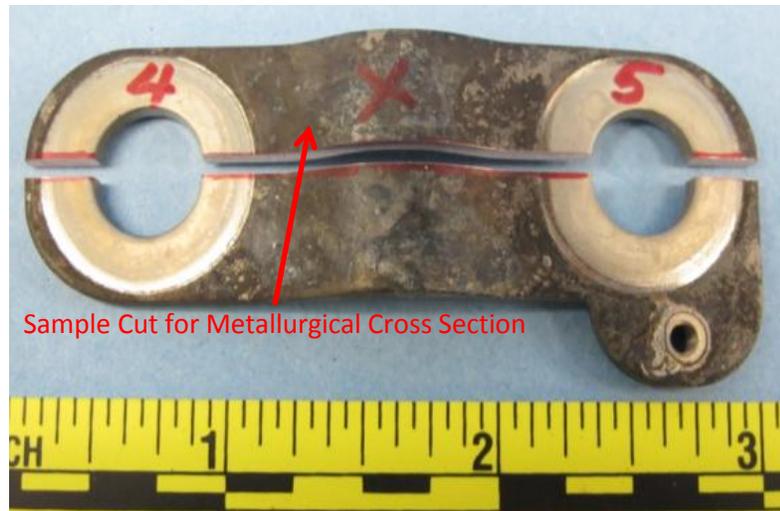
**Figure 8.** Section cut through the bus bar connecting cells 4 and 5.

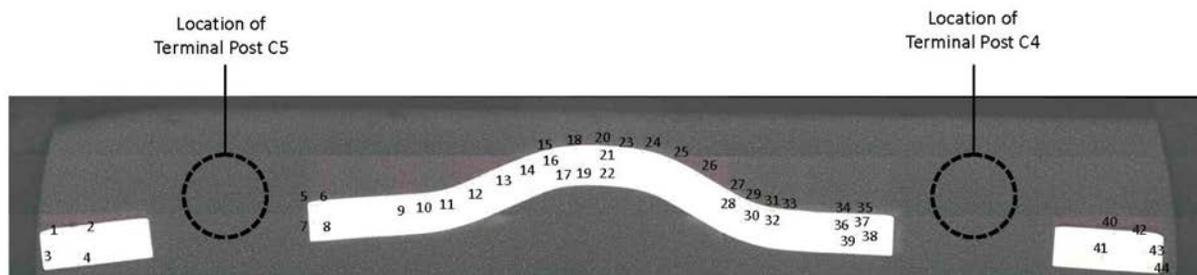
The cross sections were mounted and polished, and their microhardness was tested in accordance with ASTM E384-11e1.(6) The locations of the microhardness indentations are displayed in figure 9. The mounted samples were then microetched in accordance with ASTM E407-07e1.(7) No microstructural changes, such as grain growth or hardness changes associated with localized heating, were observed.

**Figure 9.** Microhardness indentation locations of C4–C5 bus bar.

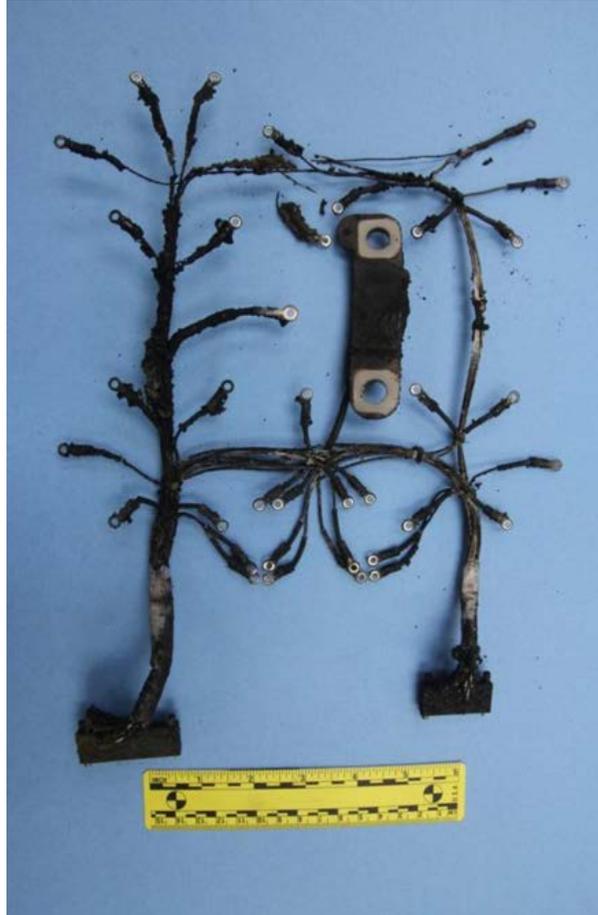
**Figure 10.** Wiring harness, as removed. (View is from the bottom.)

The overall appearance of the wiring harness was consistent with exposure to a high-temperature environment with areas of varying severity. The insulation on the wires was mostly intact, but it exhibited varying degrees of thermal discoloration and staining from the expelled battery cell contents (carbonaceous, electrolyte, and cathode material). Evaluation of the thermal damage to the wiring harness suggested an area of higher temperatures or an area of longer exposure to elevated temperatures during the event. This also corresponded to areas of higher thermal damage to items such as the upper and lower fixation trays. The concentrated thermal damage suggested an area of higher interest for establishing an origin.

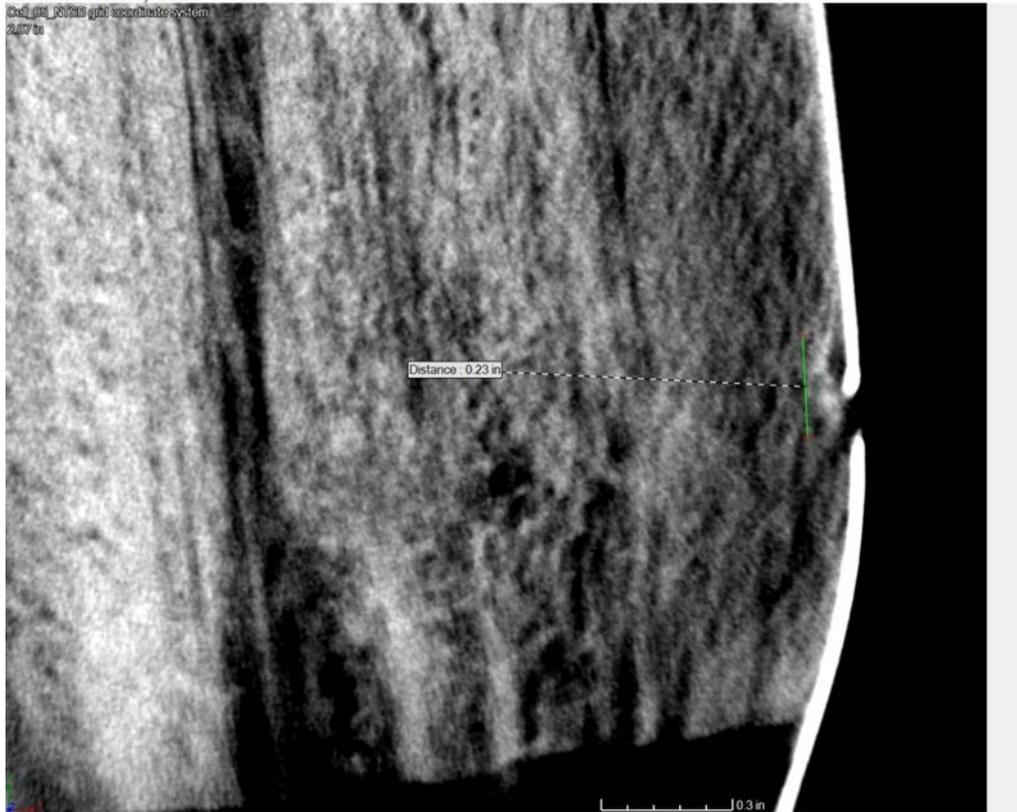
Following the disassembly of the battery, each cell was subjected to additional radiographic imaging. The resulting CT scans had a scan volume of approximately 1,300 pixels by 650 pixels by 1,850 pixels for each battery cell. As an example of the detail that can be obtained, the CT scan shown in figure 11 clearly shows a breach in the case of cell 5 less than 0.10 inch long.

**Figure 11.** CT scan of cell 5 showing breach in case.

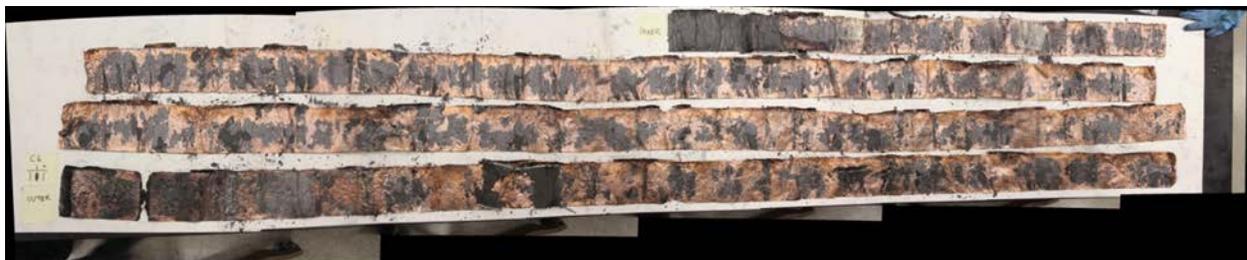
**Figure 12.** Cell 6 electrode unwound on table.

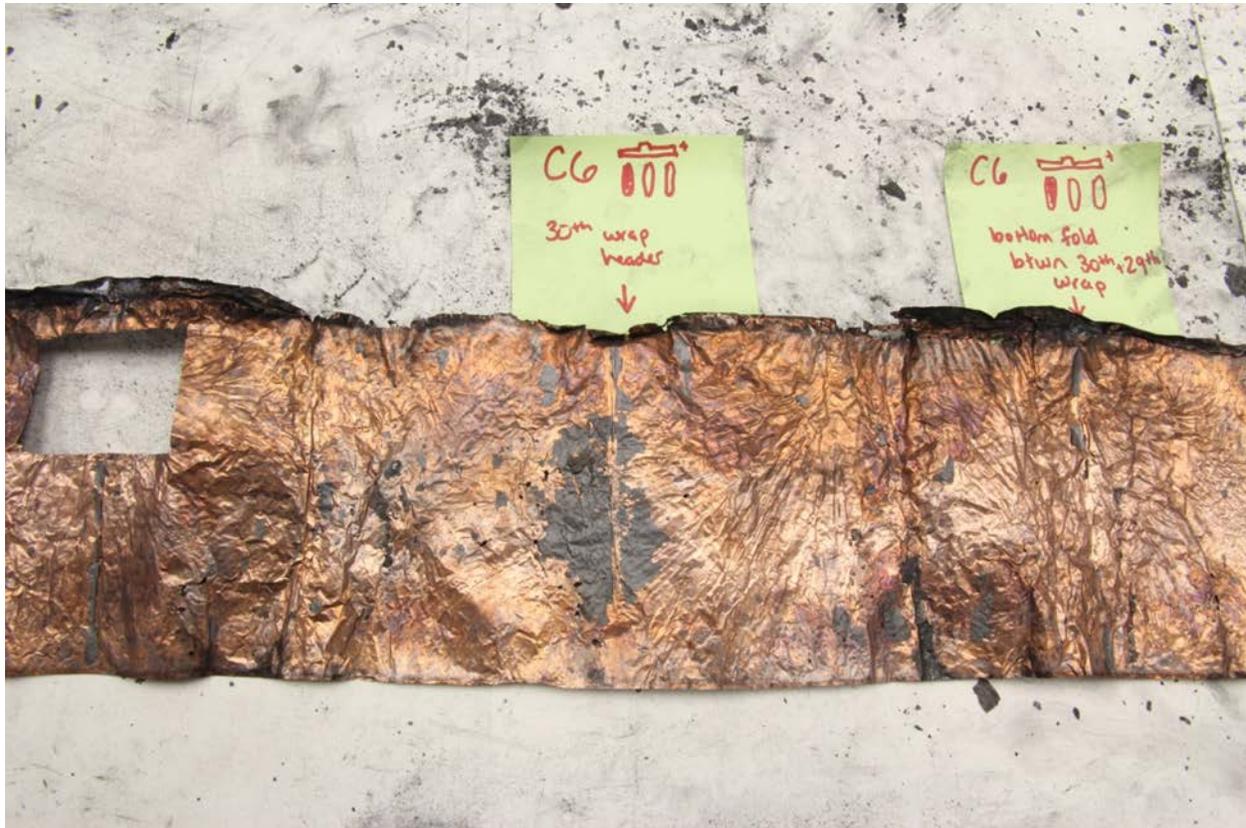
The entire surface of both sides of each electrode was then examined by the naked eye and digitally photographed. Any anomalous areas of interest were carefully sectioned and examined further with digital microscope and SEM. Areas of special interest included those showing unique thermal damage, such as burn-through spots and regions of discoloration. Figure 13 shows such anomalous areas on the electrode from cell 6. They are characterized by localized hot spots identified by purple hues in the copper foil. Additionally, these hot spots exhibit radiating patterns and repeat in the same relative position along the wraps of the winding. Small holes along the top edge of the copper foil indicate short circuiting between the electrodes of the winding.

**Figure 13.** Cell 6 electrode with anomalous areas of interest.

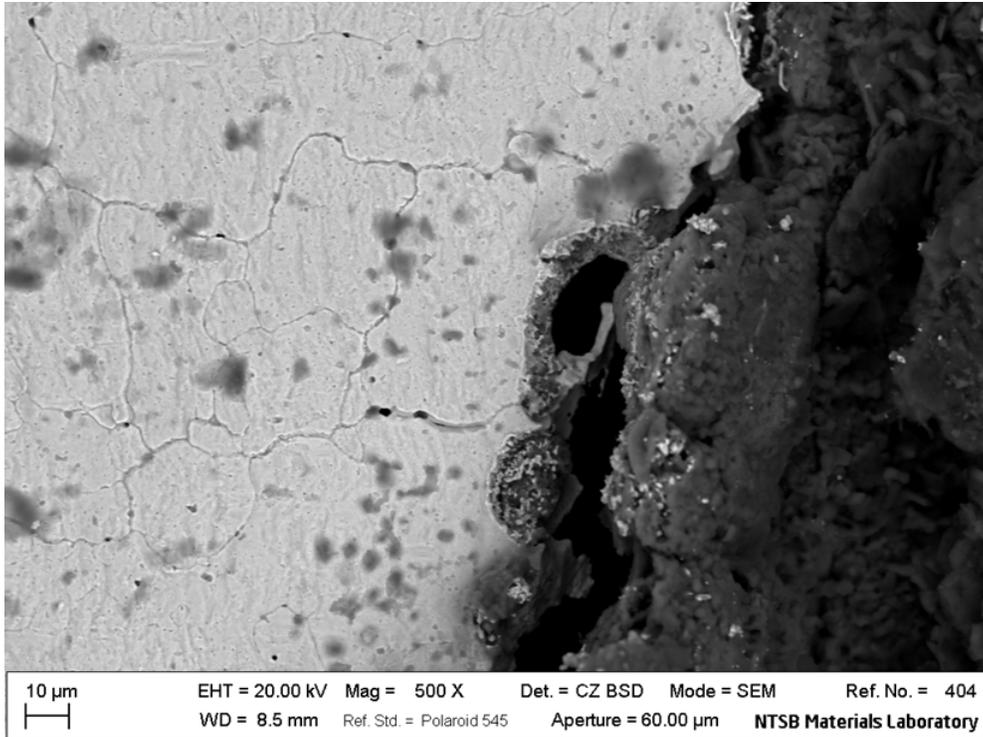
**Figure 14.** Grain boundary decohesion near a foil hole, cell 6.

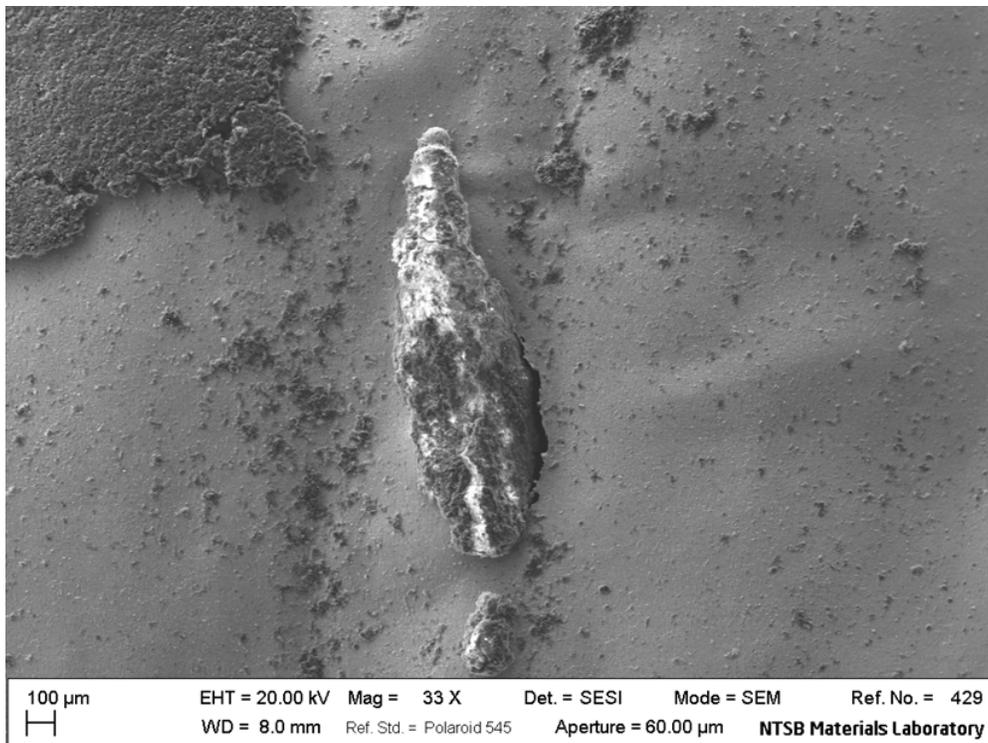
**Figure 15.** Aluminum lump projecting through the bottom of a copper foil wrap, cell 6.

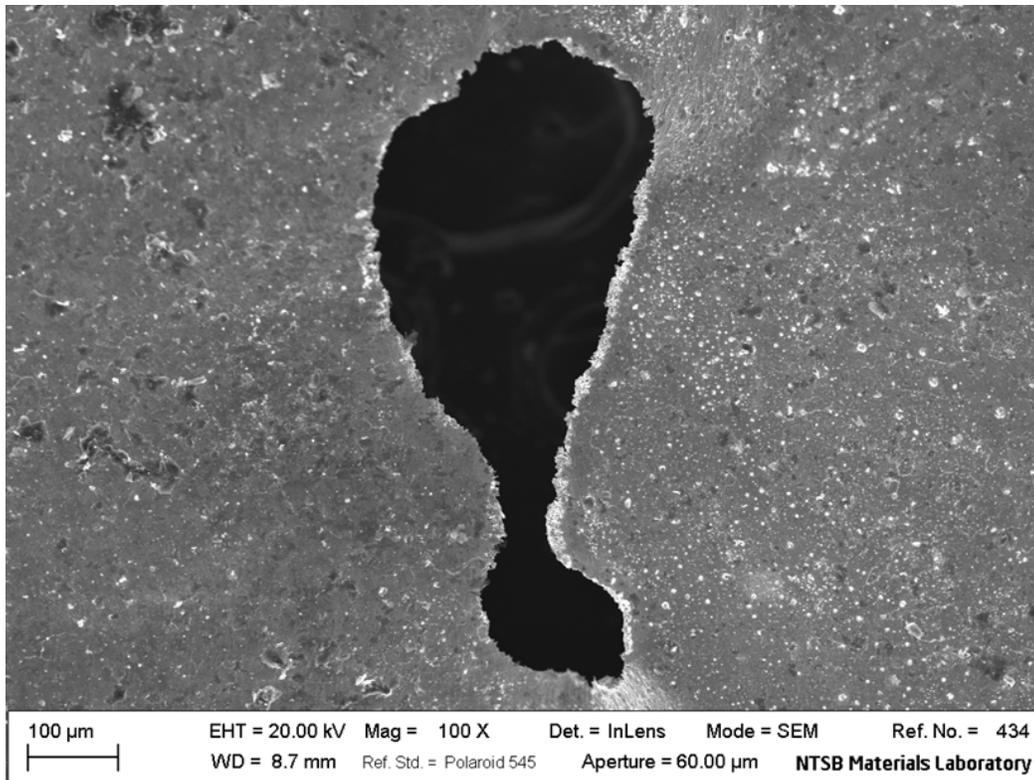
**Figure 16.** Hole in the bottom of the copper foil adjacent to the aluminum protrusion in figure 15, cell 6.
