VFR into dark night: Nothing to see but much to change

Rob Chopin and Mike Walker

Australian Transport Safety Bureau

Note: This paper is based on the ATSB's investigation AO-2011-102, Loss of control at night involving Aérospatiale Industries AS355F2, VH-NTV, 145 km north of Marree, South Australia, 18 August 2011. For further information including references, please obtain the report from www.atsb.gov.au.

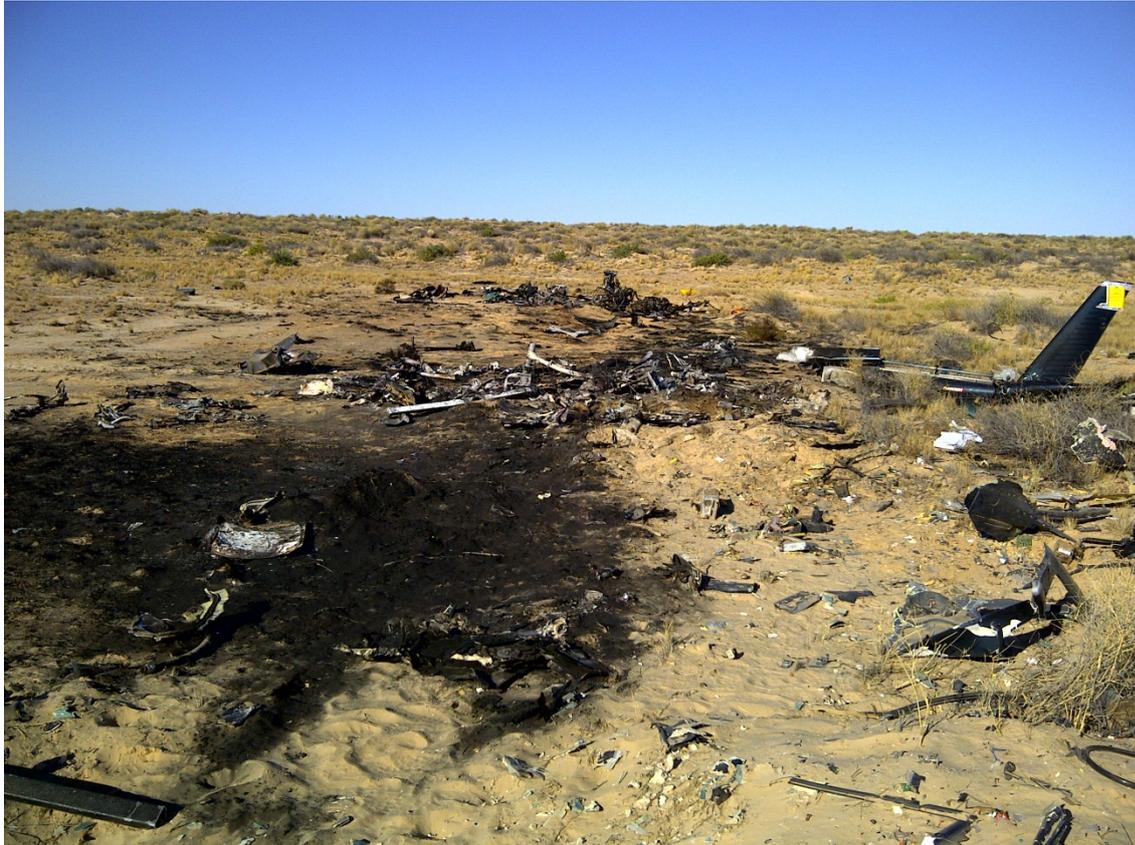
Figure 1: Helicopter wreckage

The accident occurred in a remote area, and the helicopter was destroyed by impact forces and fire (Figure 1). The site examination found that:

- The impact occurred about 3 km east-north-east of the departure point.
- The helicopter impacted terrain at high speed with a right bank angle of about 90°.
- All of the helicopter's major components were identified at the accident site.
- There were no indications of fire prior to impact.

- Component examinations showed no pre-existing defects associated with the helicopter's flight control system, engines or airframe.

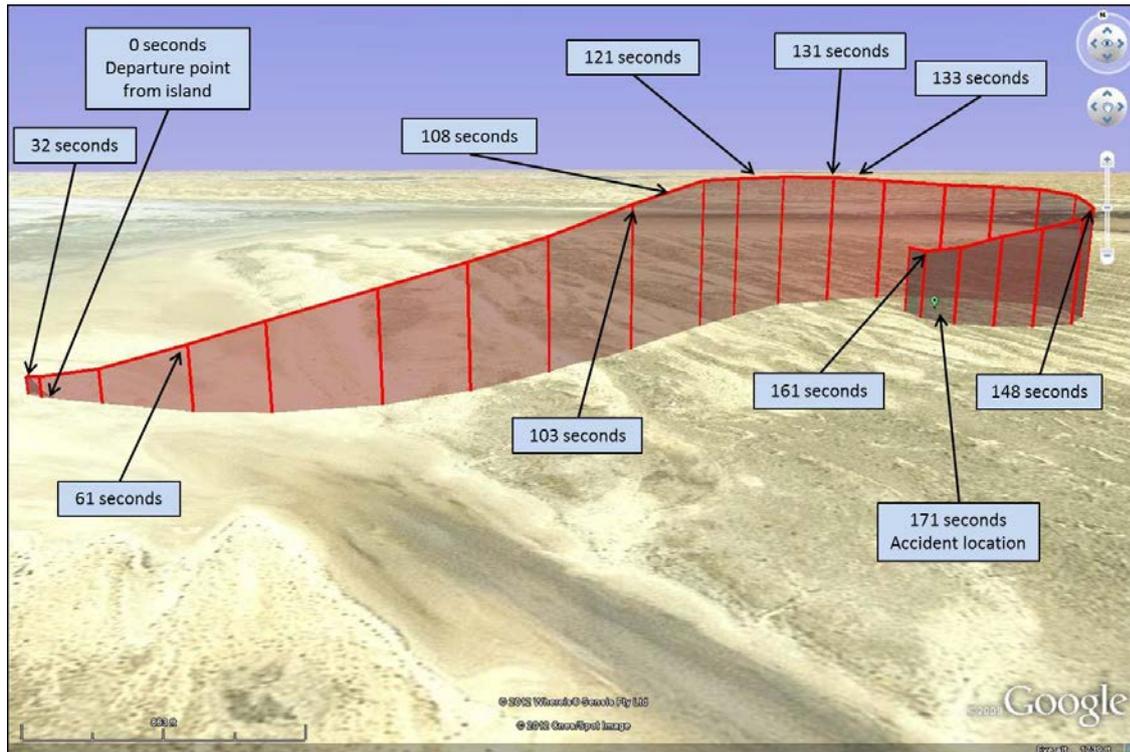
Figure 2: Flight path derived from recovered GPS data-elevation view

The GPS data indicated that the helicopter took off at about 1859. About 103 seconds after take-off, the helicopter rolled out on a heading of 035°, and at 108 seconds it levelled off at an altitude of 1,500 ft above mean sea level. After 121 seconds, the helicopter commenced a gentle right turn. About 10 seconds later the helicopter was established at cruise speed (105 kt), and soon after (133 seconds) the helicopter started descending with the bank angle increasing. Based on the GPS data and flight path estimations, it was calculated that the helicopter impacted terrain about 171 seconds after take-off, or about 38 seconds after it started descending. Figure 2 provides an overview of the helicopter's flight path.

The 035° outbound track can best be explained by the pilot having selected an incorrect destination on one or both of the helicopter's GPS units prior to departure. Analysis of the flight path indicated that the left turn onto a specific track after reaching 500 ft was consistent with the pilot using one or both of the GPS units for navigation and tracking to a destination selected prior to departure. In addition, one of the locations on the crew's itinerary, Cowarie Station, was on a bearing of 034° from the take-off point and about the same distance away as the intended destination. In summary, the investigation concluded that the right turn after reaching 1,500 ft was intentional, and it was initiated by the pilot in order to correct an unintended problem with the initial departure track to the north-east.

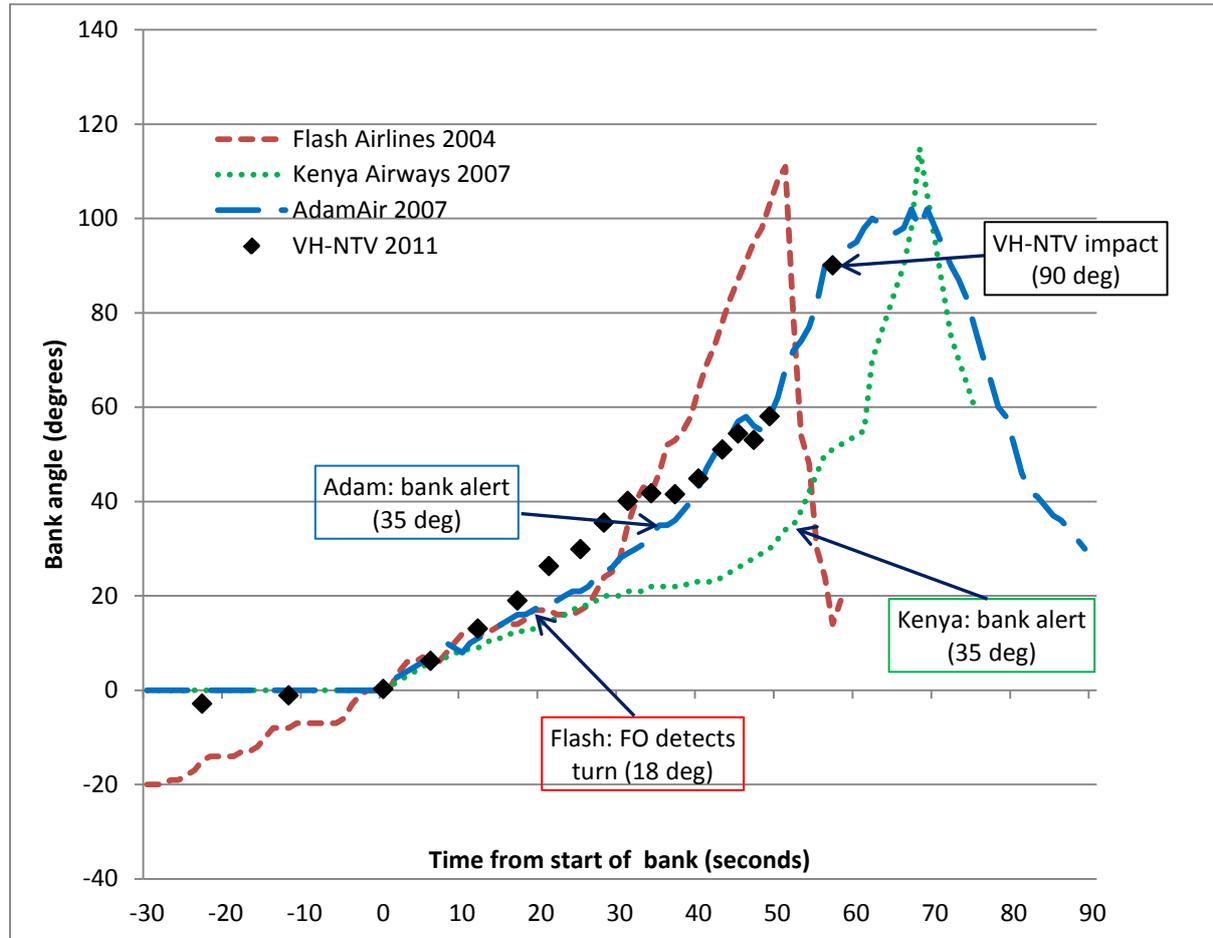
Figure 3: Bank angles in some recent air transport accidents

A significant number of aircraft accidents have been associated with a gradually increasing bank angle for an extended period. These have included several accidents involving civil air transport aeroplanes. In most cases the flight crew took a significant period of time (tens of seconds) to recognise the problem. Just as importantly, the bank often kept increasing for a significant period of time (tens of seconds) after it was detected. Common conditions in these types of accidents included the flights being conducted in instrument meteorological conditions (IMC) and/or dark night conditions, the crews not using the autopilot, and the crew's attention being diverted to other tasks. In all cases, there were two crew and both had instrument ratings. Figure 3 shows the bank angles of three aircraft involved in these types of accidents, as well as the estimated angles for VH-NTV.

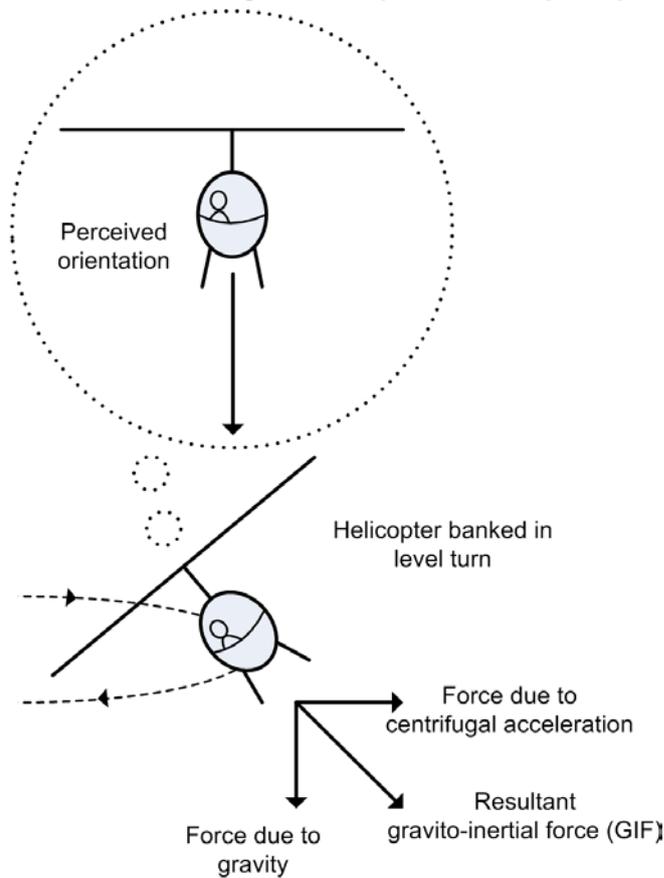
Figure 4: Gravito-inertial force during turn and potential misperception

There are many misperceptions and illusions that can be associated with a gradually increasing bank angle. These include the roll being below the detection threshold, 'the leans', the somatogyral illusion and the somatogavic illusion. Although the latter is more commonly associated with false pitch perceptions during take-off, it also occurs in other situations where a pilot misinterprets the gravito-inertial force (GIF). For example, during a coordinated turn, the combined effects of the gravitational force and forces due to centrifugal acceleration can lead a pilot to perceive that they are upright rather than in a bank (see Figure 4).

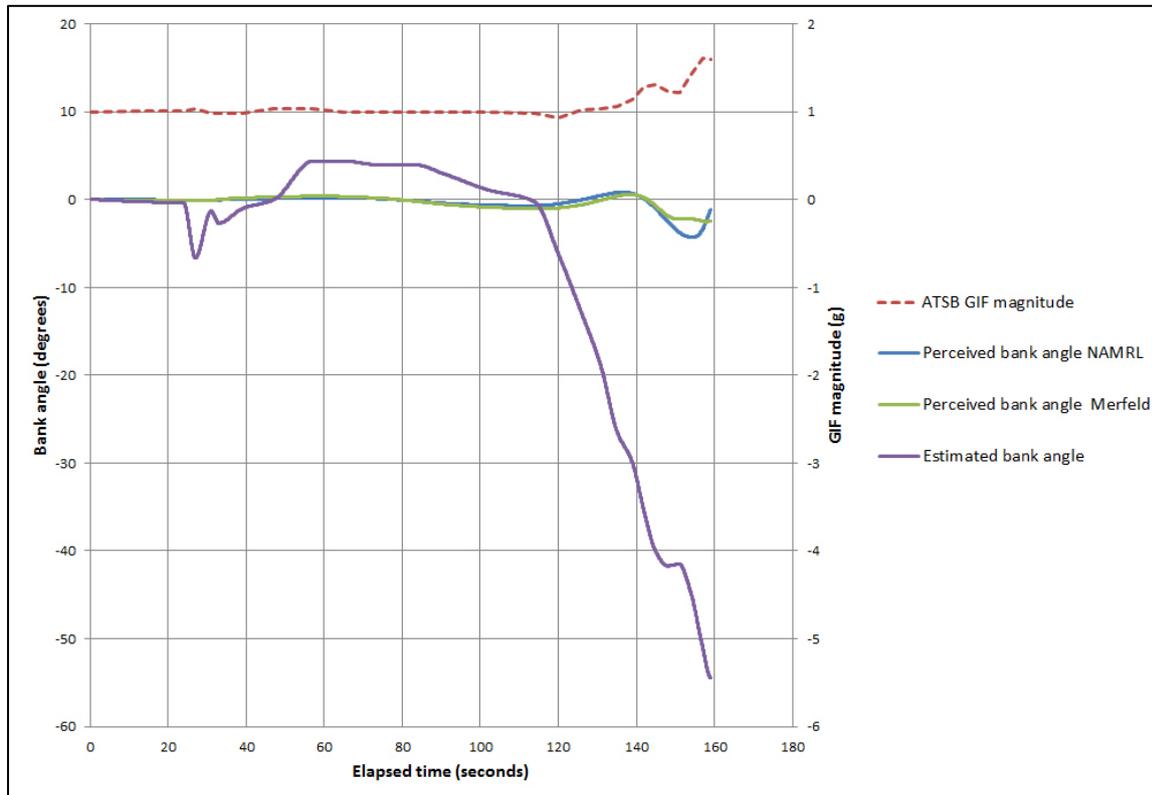
Figure 5: Estimated bank angle and perceived roll

Figure 5 provides details of the helicopter's bank angle estimated by the ATSB, and the two orientation models' estimates of the pilot's perceived roll. As indicated in the graph, the perceived roll during most of the right turn was very low in comparison with the actual roll. During the turn and descent, the magnitude of the GIF also only increased gradually. In summary, if it is assumed

that the helicopter was in or close to coordinated flight, the orientation modelling shows that the pilot would have had very limited non-visual cues of the increasing bank angle and descent.

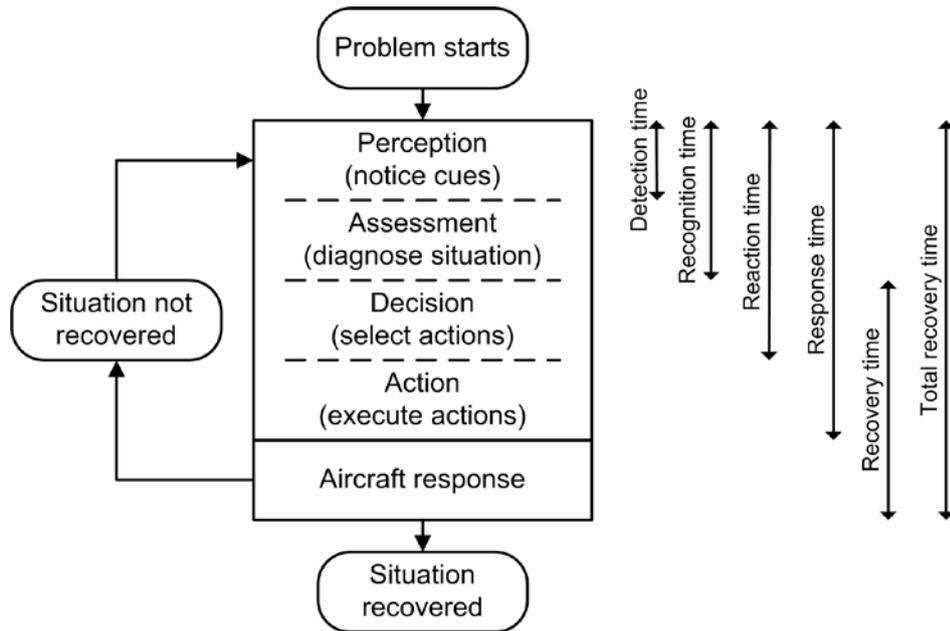
Figure 6: Activities involved in recovering from a problem

A common and significant challenge for the human factors discipline is to explain why a pilot does not appear to detect or correct a problem for a significant period of time, particularly when there are many who, with the power of hindsight, believe they would have been able to detect the problem quicker. Figure 6 provides a simplistic representation of the activities involved in recognising and recovering from a problem. Although each stage adds to the total recovery time, the more significant delays are usually the perception and assessment stages, and these delays are generally more to do with the focus of attention rather than the perception process.

Studies have found that pilots often recover from an unexpected or unusual attitude to straight and level flight within about 10 seconds. However, in these studies the pilots usually had recent practice in responding to an unusual attitude, know they will be presented with an unusual attitude, and know when it will be presented. Total recovery times in real situations will often be much longer.
