The Importance of High Load Event Reporting

Arben Dika MO7106, Member of AAIC/Investigator, Republic of Kosovo

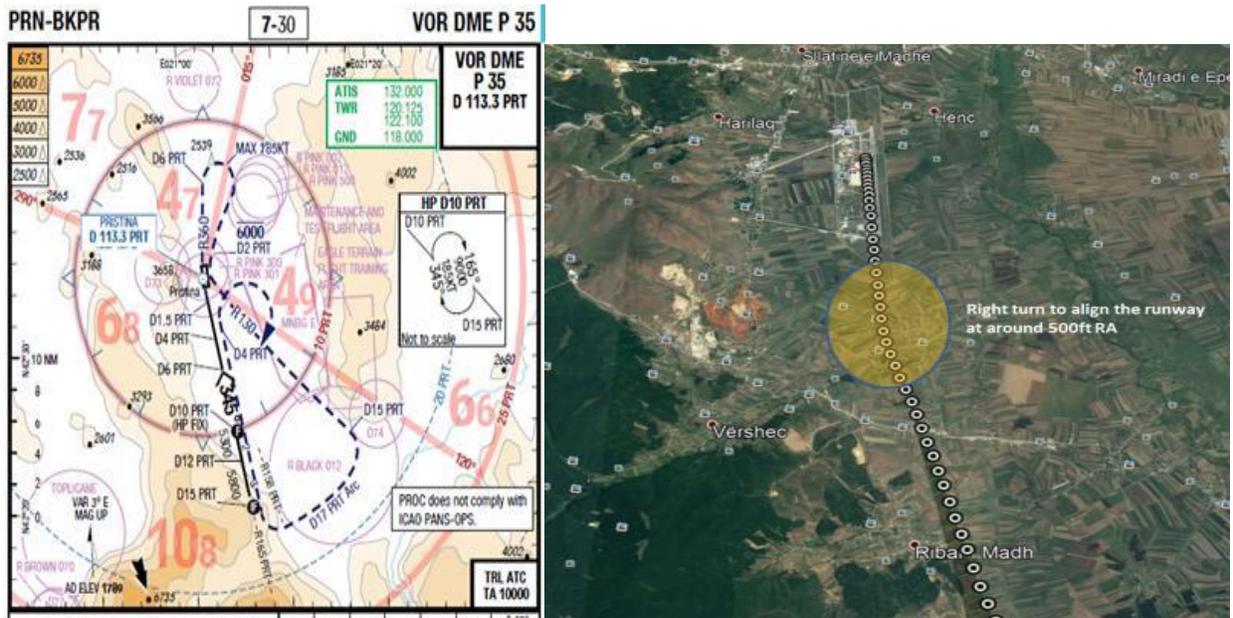
Figure 3: Pristina Approach Runway 35

During the final approach at Runway 35 VOR/DME P there is a need for a right turn. This right turn happens at approximately 500ft RA.

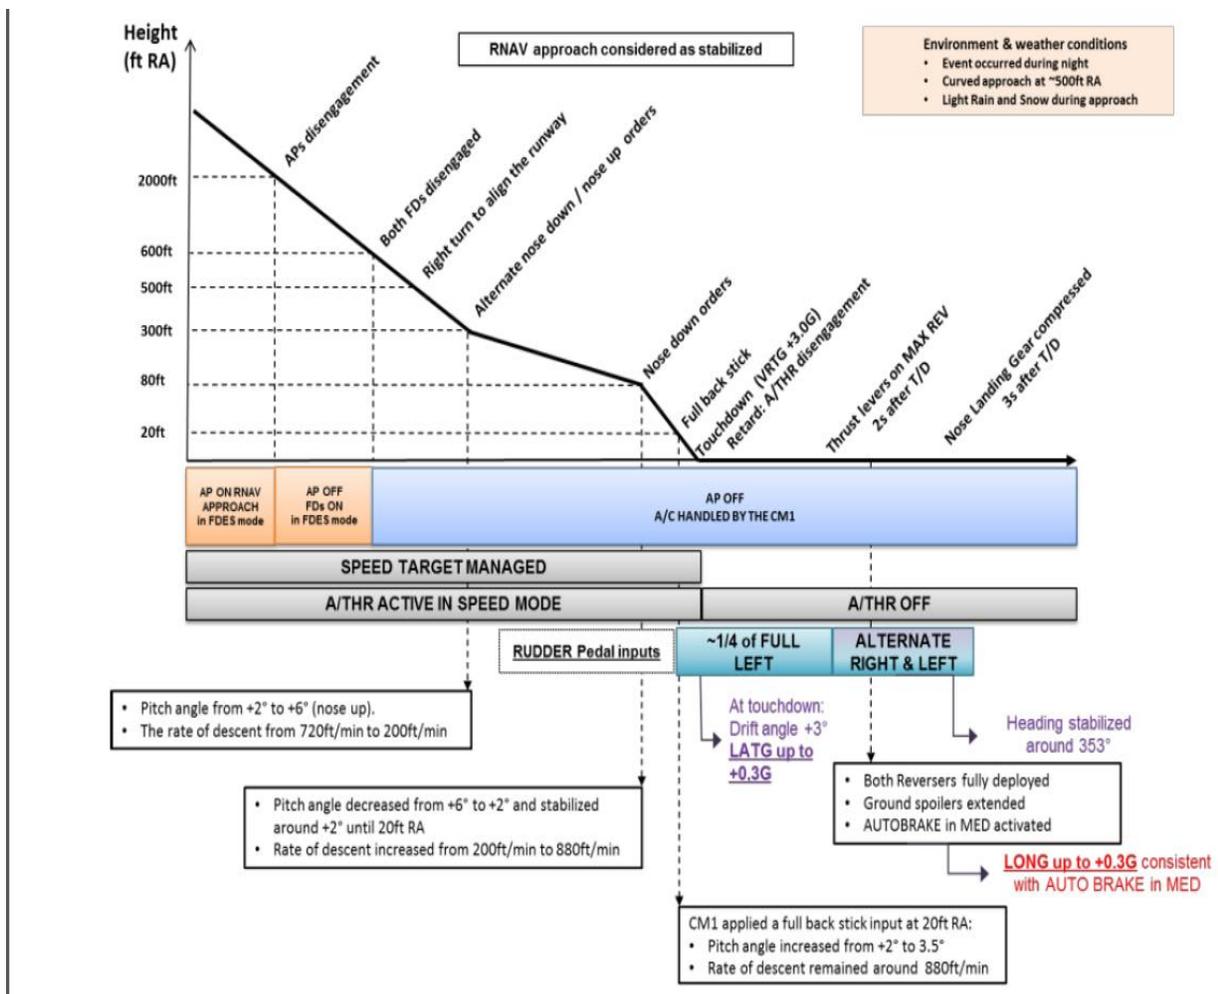
Figure 4: The approach sequence and touch down

From flare at 20ft RA to touchdown on the longitudinal axis a full back stick was applied by PF, pitch angle gradually increased from $+2^\circ$ to $+3.5^\circ$. Vertical load factor varied between $+0.96G$ and $+1.05G$. Rate of descent decreased from ~ 880 ft/min to ~ 420 ft/min. CAS decreased from 138kt (VAPP) to 135kt (VAPP-3kt). Auto thrust still engaged. On the lateral axis the PF side stick input varied between $\sim 1/2$ of full right and $\sim 1/4$ of full left. Roll angle increased from $+0^\circ$ to $+2.5^\circ$ (right wing down). Rudder pedal input was maintained to $\sim 1/4$ of full left deflection. Heading remained around 350° (QFU 353°). Drift angle reached $+3^\circ$ (aircraft nose toward the left of the track).

The aircraft touched down with following data: on the longitudinal axis:

- $+3.5^\circ$ of pitch angle.
- -17 ft/s (± 2 ft/s) of recalculated aircraft vertical speed.
- $+3.0G$ of vertical load factor.
- $+2.5^\circ$ of roll angle (right wing down).
- $+3^\circ$ of drift angle (aircraft nose to the left of the track)
- Thrust levers were retarded to "IDLE" and A/THR disengaged.
- Ground spoilers started to extend.
- CAS was 135kt (=VLS+2kt).
- Ground Speed was 138kt.

And on the lateral axis:

- 350° of heading (QFU 353°).
- $+3^\circ$ of drift angle (aircraft nose toward the left of the track).
- Lateral load factor was at $+0.3G$ (consistent with drift angle).

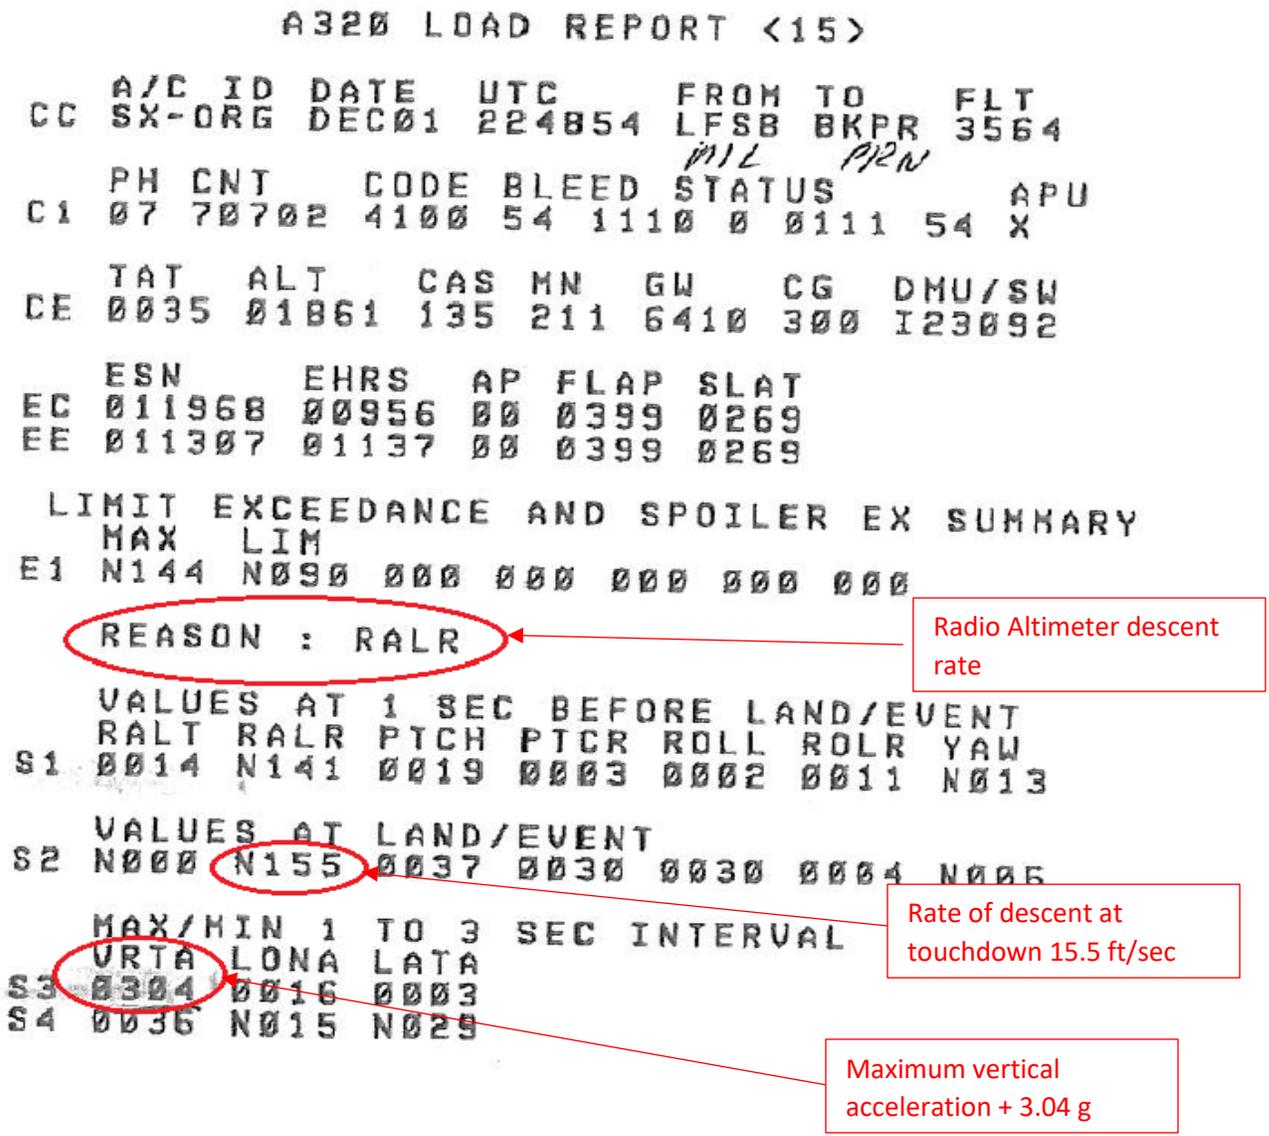
Figure 6: Load <15> report

The aircraft A320 have an Integrated Data System that is called AIDS. This system receives information from many other systems through its DMU. The DMU then processes this data and produces reports based on various parameters. The report generated that identifies the hard landings is called Load <15> report. This report will be produced automatically if any of the following conditions are met:

- The vertical acceleration (VRTA) is higher than 2.6 g (at +/-5 seconds) during the landing and after.

- The radio altimeter descent rate (RALR) is greater than 9ft/sec during the landing (at +/- 5seconds)
- When the aircraft gross weight (GW) is higher than the maximum landing gross weight (GWL) and the radio altimeter descent rate is less 6ft/sec.
- When the aircraft gross weight (GW) is higher than the maximum landing gross weight (GWL) and vertical acceleration (VRTA) is higher than 1.7 g.
- For a bounced landing the vertical acceleration (VRTA) is higher than 2.6 g (at +/- 5 seconds) during the landing.

The Load <15> report is a structural exceedence report to identify if a hard landing has occurred, if so to ensure appropriate checks and inspections followed by AMM reference.

The Operator to implement an ACARS system or to ensure that there will be no paper shortage in the DMU.
