# Black Swan events – examples from Airbus history

This technical paper provides a technical summary of these events. It will focus on the lessons learnt (design, manufacturing, procedures and training) and the product safety enhancements which were developed post-events.

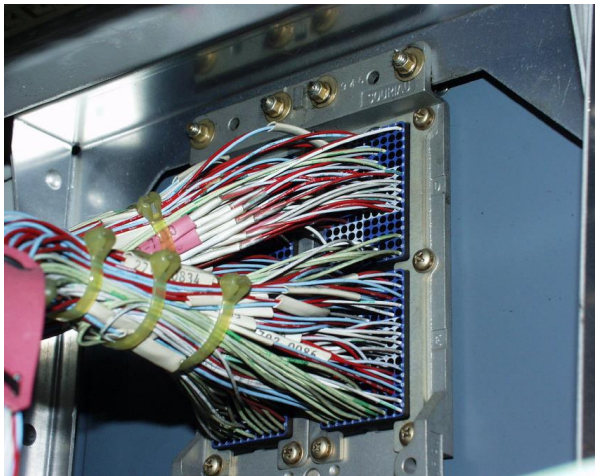
Crossed Roll Controls, A320 (2001)

The root cause of this event was that one flight control computer (ELAC) input wires had been inverted during maintenance. This resulted in the Captain’s sidestick to be inverted in roll.

The issue remained undetected during maintenance and the pre-flight control check.

At take-off the Captain (PF) applied a lateral sidestick input to the right but the aircraft banked to the left.

The F/O took over aircraft control promptly, without the captain’s expressed demand.

Post-event, AMM improvements were introduced regarding flight control system maintenance and the Flight Control Check procedure was modified.

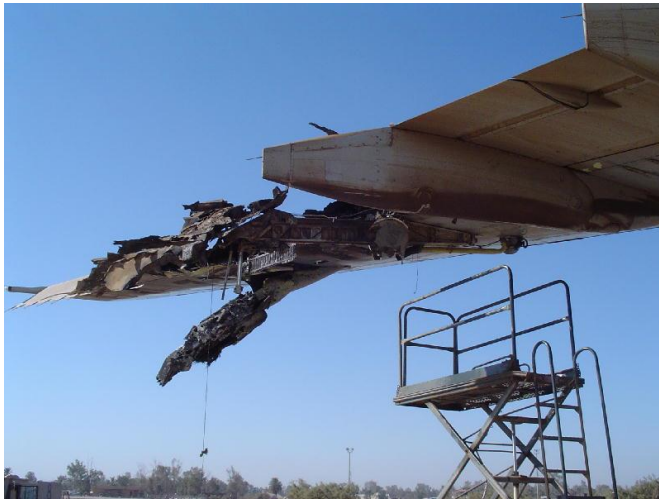
### Total loss of hydraulics, A300 (2003)

This event was caused by a terrorist act. The left wing was hit by a missile during the initial climb (around 8000ft).

This resulted in the loss of all 3 hydraulic systems in ~20s. Subsequently all flight controls were lost and slats & flaps were frozen at their current position.

In addition, a significant amount of the left wing surface was missing, a fire had started and the associated fuel tank was emptying.

However, both engines were still running. The crew managed to learn how to control the aircraft pitch & roll using thrust only.

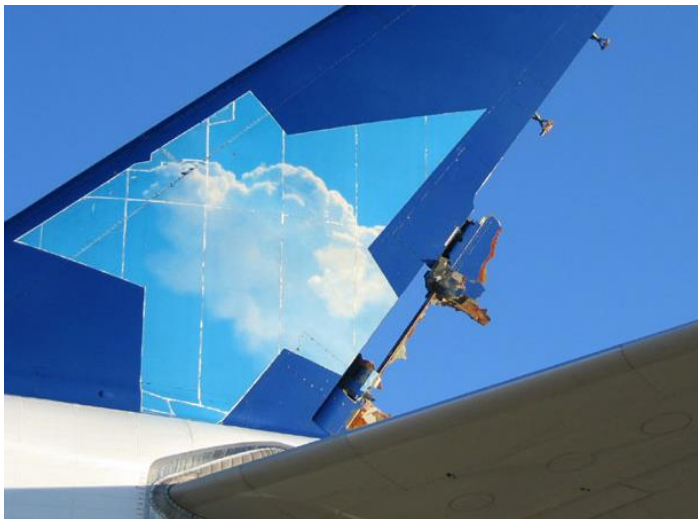
### Rudder loss, A310 (2005)

During this event, the rudder was lost due to weakening of its structure (composite sandwich disbonding leading to reduced torsional stiffness).

The flight was normal until the cruise, when sudden vibrations and loud noise were experienced and dutch-roll oscillations started.

The dutch-roll decreased and stopped when descending. On ground, a major part of the rudder was found missing from the aircraft.

The product enhancements which were developed following this event focused on reinforcing the inspections, and enhancing the design of sandwich rudders. Technology and design evolution (monolithic rudders) were introduced on new programs.

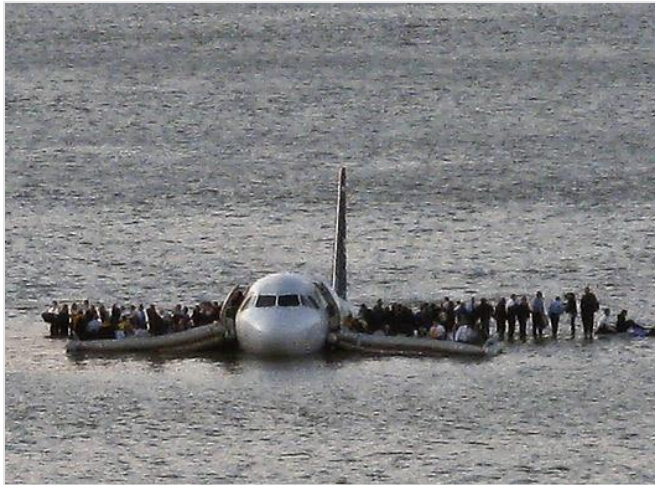
### Emergency water landing, A320 (2009)

This aircraft encountered a flock of birds after take-off, resulting in multiple bird strikes impacting both engines, with subsequent significant loss of thrust on both engines.

The APU was proactively started by the crew, which allowed retention of the NORMAL Law, and thus all the flight envelope protections.

The flight crew focused on the essential task of flying the aircraft given the emergency. The aircraft was flown occasionally within the alpha protection range, until an emergency water landing was performed.

Following this event, a new QRH procedure “EMER LANDING - ALL ENG FAILURE” was developed, new engine birdstrike certification requirements were issued and an APU auto-start function was introduced on A350.

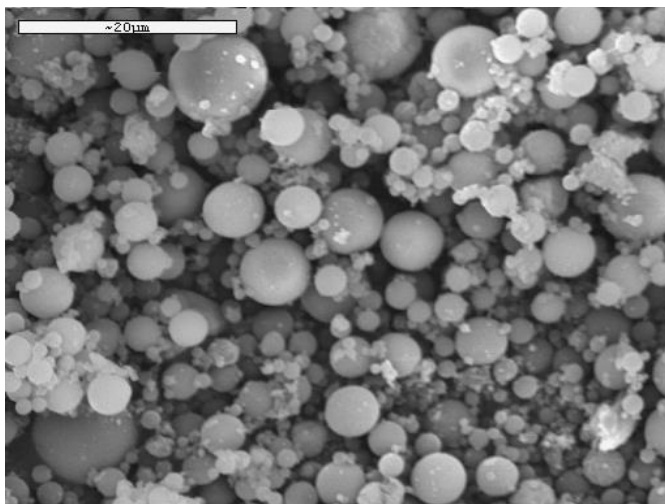
### Fuel contamination, A330 (2010)

During descent, approach and landing this aircraft encountered a loss of thrust control affecting both engines.

The investigation determined that the root cause was fuel contamination, which was traced back to the refuel dispenser (truck).

As a result of the contamination, both engines' fuel metering valves were blocked. The engine 1 remained at ~70% N1, the engine 2 at sub-idle.

The fuel contaminants were composed of Super Absorbent Polymer (SAP) combined with salt and water.

After the event, new operational guidance (QRH procedure) was developed to assist flight crews.

At industry level, it confirmed that fuel uplift quality was critical as it may affect several or all engines, therefore IATA Fuel Working Groups were formed. This resulted, as a lesson learnt, in the decision to phase out SAP from fuel filters (deadline January 2020).

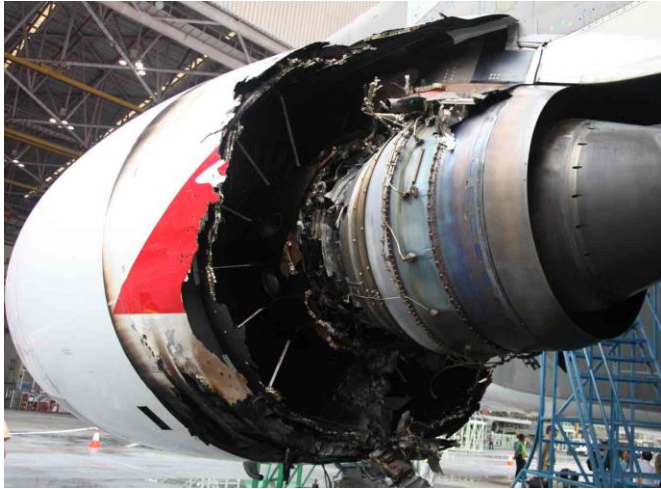
#### Uncontained engine disc failure, A380 (2010)

This A380 aircraft experienced an Intermediate Pressure Turbine (IPT) disc failure to engine #2 during climb.

The airframe was impacted by disc debris, resulting in multiple structure and systems damage.

An In-Flight Turn Back was performed, during which numerous ECAM alerts had to be processed.

Several product enhancements were developed following this event :

- IPTOS function : automatic engine shutdown in case of IPT overspeed
- Enhanced engine design and manufacturing process
- ECAM enhancement, equivalent to scroller introduced on A350
- Additional Fuel Shut Off Valves wiring routing precautions on new programs
- OIS optimized landing distance calculation based on actual aircraft capability

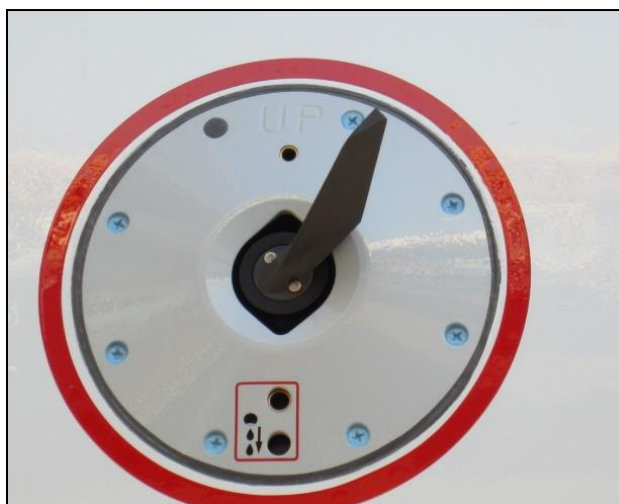
#### AoA probes blockage, A330 (2012)

This A330 experienced a blockage of all 3 Angle-of-Attack (AoA) probes. They were fitted with a new configuration known as the conic plates.

The 3 AoA became blocked during climb (~FL100). When reaching FL310, the AP disconnected and the high AoA protection was unduly triggered, resulting in a commanded pitch down.

The flight crew switched all 3 ADRs OFF and stabilized the aircraft at FL300.

As a result of the event, the conic plate configuration was removed. Enhanced AoA monitoring by the flight control system was introduced and development of new AoA probes was initiated.

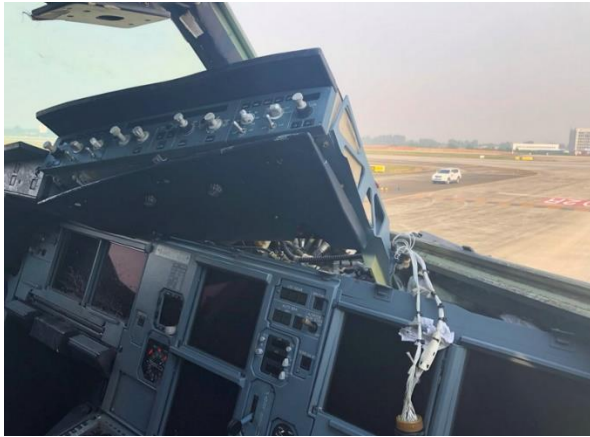
#### Loss of RH windshield in flight, A319 (2018)

40 min after take-off, while in cruise (FL321), the RH windshield of this A319 separated. An immediate descent towards a lower altitude was conducted, followed by a diversion to the nearest airport (Chengdu, China), where an uneventful landing was performed.

The first officer and one cabin crew suffered minor injuries.
