Take-Off performance incidents: do we need to accept them or can we avoid them?

Bart Benard (Martinair)

Martin Nijhof (KLM)

ISASI annual Seminar, September 2019

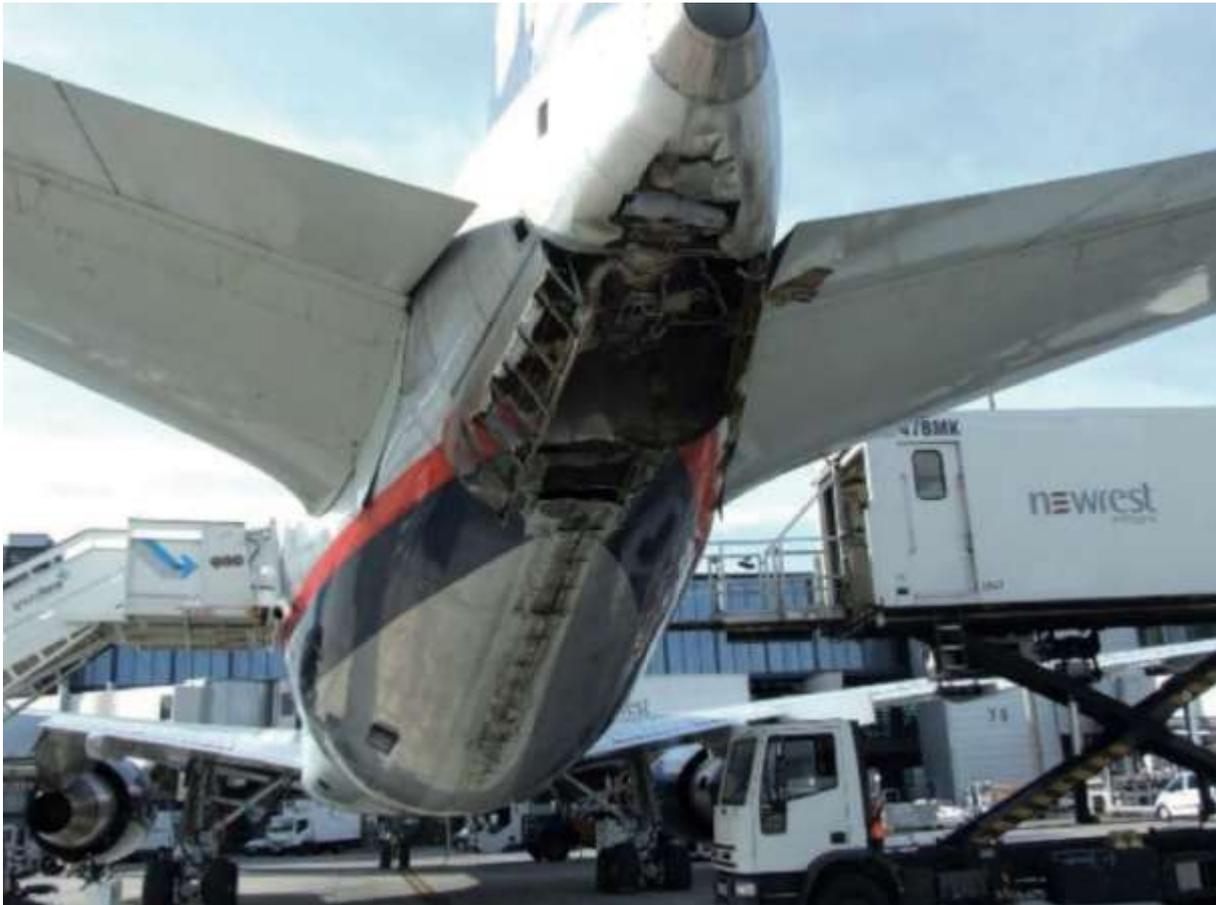
Table 1, case 6: Boeing 767, Madrid, 16 April, 2013 (Photo from CIAIAC report A-010/2013)

5	7Jul13	Boeing 777-300	DSB Summary First quarter 2016 - Serious incident	<ul style="list-style-type: none"> Takeoff data based on improper weight (Δ 100 ton / 30.4 % of TOW). Aircraft took off without further incident.
6	16Apr13	Boeing 767-200	CIAIAC A-010/2013 Accident	<ul style="list-style-type: none"> Takeoff data based on ZFW (Δ 66.6 ton / 38.8 % of TOW) Stick shaker activated during rotation. Fuselage suffered substantial damage and cabin altitude warning activated before aircraft was returned to departure airport. Aircraft was written off.
7	14Apr12	Boeing 737-300	AAIB EW/C2012/04/03 Accident	<ul style="list-style-type: none"> Takeoff data based on TOW previous flight (Δ 6.8 ton / 12.5 % of TOW) Tail strike, causing damage to pressure hull. Flight continued to destination.
8	29Apr11	Airbus A321	AAIB EW/G2011/04/29 Serious incident	<ul style="list-style-type: none"> Takeoff data based on ZFW (Δ 16.9 ton / 19.5 % of TOW) Takeoff path flight adapted to accelerate, further uneventful.

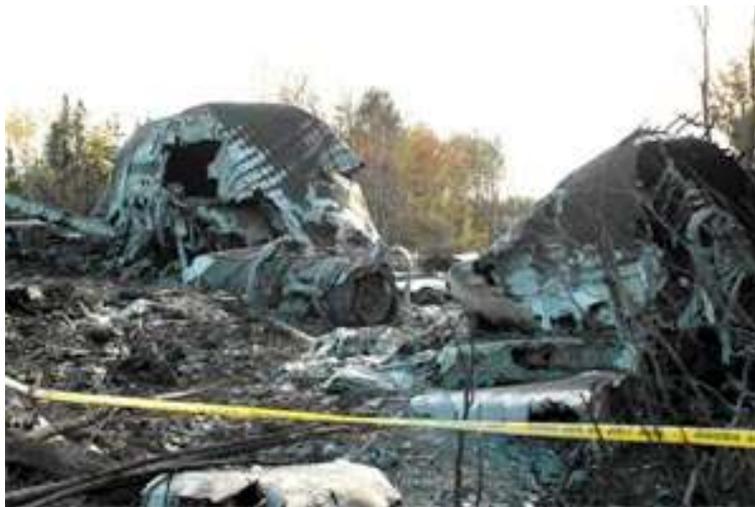
Nearly 34 years after the accident at Anchorage, on 14 October 2004, a Boeing 747 Freighter collided with an earthen berm supporting an ILS localizer antenna at Halifax International during a failed takeoff attempt. All seven crew members were killed and the aircraft was destroyed. The investigation determined that the aircraft’s takeoff speed and thrust setting were too low to enable the aircraft to take off safely for the actual weight of the aircraft. One of the recommendations called for the establishment of a requirement for transport category aircraft to be equipped with a Take-off Performance Monitoring System that would provide flight crews with an accurate and timely indication of inadequate take-off performance. Today, 15 years after Halifax accident, still no operational system exists that can warn the flight crew in the event that takeoff performance is degraded.

Table 1, case 20: Boeing 747-200F, Halifax, 14 October, 2004
(Photo from TSB report A04H0004)
