Erroneous takeoff performance:

Why the past is still highly relevant today

Eur. Ing. Steve Hoare CEng BEng(Hons) MRAeS

United Kingdom Air Accidents Investigation Branch

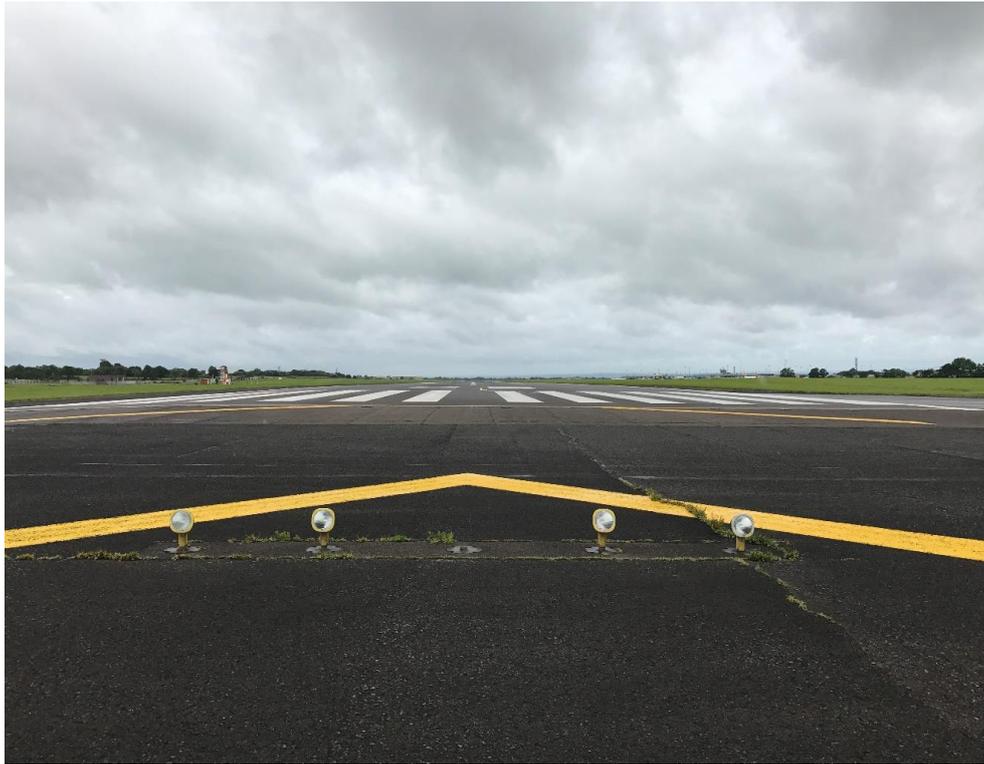
On the 21st July 2017, a Boeing 737-800 with 179 passengers and 6 crew onboard took off from Belfast for Corfu with the incorrect thrust set and struck an approach light for the reciprocal runway (1). The damaged light was 36 centimetres high and situated 29 metres beyond the end of the takeoff runway, itself 2.6 kilometres long, and ample for operation of the Boeing.

Figure 1 – The damaged approach light

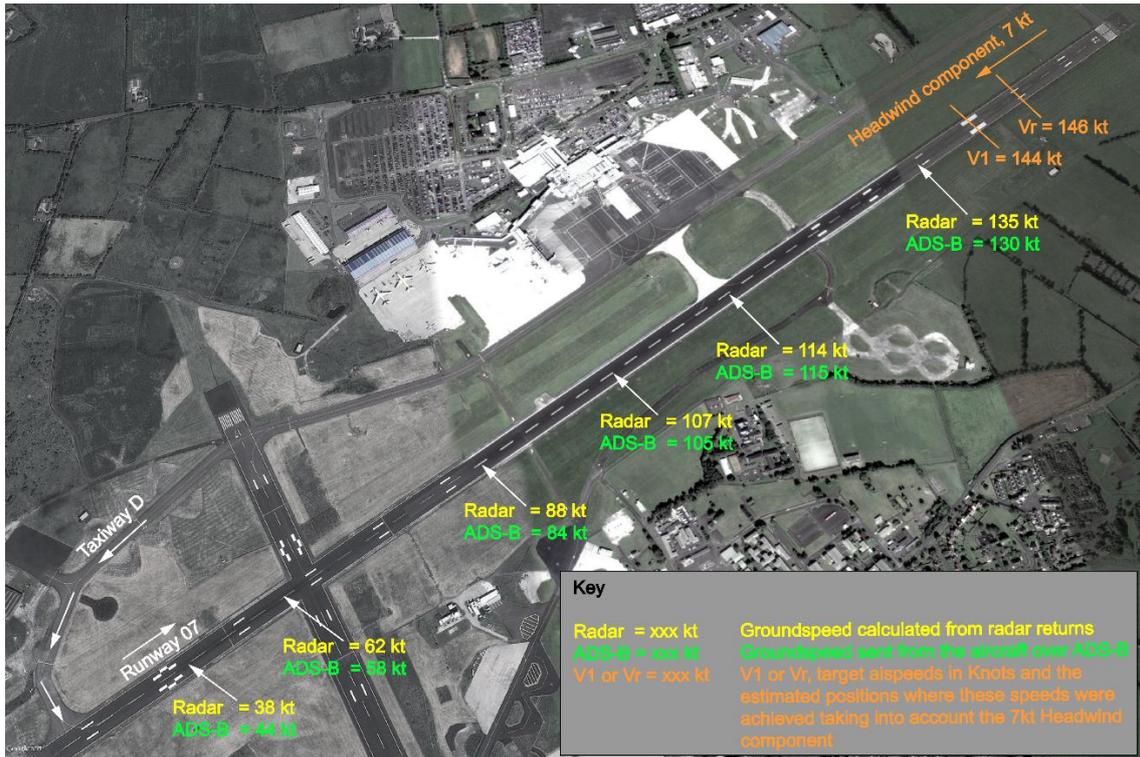
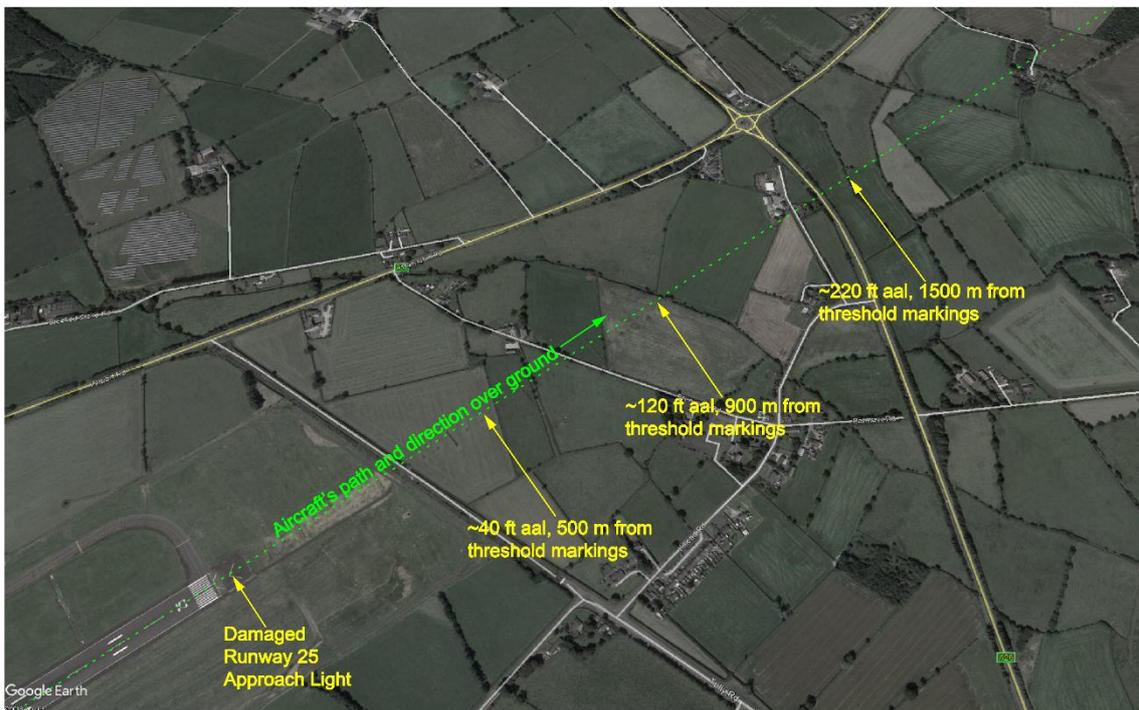
The crew realised as the aircraft's speed approached V_r during the takeoff roll that they were not accelerating as expected but did not recognise the reason for the shortfall in aircraft performance. After the aircraft became airborne it climbed away very slowly and it was only when 4 kilometres from the end of the runway that full thrust was applied by the crew.

Figure 2 - The takeoff roll, showing groundspeeds and the estimated point where V_1 and V_r were attained, and initial climb

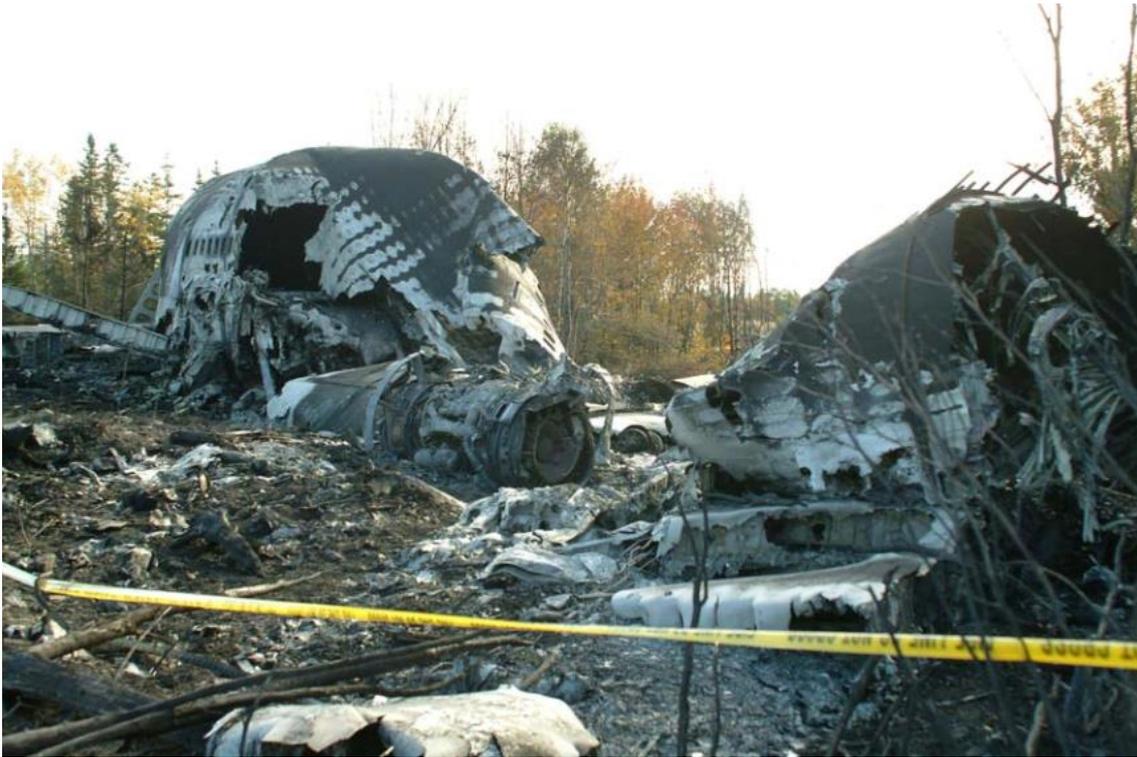
Figure 3 - The remains of the main fuselage and number 4 engine from MK Airlines flight 1602

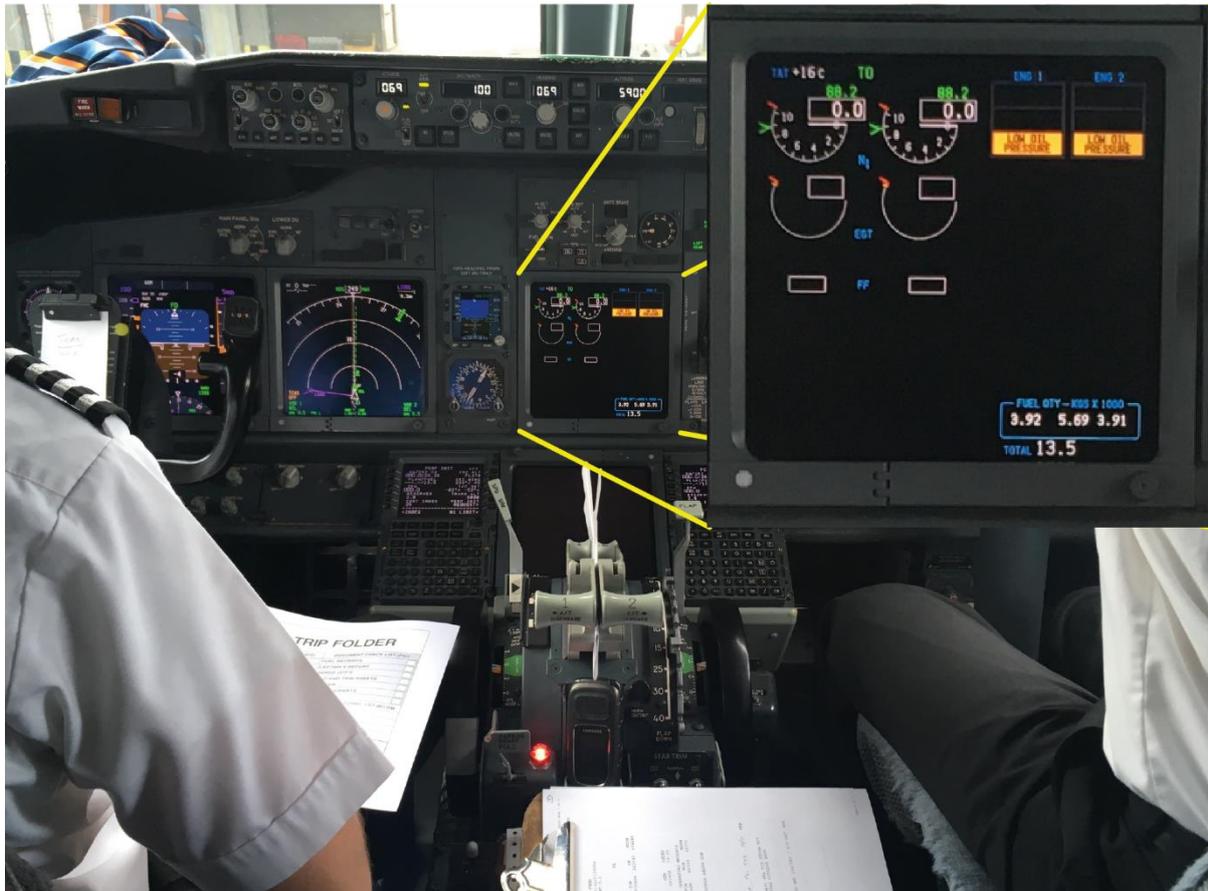
Figure 4 - The cockpit before first leaving the stand

This shows a target N_1 of 88.2% (in green text at the top of the engine gauges), prior to the application of any engine derate, which could only be achieved by the OAT entry shown in the FMC photo below.

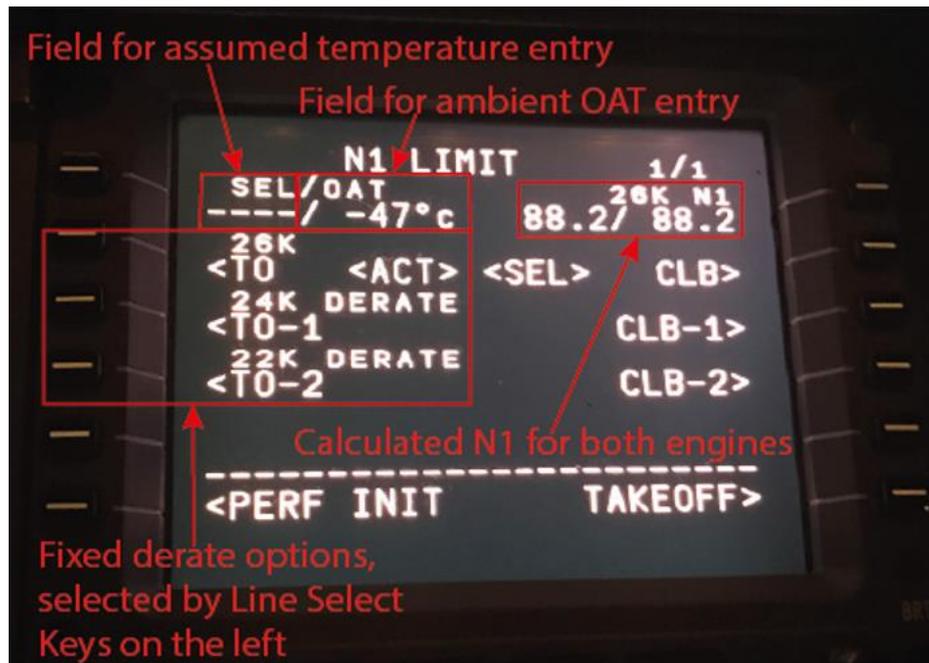
Figure 5 - The FMC engine derate page

However, this doesn't fully explain how an N_1 of 81.5% was used for the takeoff. One way on the Boeing 737-800 of reducing the takeoff thrust to the minimum required for takeoff, which is common airline practice used to conserve engine life and reduce maintenance costs, is by entering a higher than ambient temperature called an assumed temperature into the 'SEL' (for SElected temperature) field of the FMC. The assumed temperature method, as it is known was regularly used by this airline, and the crew having correctly calculated this temperature entered it into the FMC, which resulted in the target N_1 changing to 81.5% for the takeoff.

engine derate information on the FMC (see Figure 5) bears little similarity to the layout of the EFB calculation results page shown below. Not only does this hinder any cross-check but also the transposition of data from one presentation to another.

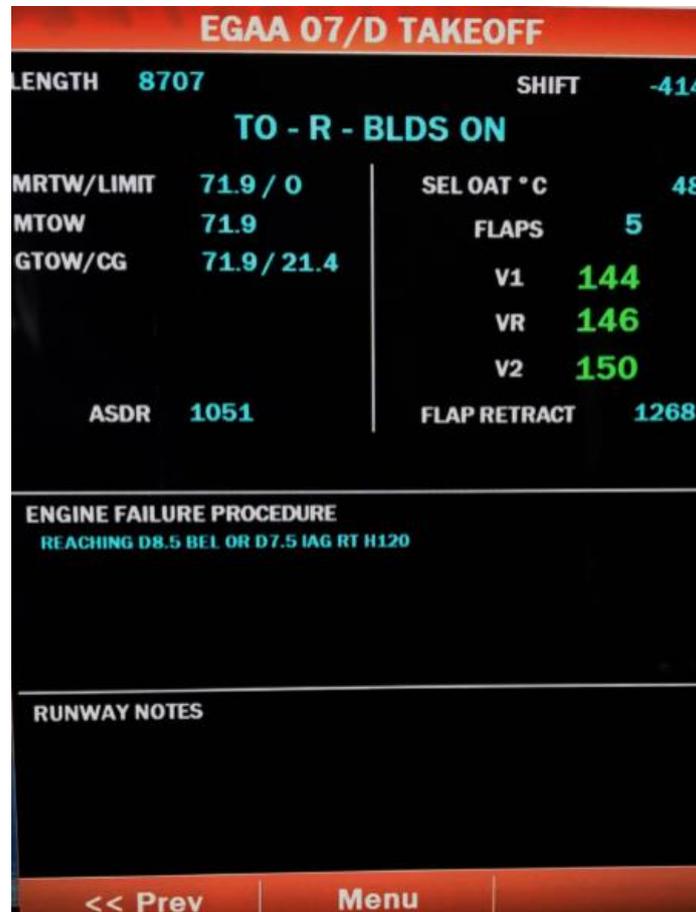
Figure 6 - EFB Calculation results page

For instance, the OAT, pertinent information on which the engines' thrust is based and a required entry on the FMC page, is absent from the EFB results page but instead is entered on a previous screen no longer visible to the crew. The nomenclature used on the EFB also differs with the assumed temperature on the EFB labelled 'SEL OAT' whereas on the FMC there are separate fields for the two, distinctly different, variables 'SEL' and 'OAT'. As all FMC derate data leads to a thrust setting, expressed as an N_1 value and shown on the FMC, you might think that this vital information should be displayed on the EFB, but this is also absent on the results page.

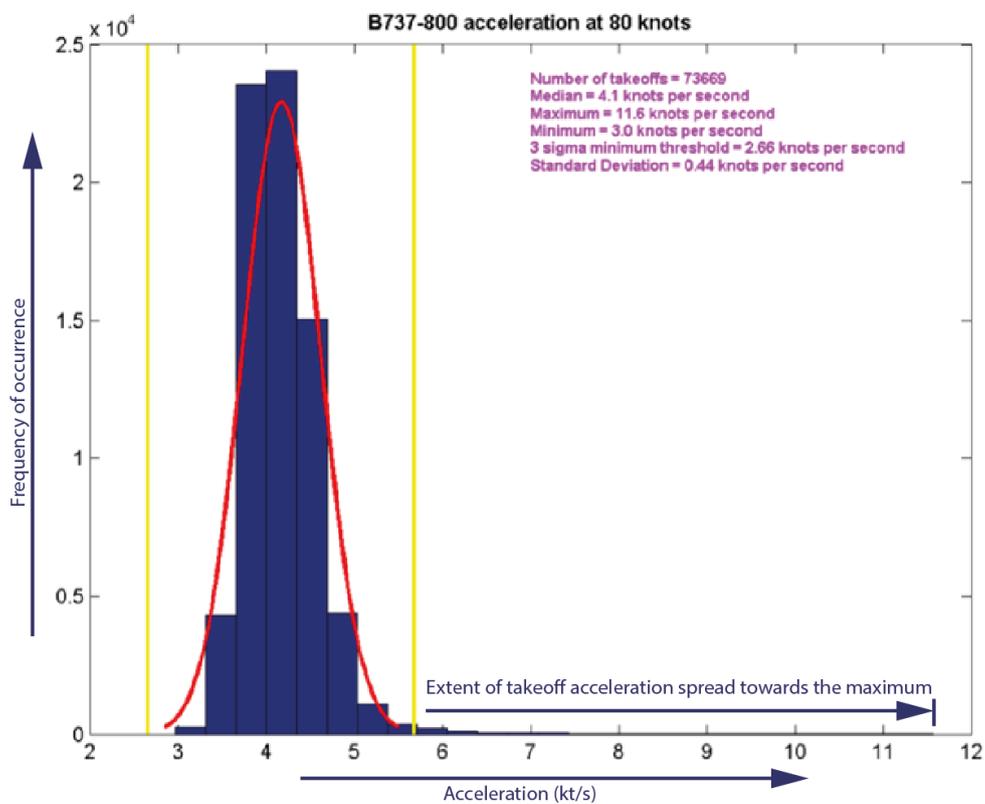
Figure 7 - Acceleration histogram of 73,669 Boeing 737-800 departures

Across all departures, the data showed a Standard Deviation in acceleration of only 0.44 knots per second with the median acceleration being 4.1 knots per second. Any skew in acceleration also tended to be in favour of higher accelerations, rather than lower values, meaning any system proposed to detect cases of poor acceleration would benefit. Plotting the same data set but this time against runway length, shown below, also shows this skew and that a 'best fit' line of minimum acceleration required for takeoff could be drawn.

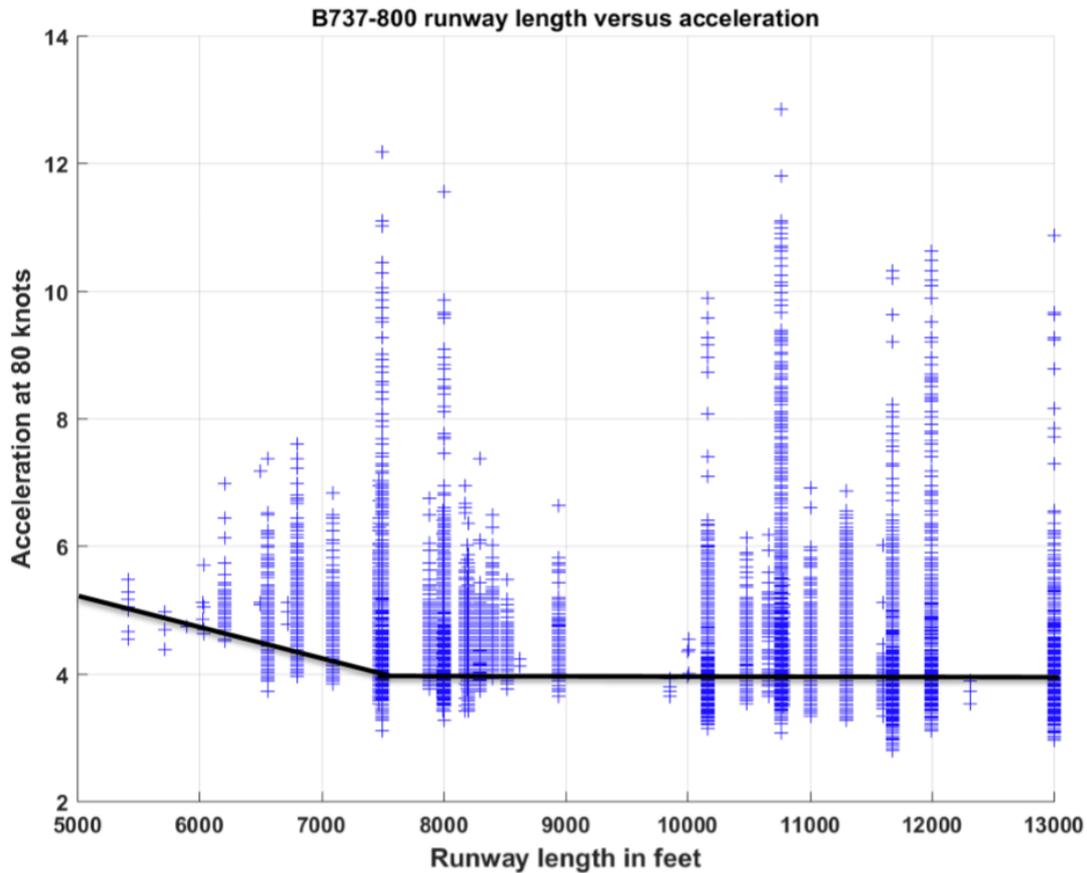
Figure 8 - Acceleration rate against runway length for 73,669 Boeing 737-800 departures

This confirmed that the minimum acceleration required remained constant for most runway lengths, but an increase was noted as the runway length becomes the limiting factor.
