Tailplane or main wing stall? LOC-I event due to suspected icing

Kåre Halvorsen, NSIA, Norway

LN-IDB, a Cessna 560 Encore with serial number 560-0637 was manufactured in 2003. The aircraft type is certified for two pilots, commander and co-pilot. The cabin has room for 7 passengers.

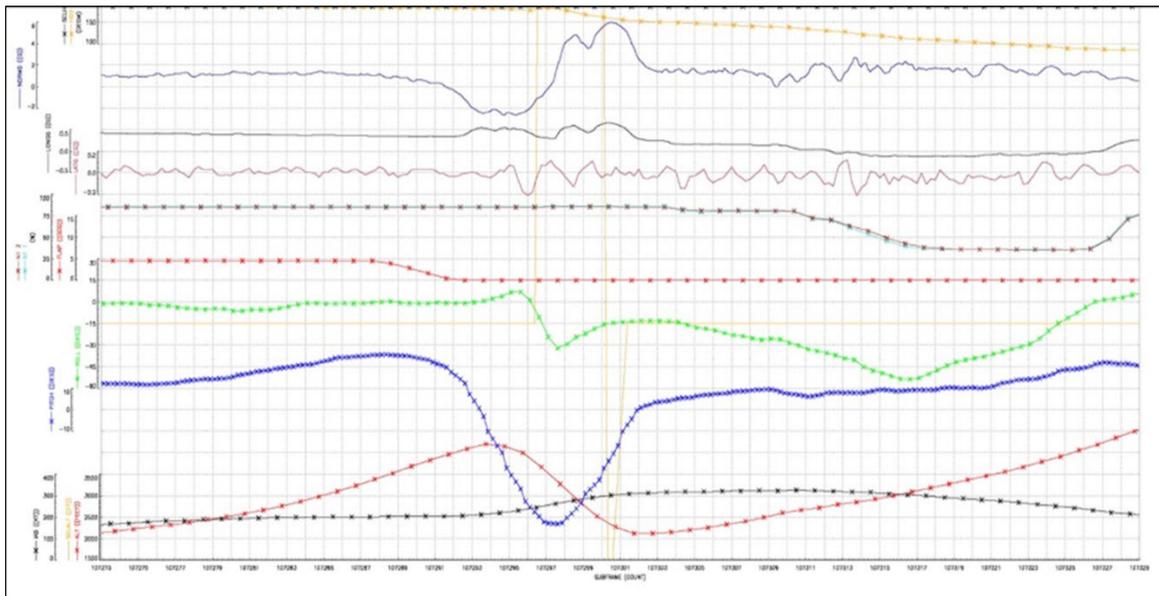
Figure 2, Flight Data Recorder Output (1)

Initially, the take-off proceeded as normal. Figure 2 shows a plot of the most important parameters retrieved from the Flight Data Recorder plotted over one common timeline (1). The landing gear was retracted and both pilots observed that the speed was rapidly approaching 200 kt, which is the maximum speed with flaps deployed. As the flaps were retracted, the crew experienced a violent nose-down movement and the pilots were "hanging by their seat belts", while the aircraft started sharply banking to the left. Following the accident, data from the Flight Data Recorder (FDR) showed that the aircraft at this moment experienced negative 2.62 G. The Commander did not trust the instruments while the First Officer, which was Pilot Monitoring (PM) had better situational awareness. The First Officer quickly took control and started a pull-out from the dive. The aircraft descended below the cloud base, and even though it was dark, the pilots could glimpse the ground. The control was regained, and the aircraft levelled off 170 ft above the ground. The aircraft was overstressed to 5.99 G during the pull-out. The crew called "MAYDAY" to the Air Traffic Control. The engines were left in take-off position during the entire pull-out and the speed increased to 325 kt. Once control was regained, the "MAYDAY" was cancelled, and the flight continued towards Torp where an approach and landing took place without further problems. The NSIA investigation has not revealed any technical malfunctions in the aircraft and its control systems.

The aircraft's anti and de-icing systems on the wings and tailplane were switched on. The aircraft's tailplane rubber de-icing "boots" were in automatic mode and inactive during the take-off and when the stall occurred. It is NSIA's (AIBN's) assessment is that the systems were not suitable to remove this relevant type of ice and snow. This accident shows the significance of functioning crew resource management (CRM) in the cockpit when an unexpected and extreme flight situation occurs. In this instance, the First Officer's situational awareness and initial pull-out saved the crew.

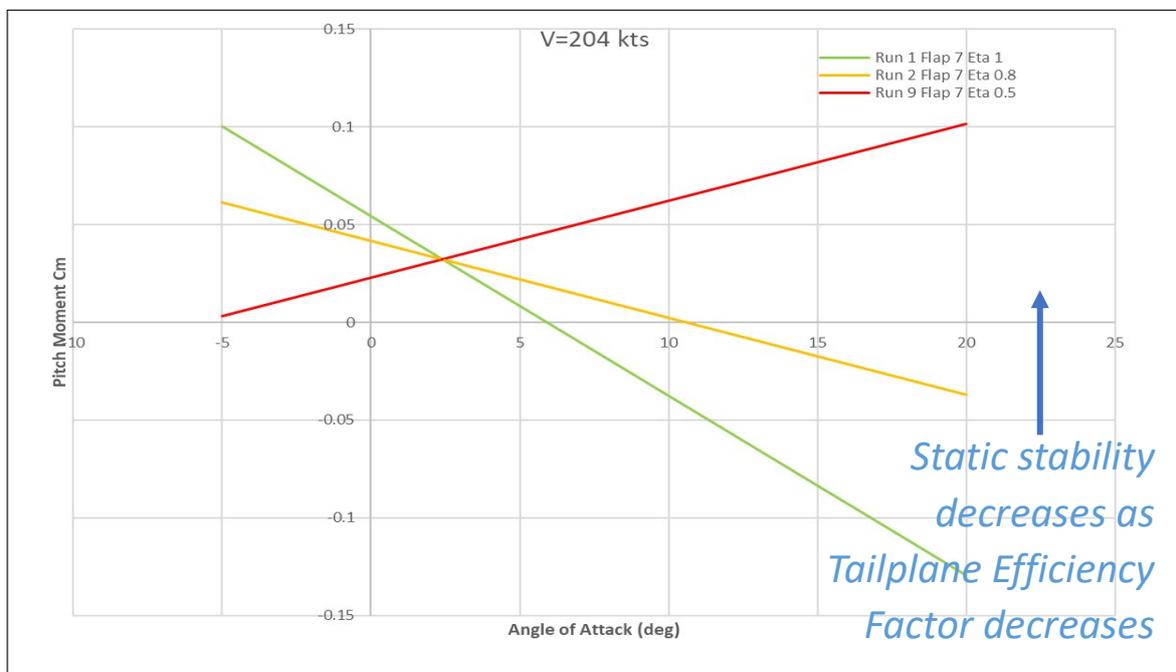
Figure 7, Pitch Stability - Pitching Moment vs Angle of Attack

For the 'generic business jet', using the given flight condition of $V = 204$ KTAS, $H = 4,000$ ft pressure height, $T = 29F$, aft CG/low MTOM with flap = 7 degrees, the variation of pitching moment with angle of attack was obtained for a range of horizontal tailplane efficiencies from 1.0 (100%) to 0.5 (50%) to simulate the effects of icing on the aircraft tailplane (Figure 7). The results show that the pitching moment versus angle of attack gradient decreases as the horizontal tailplane efficiency decreases, hence aircraft static stability also decreases as horizontal tailplane efficiency decreases.

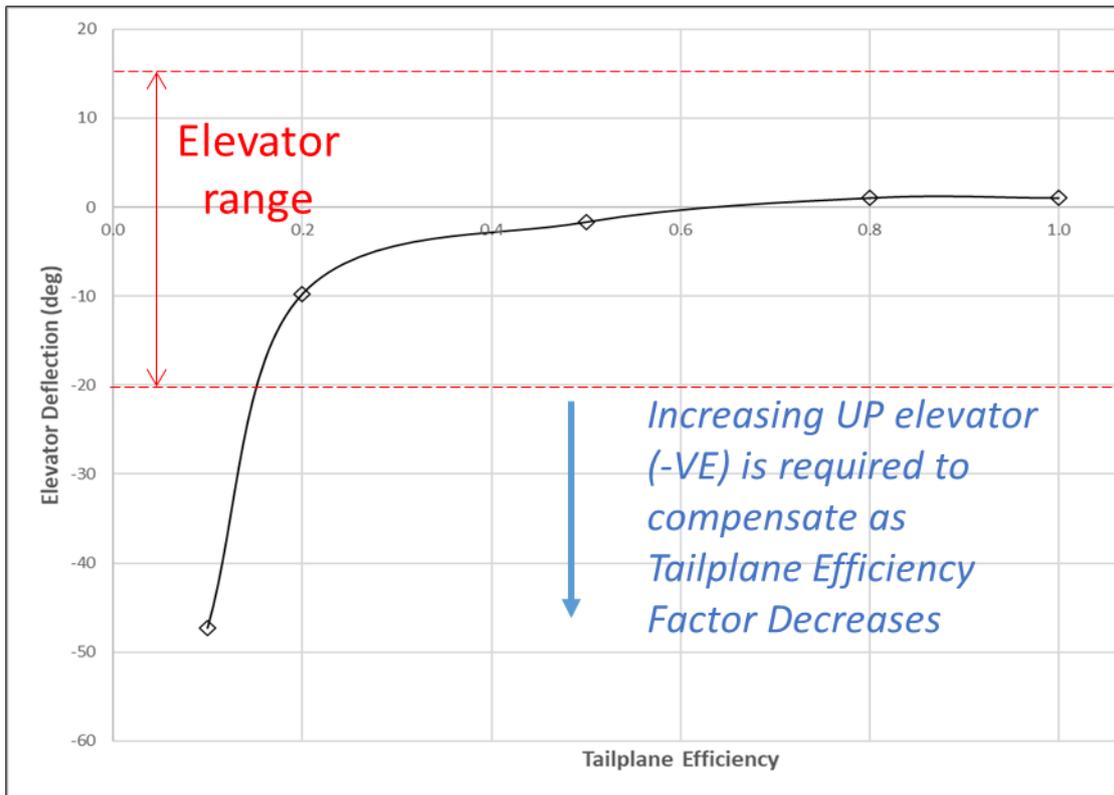
Figure 8, Elevator Deflection vs Tailplane Efficiency

Further analysis of elevator deflection versus horizontal tailplane efficiency (Figure 9) suggests that increasing UP elevator (-ve deflection) is required to maintain trimmed flight as the horizontal tailplane efficiency decreases. The range of elevator deflection for the 'generic business jet' model was 20 degrees UP and 15 degrees DOWN. The results suggest that as horizontal tailplane efficiency decreases below approximately 0.2 (20%), there is insufficient UP elevator to maintain trimmed flight.

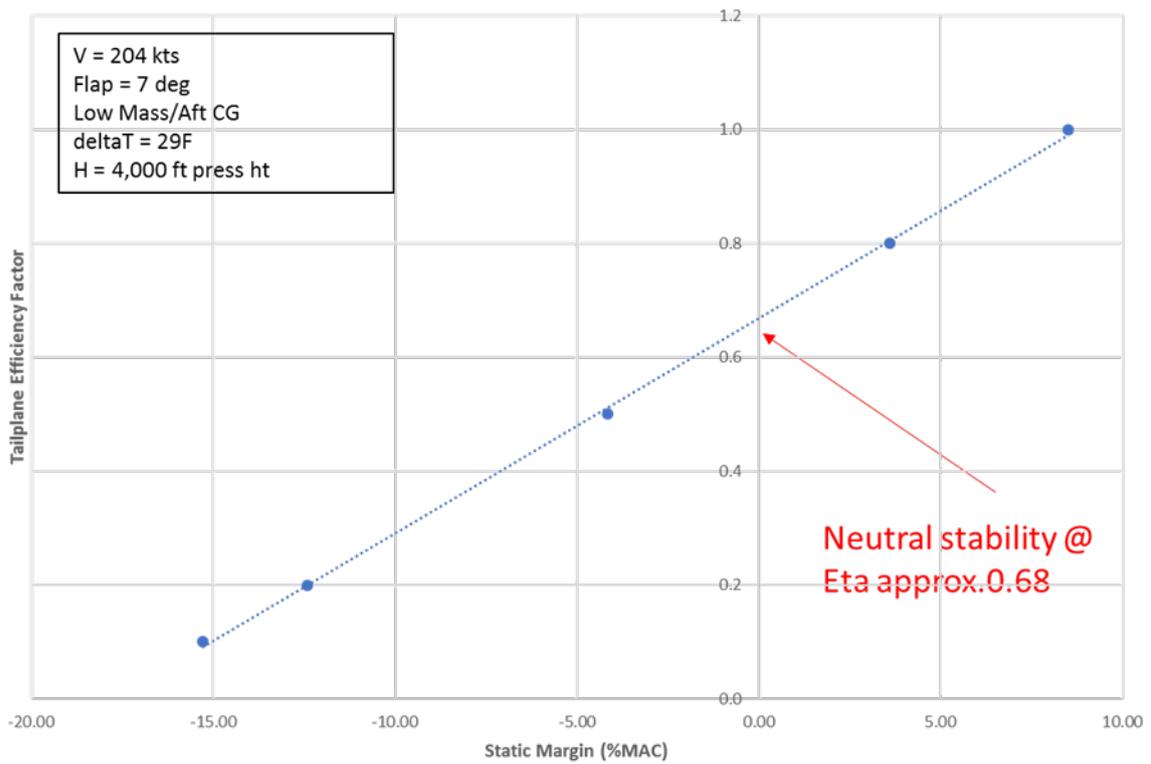
Figure 9, Tailplane Efficiency Factor vs Static Margin

The results also show that the angle of attack for trimmed flight conditions increases as tailplane efficiency decreases. Analysis of horizontal tailplane efficiency versus stick-fixed static margin suggests that static margin decreases as the horizontal tailplane efficiency decreases and that the aircraft is neutrally (statically) stable when the horizontal tailplane efficiency is approximately 0.68 for the 'generic business jet' model in given flight conditions (Figure 8).

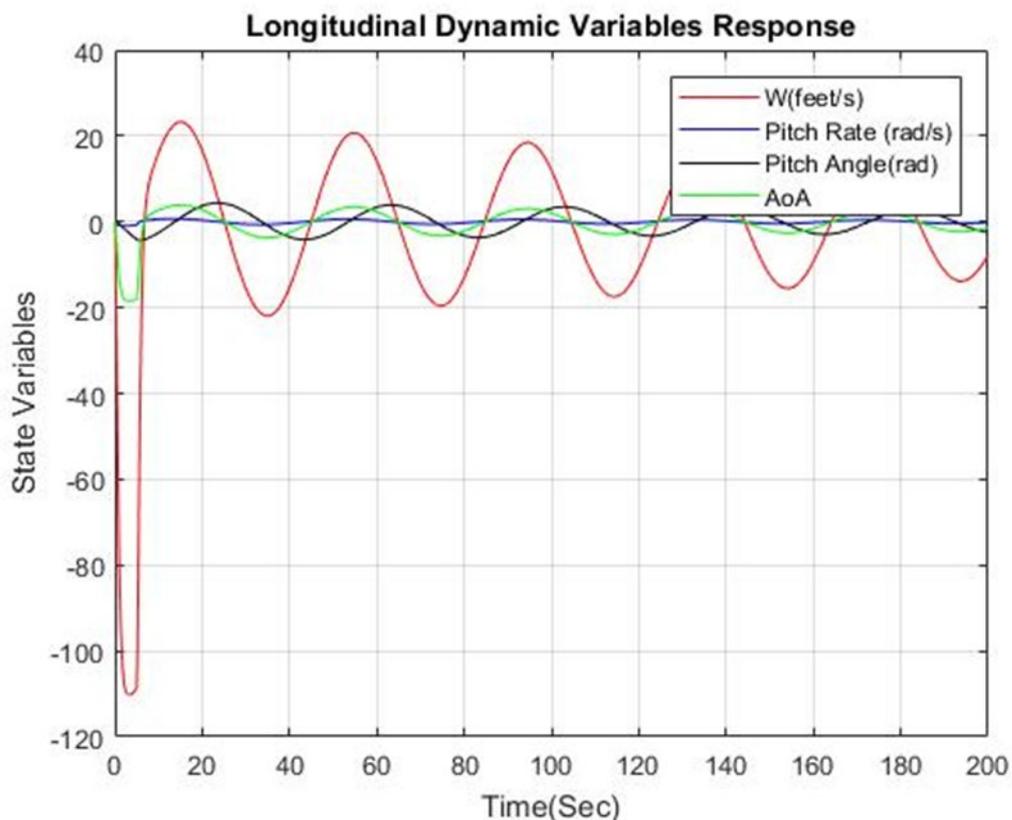
Figure 10, Long Period Oscillation (LPO) with 80% Horizontal Tailplane Efficiency

For model validation purposes, the longitudinal dynamics were analysed by excitation of the Short Period and Long Period modes using the eigenvectors (specific to modes) of Matrix A to specify initial conditions. The variables simulated were relative changes (variations with respect to a trim condition). The results show that for a horizontal tailplane efficiency of 100% the aircraft is statically and dynamically stable with heavy and moderate damping for the SPO and LPO respectively. In addition, the model was independently verified by comparing results to a reduced order model (**Error! Bookmark not defined.**). When the efficiency is reduced to 80%, the response for the LPO is also stable although with less damping of oscillations than the 100% efficiency case (Figure 10). The results of the dynamic stability are in agreement with those of the static stability analysis.

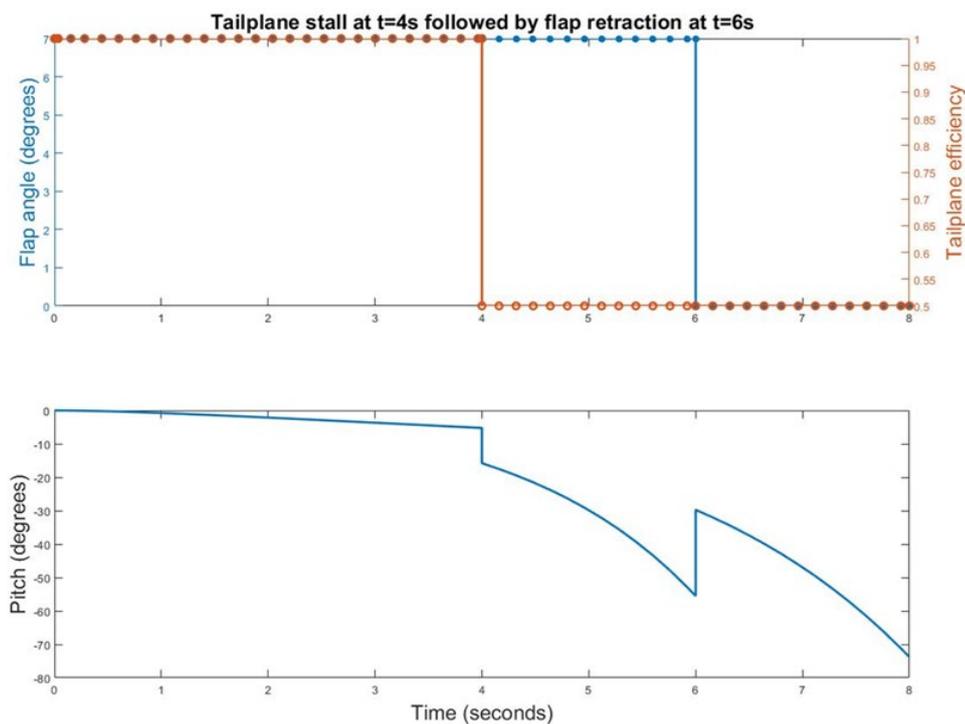
Figure 11, Tailplane Stall Followed by Flap Retraction

The results of a flap retraction following a simulated tailplane stall (Figure 11) were analysed with the tailplane efficiency of 100% and the flap deflection of 7 degrees. At $t=4$ seconds, a tailplane stall was modelled by a step reduction of 50% to horizontal tailplane efficiency, which destabilises the system response. The aircraft pitches down (-30 degrees) within 2 seconds. At $t=6$ seconds, the retraction of flaps from 7 degrees to 0 degrees initially helps, but not sufficiently to stabilise the response with 50% tailplane efficiency. The effect of tailplane efficiency on the initial response to a 1 second elevator impulse (Figure 13) shows that at 100% horizontal tailplane efficiency, a large 20deg elevator down during 1 second is needed to initiate a large magnitude but stable phugoid response, which is shown during the first 20 seconds for comparison purposes. At 50% efficiency, a 1 second 2-degree elevator down input destabilises the system with oscillations and at 20% efficiency, 1-degree elevator down is sufficient to produce very fast divergence without oscillations. Load factor changes with 1 second elevator down commands for varying horizontal tailplane efficiencies were also presented (Figure 11). With 100% efficiency, load factor remains very close to 1 with a small elevator command, as expected. With 50% tailplane efficiency, load factor is reduced but changes are small. Major changes to load factor are however obtained with 20% tailplane efficiency and negative G is quickly reached in this case. This is believed to be closer to the conditions experienced during the incident (1).
