Application of Innovative Investigation Technologies

By Sundeep Gupta, Accident Investigator, Product safety team, Airbus

Event Synopsis

On the 30th September 2017, an A380 fitted with Engine Alliance GP7200 engines suffered an uncontained engine failure while cruising at 37,000ft over Greenland.

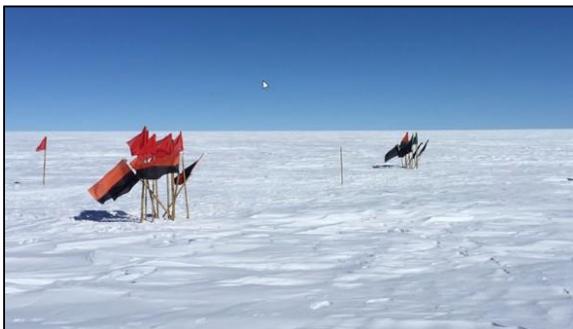
Below is an example of the image resolution achievable. Flags left on the Greenland ice sheet later in the investigation were captured by the satellite images.

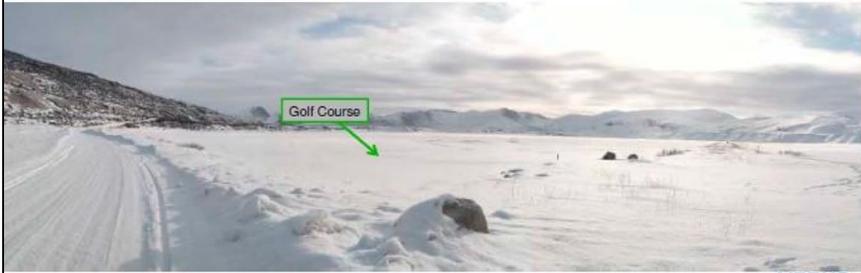
Calibration Trial

A calibration test piece was mounted on a tripod and positioned on a snow covered golf course with its exact angle and GPS position noted. The aircraft overflew the area at the 2 radar operating altitudes to capture the landscape with all 3 radar bands.

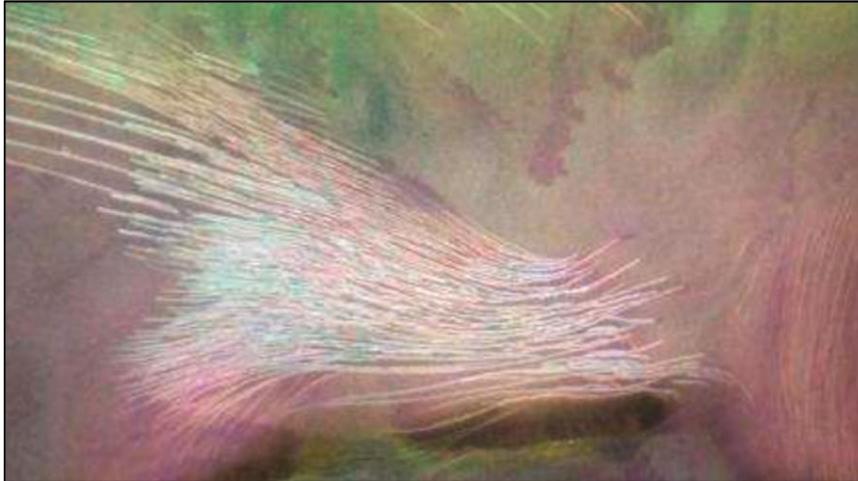
Below is an image covering an area approximately 4km by 2km. Each of the 200 million pixels, each covering 20cm² in X-Band, is scanned by a total of 72 images at different angles and polarizations.

The large amount of data is now undergoing complex post treatment to differentiate crevasse returns and background noise from credible fan hub targets.
