ISASI 2019 - Investigation of the in-flight failure of the Stratos III Sounding Rocket

Delft Aerospace Rocket Engineering, Stevinweg 1 2628 CN Delft, South Holland, The Netherlands

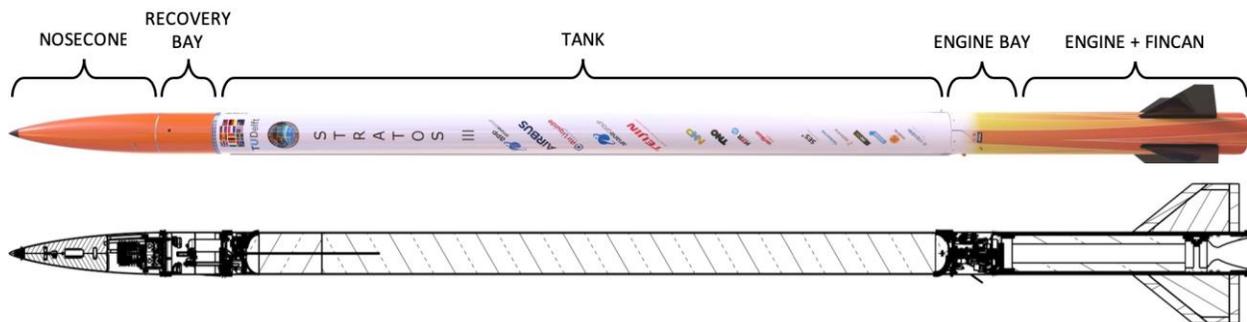
Figure 1: The sections of the Stratos III rocket on the outside and on the cross section

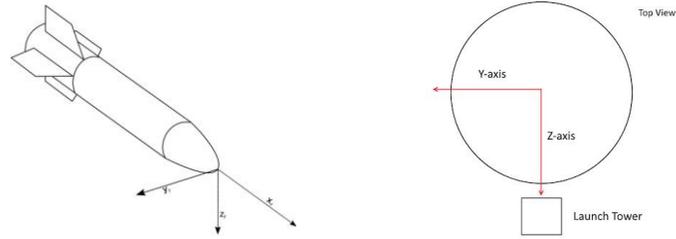
Figure 2 shows the reference frame used for the Stratos III rocket, the body-fixed frame. This is the reference frame that will be used for the rocket throughout this report. The second frame used is the world-fixed frame, which is an inertial frame with the origin at the launch location, the X axis pointing North, the Y axis pointing West and the Z axis completing the orthogonal right-handed coordinate frame.

Figure 2: Body frame of the Stratos III rocket. Isometric and top view

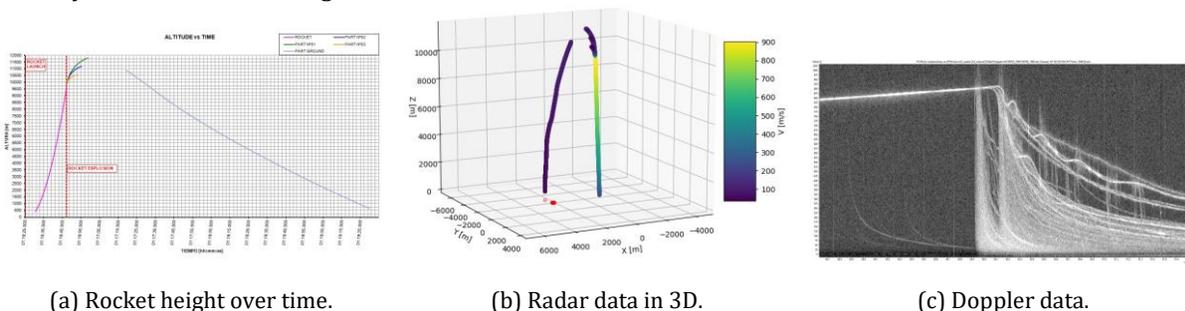
The coordinates from the radar installation were used to plot the location of the various objects throughout time when viewed different perspectives, as well as plotting these debris locations versus time. In addition, the velocity of these objects may be inferred from the "location versus time" plots. In addition to the standard 2D plots supplied by INTA, exemplified in Figure 3a, a number of 3D plots were generated, such as Figure 3b, that allowed the trajectory of the vehicle to be visualised in addition to the velocity being illustrated with a colour profile. This is particularly useful in visualising the trajectory of the debris post anomaly, but also how the debris decelerated and the direction in which they decelerated. The Doppler shift measurements illustrate the velocity of different objects in the instruments field of view. This instrument gives a clear view of when the various break up events occur as each appearance of a new object and its subsequent deceleration is very visually evident as seen in Figure 3c.

Figure 3: Plots of the radar and Doppler data.

Since the fins and bottom part of the fincan were not attached to the rocket anymore, the vehicle did not have any more stabilising surfaces and flipped. This would also line up with the Doppler data in Figure 3c, where the first explosion is the separation of the lower fincan and the rocket, and the second one the full disintegration of the rocket. Structural tests to verify this cause and effect problem were planned but have never been performed.

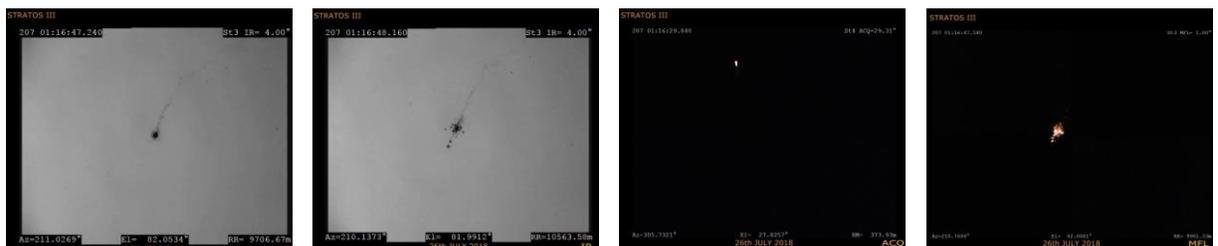
The optical tracking footage, Figure 4c and Figure 4d, does not provide much insight beyond the moment of the disintegration, when the thrust plume disappears and some different debris is lit up spreading out. The infra-red footage, Figure 4a and Figure 4b, however was much more useful in observing the flight. The exhaust plume dominates the footage, but this plume also clearly illustrates the motion the vehicle is undergoing as it almost traces out the trajectory. Post anomaly the debris falling away from the vehicle can be seen, however the perspective of the footage makes it difficult to judge the direction in which the debris flies. In this manner the footage provides more of a visual qualitative source than specifically quantitative information. The Doppler plot that was generated from the footage together with the radar data of the flight is a lot more insightful. Here, two distinctly separate events are visible with 140ms offset from each other. In between the two, some large component keeps accelerating at the same rate as before.

(a) IR footage w/ exhaust trail showing trajectory (b) IR footage showing debris dispersing post anomaly (c) Optical footage pre anomaly (d) Optical footage of debris post anomaly

Figure 4: Frames from IR and optical cameras pre and post anomaly

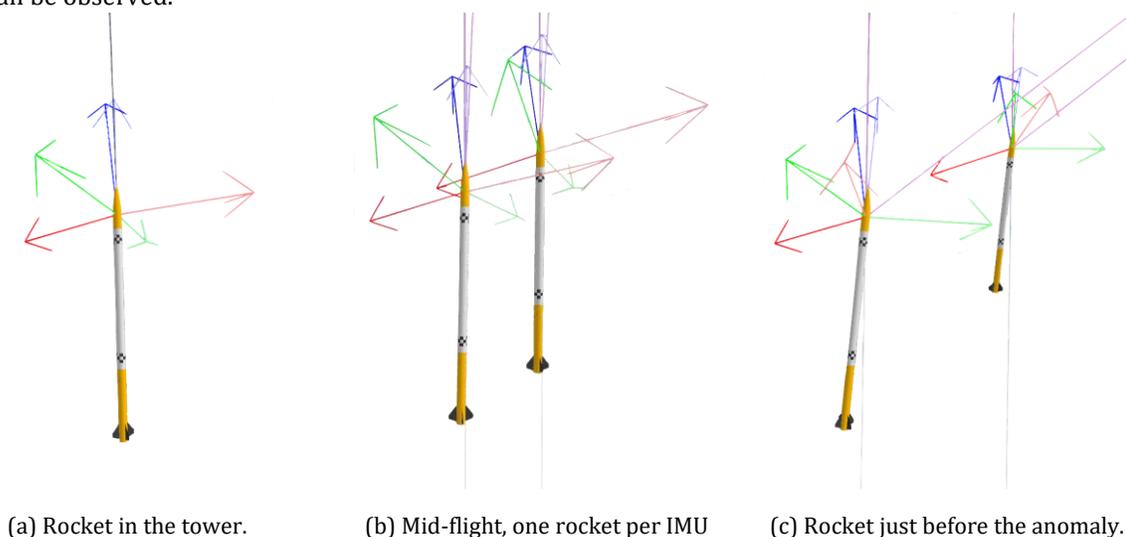
Figure 6b represents the initial stable flight of the rocket. The purple line in Figure 6b represents the velocity, and the pink arrow represents the acceleration. Please note that the two rockets in the image result from a small difference between the two IMUs that were on board. Since the data is integrated twice, the error enlarges, resulting in a few meters over the entire flight until the anomaly at an altitude of 10km. The integration error between the sensors starts to add up to a few meters of offset, which is represented by the two rockets flying slightly different trajectories in the animation. A small angle between the acceleration (pink) and velocity (purple) can be observed and a small angle between the nominal flight path and the rocket's longitudinal axis appears.

Figure 6c shows the rockets right before the anomaly. The acceleration vector has diverged sideways significantly. Moreover, a large angle of attack, the angle between the rocket's X-axis and the nominal flight path, can be observed.

Figure 6: Frames taken from the animation tool, based on the IMU data

The most intuitive evidence of inertial coupling can be seen in the animation created from the IMU data, presented in Figure 6. The animation clearly shows that the vehicle's pitch and roll motions are coupled, diverging in behaviour after passing Mach 1, becoming unstable and resulting in disintegration after 22.12 seconds of flight time.

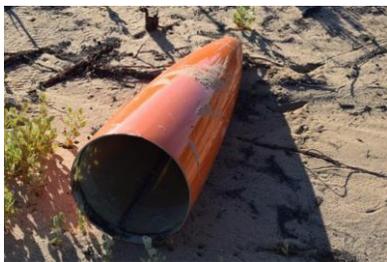
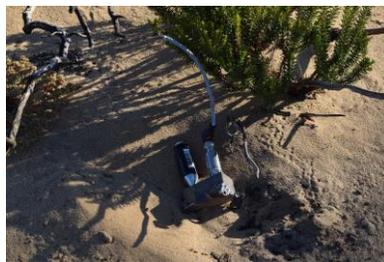
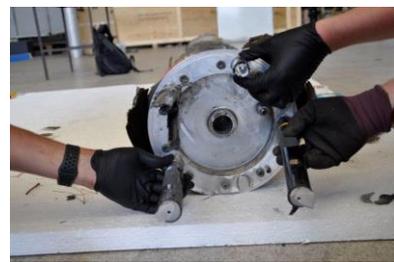
The rocket components that were found were photographed and inspected, then taken back to the launch base for further research. Here they were closer inspected, photographed, and analysed by members of DARE. The nosecone, Figure 7a, was seen to be cracked along the glue joint of the two halves, likely from impact forces as the cracked lines ran parallel with the ground. The flight computer had been ejected from the shell as a result of the impact and was badly deformed. The nosecone was broken along its interface with the recovery bay, and no debris was found of the separation system sitting on the lower side of the recovery bay. The drogue parachute feedsystem Figure 7b was seen to have had its connectors sheared out of their ports. The engine bay, Figure 7c, was found with a number of the longitudinal elements (longerons) missing. Those missing had broken off the segment of the aluminium ring they had been attached to, meaning the ring itself had failed before the carbon-aluminium glue joint had. A length of detonation chord was found wrapped around one of the longerons, showing the FTS had not been triggered.

(a) Nosecone Shell

(b) Drogue Parachute Feedsystem

(c) Engine-bay debris

Figure 7: Examples of the recovered debris.

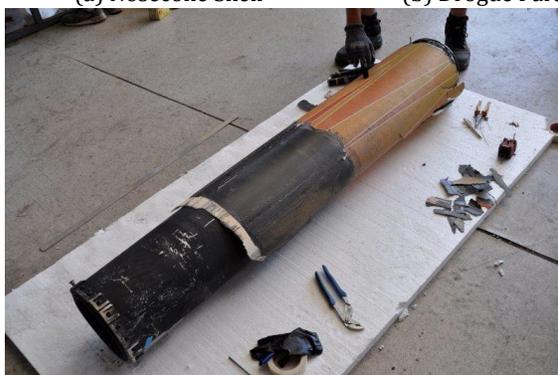
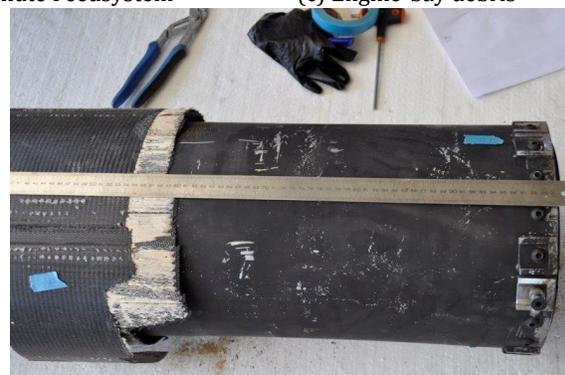
One of the most interesting parts retrieved was the fincan, Figure 7d and Figure 7e. The entire lower half, where the fins had been attached, was missing, having been ripped off during flight. This failure appeared to have been a result of torsional loads. This leads to further investigation of the torsion keys constraining the fincan. It could for instance be that the lack of rigidity of the torsion locks and keys might have contributed to the possible roll-pitch coupling. Or the other way around, where the roll-pitch coupling caused increasing lateral loads on the fins and fincan, until the glued attachment of the torsion keys to the fincan failed. This could have twisted and torn the fincan.

(d) Combustion chamber with upper half of fin can remaining.

(e) Combustion chamber region where fins were attached

The engine was squashed from the impact, causing the remaining fuel and nozzle to have cracked, but otherwise it appeared to have burned nominally during the flight, with no evidence of a burn through, a problem that had been observed multiple times during ground tests, being visible.

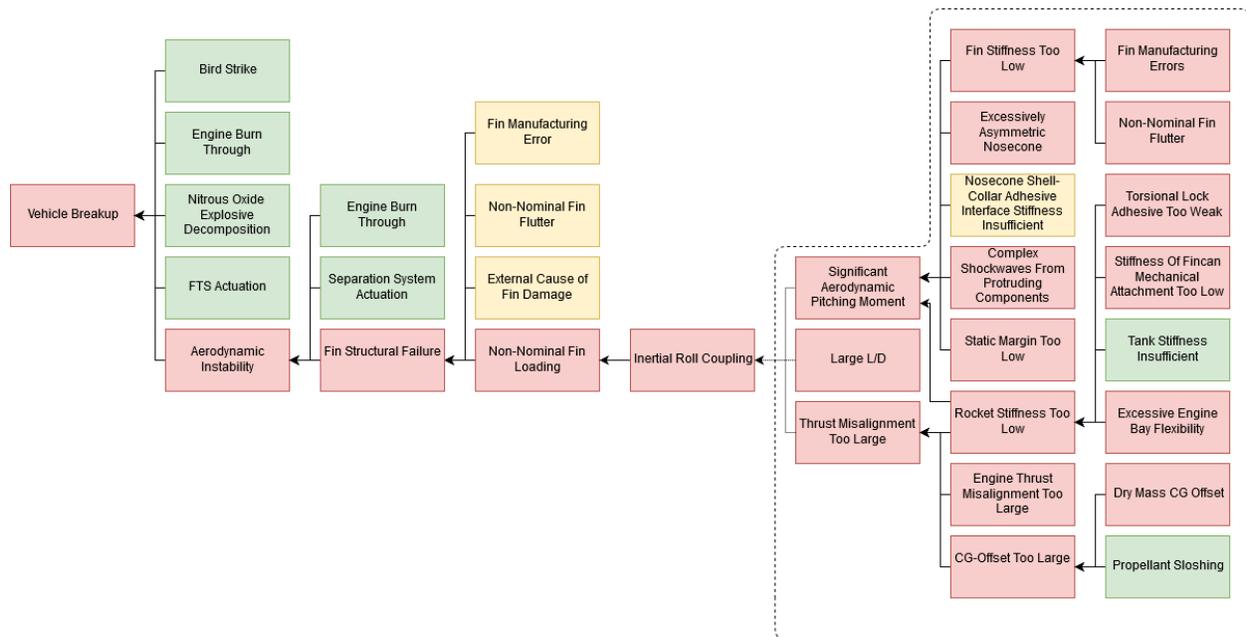
The different theories for the cause of the anomaly are organised in Figure 8. This fishbone diagram shows which theories are connected and provides a clear basis to work towards determining the root cause.

Figure 8: Fishbone diagram of all considered causes for the flight anomaly.

All the suspected causes are analysed separately, after which they are classified as being *closed*, *unlikely* or *open*, depending on their suspected influence on the anomaly. *Closed* means that the cause is discarded as a cause for the in-flight anomaly and corresponds to the colour green. *Unlikely* means that the cause could not be discarded with the available evidence, but that it is not likely that this cause resulted the anomaly. This corresponds to the colour orange. *Open* means that the cause is still a possibility for the anomaly and corresponds to the colour red.

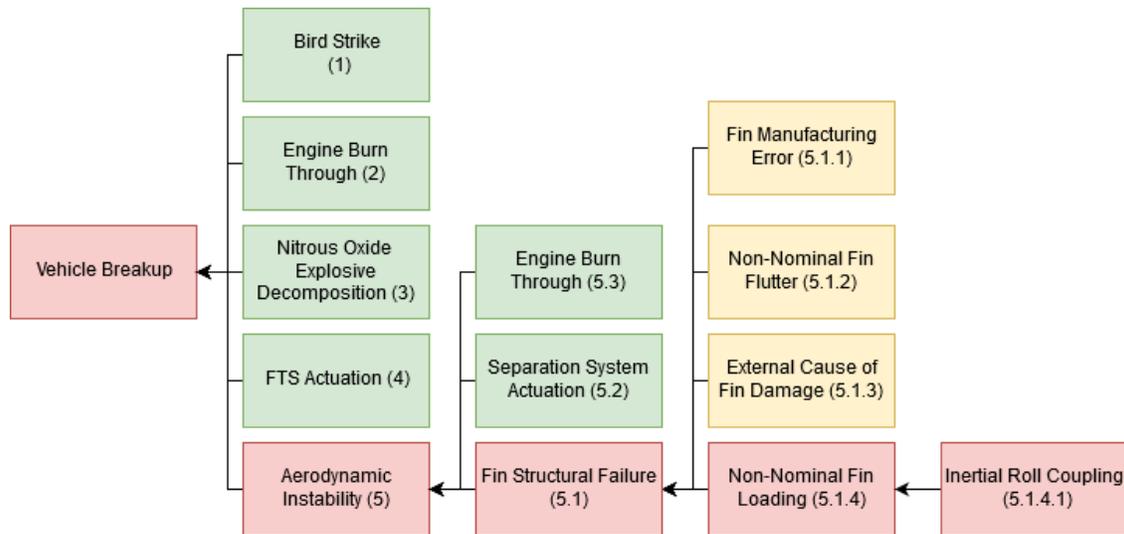
A fishbone diagram is used to establish a causal tree of events that could have precipitated the vehicle failure. The fishbone diagram is shown in Figure 9. For brevity the titles were summarised. Compared to Figure 8, note that the methodology is discontinued after inertial roll coupling (5.1.4.1). This was done in order to be able to show one distinct cause of the failure. In this investigation it became apparent that there was no single lowest level root cause to the anomaly. There are instead, multiple contributing factors. All these open sub-causes are treated as a contributing factor to their parent cause: inertial roll coupling.

Figure 9: Fishbone diagram with the suspected causes for the rocket failure

The primary cause of the Stratos III in flight anomaly is concluded to be inertial roll coupling as this is the only failure case that remains open after analysis of the fishbone diagram and eliminating all other failure cause theories.

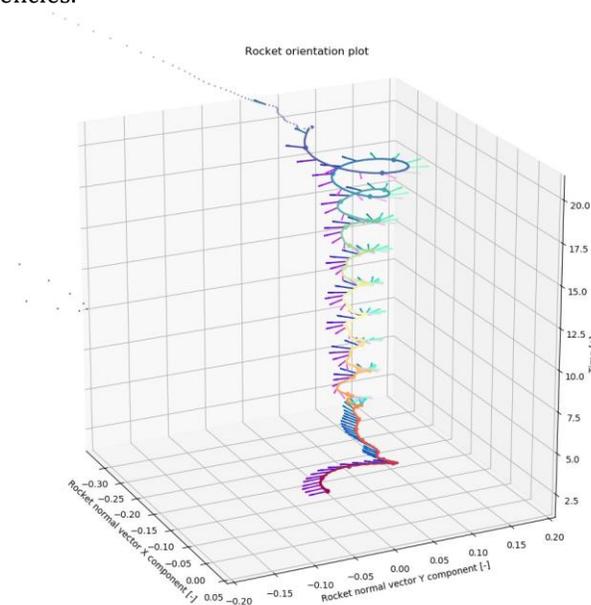
On paper, the clearest source is Figure 10, which is a 3D representation of the orientation of the rocket. It shows the length of the component of the unit vector of the body fixed X axis, resulting from successive projections onto, firstly the world-fixed XY plane and secondly the world-fixed X or Y axis. The plot demonstrates that while the rocket is spiralling due to rotation around its Y and Z axes, it is also rotating around its longitudinal X axis. Note that all of the Y axis vectors face outward from the centre of the spiral, so the same side of the rocket was always facing the velocity vector. This means that the roll rate of the rocket matched the natural pitch and yaw frequencies.

Figure 10: Orientation of the Stratos III rocket during flight, plotted over altitude.

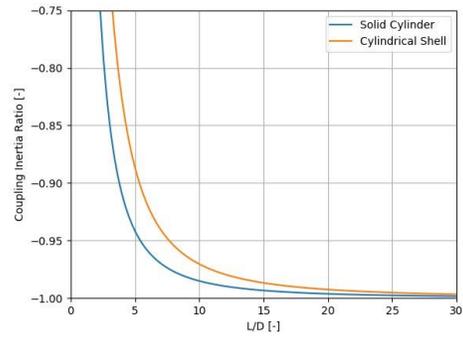
Some ratios for relatively fast and slender aircraft are given in Table 7 [1]. These aircraft are susceptible to inertial roll coupling and some have experienced it to the extent of catastrophic failure. To achieve an estimation of the inertial coupling ratio of the Stratos III rocket, one can assume the rocket to be either a solid cylinder, or a cylindrical shell. These two objects both have very well-defined inertial coupling ratio, which can be plotted as a function of the length to diameter ratio. A rocket with a certain L/D will then be located at some arbitrary point between the two lines. This is shown in Figure 11.

Figure 11: Relationship between coupling inertia ratio and length over diameter ratio. [4]

The closer the coupling inertia ratio lies to -1.0, the more susceptible the vehicle will be to lock into the inertial coupling ratio [1]. Since the L/D of the Stratos III is around 28.5, one can easily determine that the Stratos III rocket is very susceptible to this motion. However, it can also be seen that the L/D of the rocket essentially has to be below 15 before any minor improvement in the coupling inertia ratio can be observed. Since it is very unlikely that DARE will ever develop a rocket with an L/D of lower than 15 due to manufacturing difficulties (manufacturing large diameter parts, above 30 cm, is difficult with the machining capabilities available to DARE), lowering the L/D is not a realistic option for preventing the inertial coupling motion. Moreover, with a lower L/D for a rocket with the same volume, the frontal area would significantly increase. The drag would then scale linearly with the frontal area. This is exactly the reason why sounding rockets still have this large L/D and all of them deal with inertial roll coupling in a different manner.

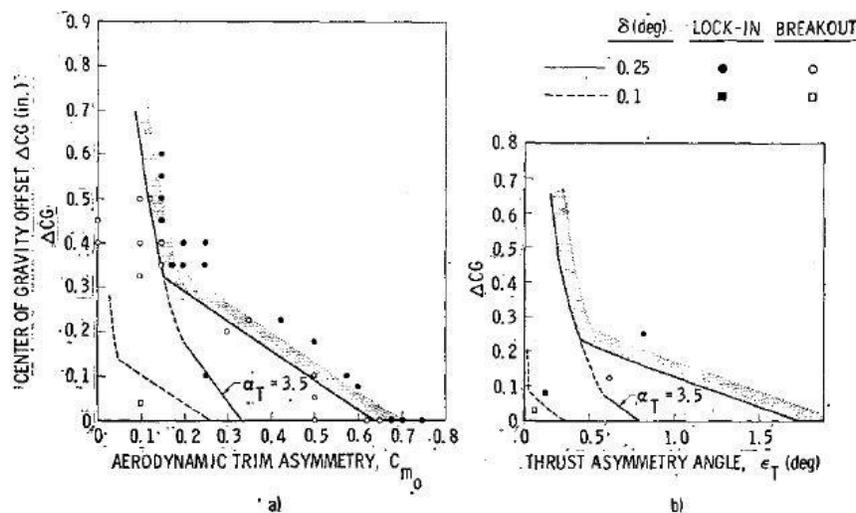
Evaluation of the Δcg tolerance for an appropriate range of C_{m0} and τ yields the asymmetry tolerance contours shown in Figure 12 for the Aerobee 150A vehicle. Below and left of the contour the asymmetry tolerances will not cause lock-in.

Figure 12: Centre of gravity asymmetry tolerances for the Aerobee 150A vehicle [3]

For their nominal $\delta = 0.25^\circ$ they find the contours contain reasonable asymmetry tolerances. The tolerable Δcg offset increases significantly as c_{m0} and τ decrease. A drastic decrease in tolerances occurs if δ is reduced to 0.1° , due to an increase of the altitude at which resonance occurs. For a student project, the tolerances at a nominal effective fin cant are already hard to realise, but the additional uncertainty due to vehicle differences and altitude sensitivity even more emphasise how hard it is to predict rocket dynamic stability before any validation launch.

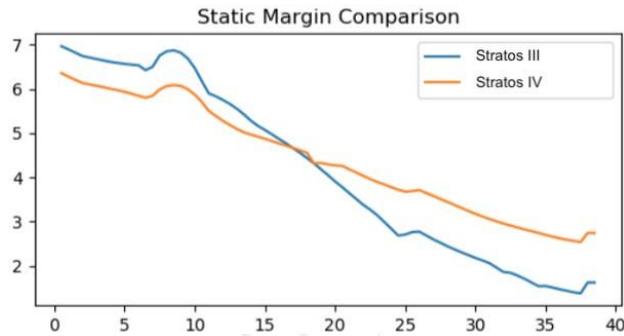
To increase the aerodynamic stability of the rocket, two design changes were implemented. First, the shape of the fins was changed. It was discovered that for stable flight, the static margin shall be higher than 2[6]. For the Stratos III rocket, this would not have been the case at higher altitude, so it had a higher chance of becoming unstable in the part of the flight after the anomaly. With the new fin design, the static margin over time curve is flattened, while still keeping it above 2 at all times. Because of the lower static margin at the start of the flight, the rocket will be less prone to wind cocking. A plot of the static margin can be seen in Figure 14.

Figure 14: Static margin over time
