# **An Additional Approach to Establishing the State of Operation of a Turbofan Engine During an Aircraft Accident**

**Douglas Zabawa**

Pratt & Whitney

## **Abstract**

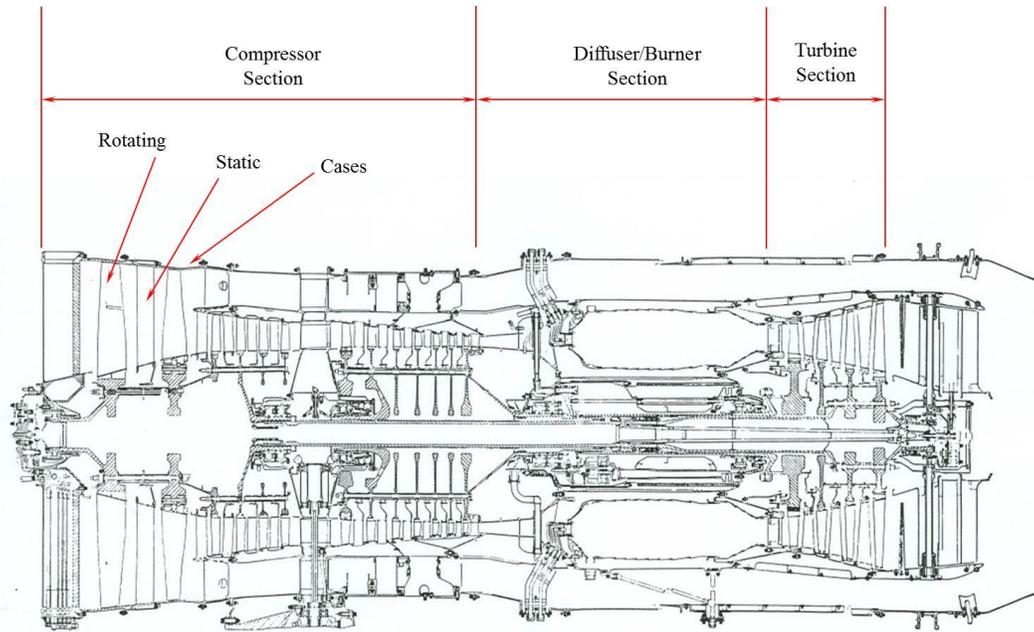
The mechanical construction of the compressor and turbine sections involves the close proximity, usually in an alternating pattern, of hardware that rotates and hardware that remains stationary. The diffuser/combustor section, that does not contain any rotating hardware, separates the compressor and turbine sections from one another. Surrounding all of the static and rotating hardware are cases that provide the positioning of the rotating hardware relative to the static hardware. Figure 5 is a cross section of an exemplar turbofan engine.

Figure 5: Cross-section of an exemplar turbofan engine
