FORUM

JULY-SEPTEMBER 2019

Journal of the International Society of Air Safety Investigators

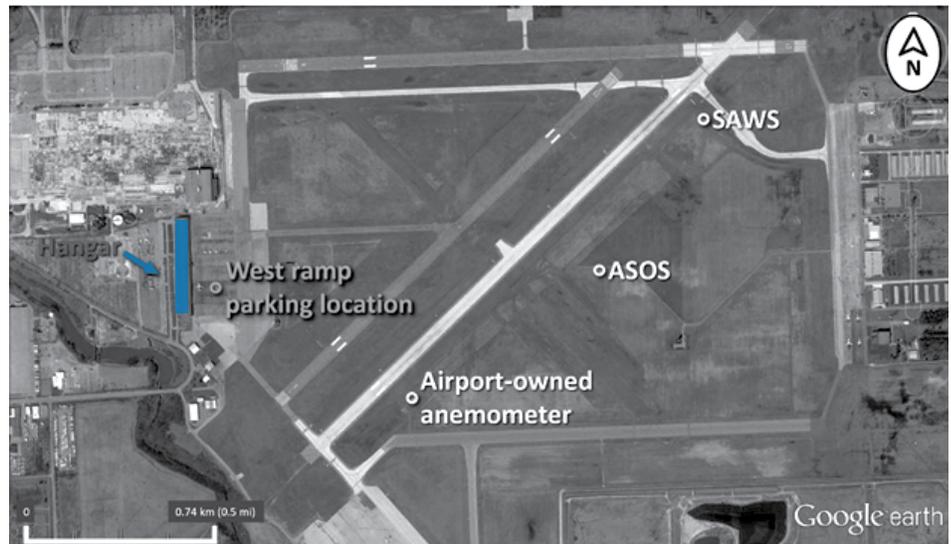
Figure 1. Airport map showing the relative locations of the hangar (dimensions highlighted in blue), the accident airplane's parking spot, and various weather observing equipment.

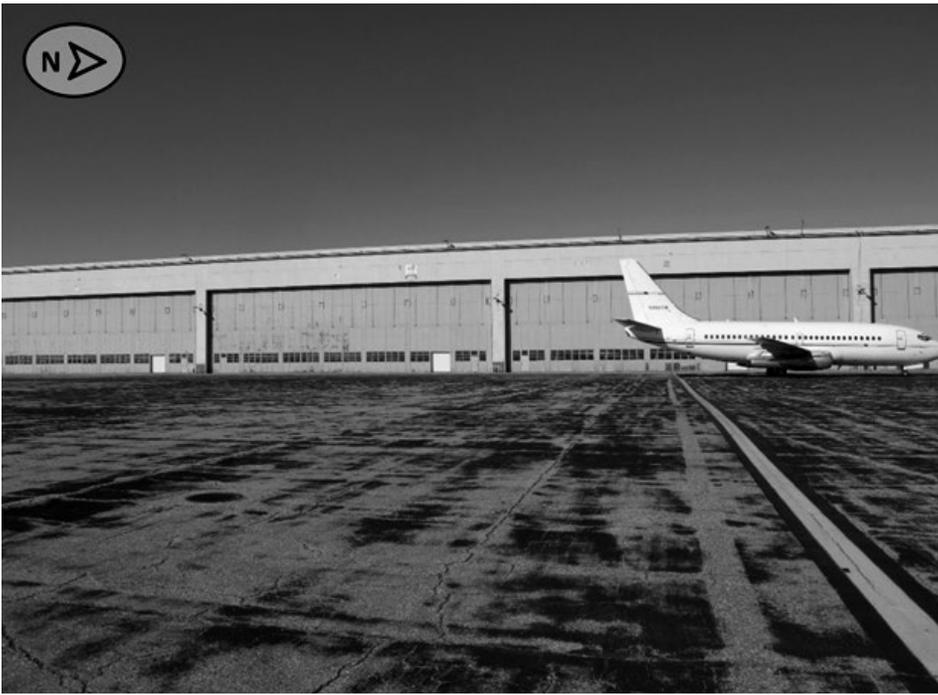
Figure 2. View looking west toward the hangar, taken from the approximate parked location of the accident airplane. (Airplane in picture is much closer to the hangar.)

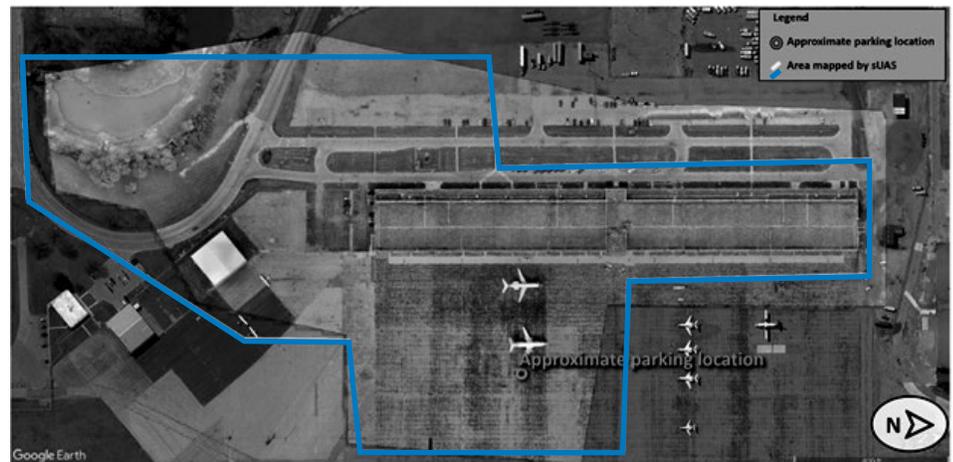
Figure 3. Orthomosaic image showing planned sUAS mapping area in blue.

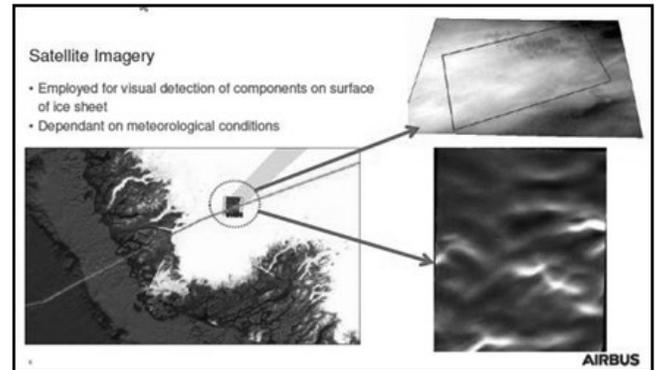
The first images received were obscured due to cloud cover (see Figure 1). The satellite continued to take images daily; and over the next few days, the cloud disappeared and we received the first images of the visible ground beneath. However, a blanket of snow had fallen, making it impossible to visually detect any engine parts.

Figure 1. Initial satellite imagery.

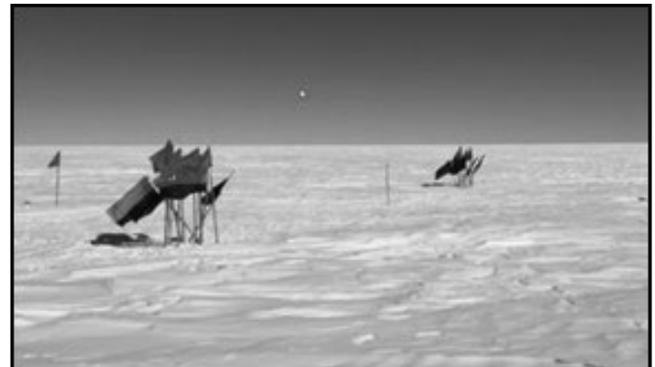
While satellite imagery did not provide any tangible results during this investigation, it may prove useful for other events such as locating an accident site in remote or inaccessible areas, mapping large accident sites, or runway excursions. Figure 2 shows an image of flags on the Greenland ice sheet, obtained later in the investigation, that were possible investigation sites captured by the satellite images.

Figure 2. Flags on the Greenland ice sheet.

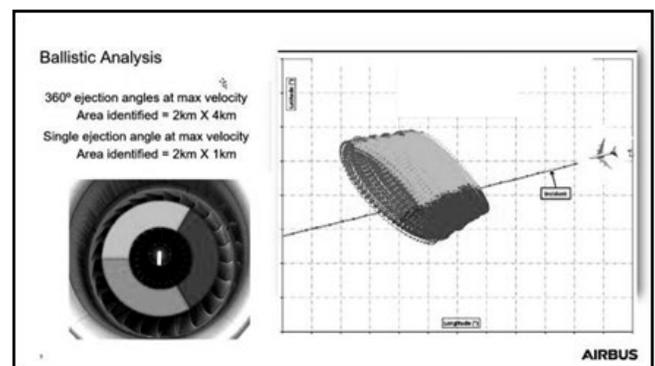
Figure 3. Ballistic analysis of engine fragments helped narrow the search area.

Examination of the engine revealed that the fan hub had ejected in several pieces. Ariane Group's analytical models (see Figure 3, page 15) were able to narrow the primary search area to 2 kilometers x 4 kilometers when provided with properties of a fragment, such as altitude, aircraft speed, wind, etc.

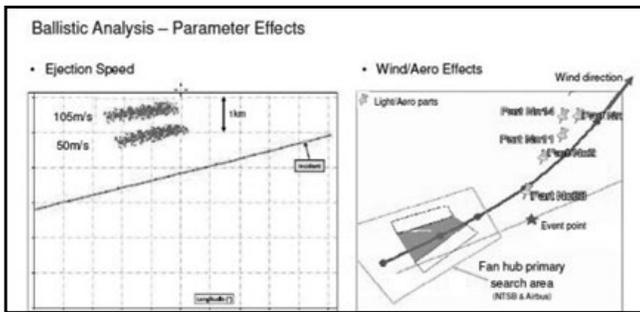
Figure 4. Parameter effects of the liberated parts.

The ongoing investigation established the fragment ejection angle and ejection speed (see Figure 4). This allowed the area to be refined to 1 kilometer x 2 kilometers. The parameters of the liberated parts influenced the ballistic analysis. Smaller, heavier parts would be projected forward of the event point while lighter, larger parts that have aerodynamic drag would be carried rearward of the event point in the direction of the wind.

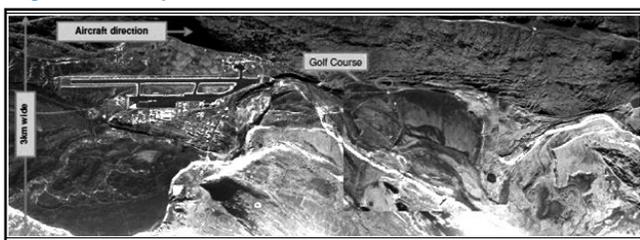
Figure 7. A processed image shows the ground and detects the test piece.

Once the image was processed, the radar scan revealed the ground beneath the snow and ice (see Figure 7).

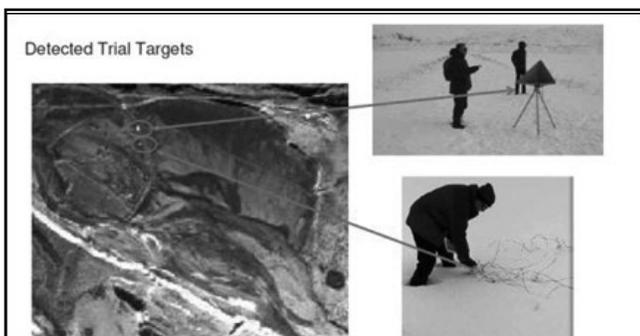
Figure 8. The test reveals a metal fence buried beneath the snow.

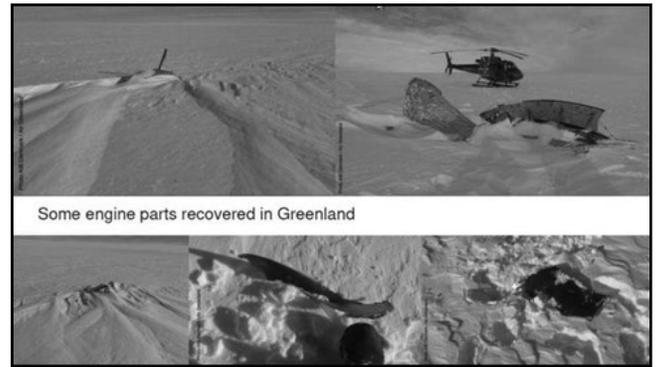
locate and recover the larger, aerodynamic engine components that had been liberated during the event. Due to their size, they were easier to spot by the helicopter crew (see Figure 10).

Some engine parts recovered in Greenland

Figure 10. The BEA and AIB of Denmark use helicopters to locate and recover the larger, aerodynamic engine components.

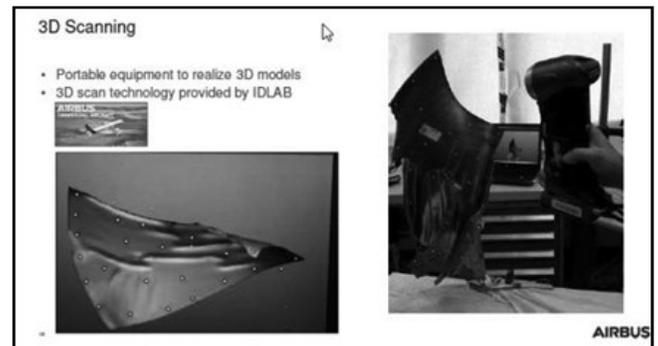
Figure 11. Airbus uses state-of-the-art 3-D scanning technology to create 3-D models of the retrieved components.
