Tailplane or main wing stall? LOC-I event due to suspected icing

Kåre Halvorsen, NSIA, Norway

LN-IDB, a Cessna 560 Encore with serial number 560-0637 was manufactured in 2003. The aircraft type is certified for two pilots, commander and co-pilot. The cabin has room for 7 passengers.

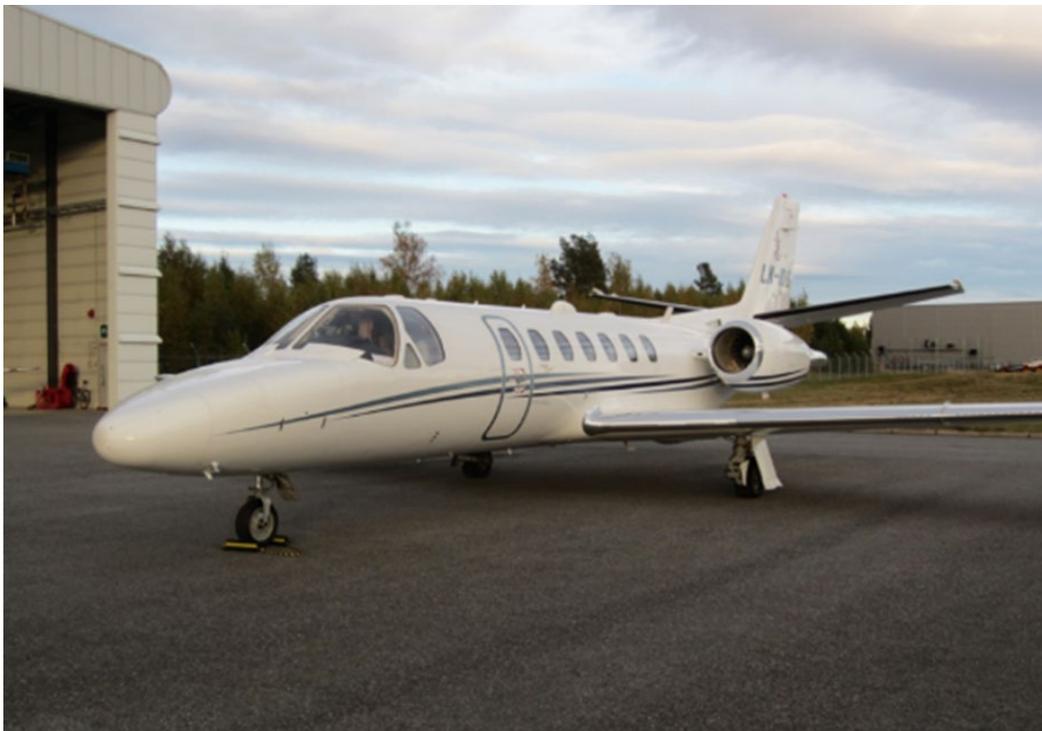
Figure 1, Cessna 560 Citation Encore LN-IDB (Hesnes Air As)

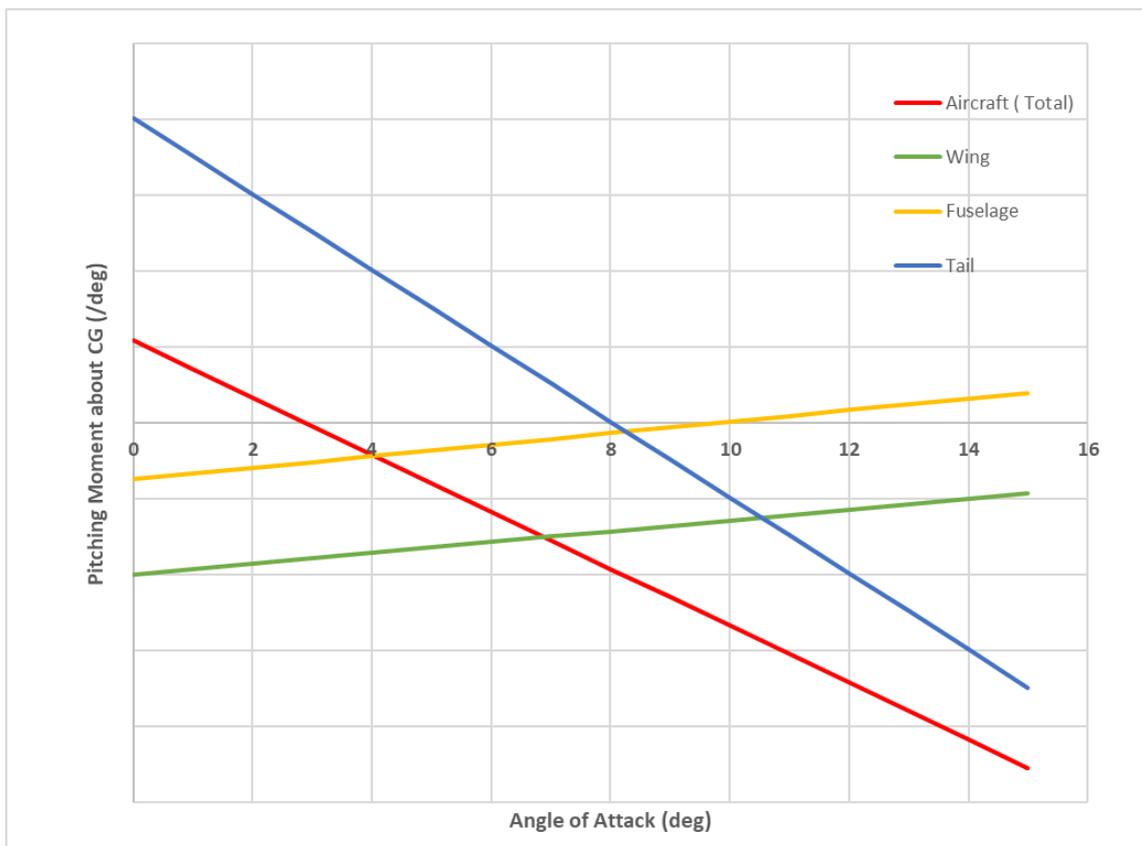
The total aircraft pitching moment about the aircraft's centre of gravity (3) consists of contributions from wing, tail and fuselage (Figure 3). Each contribution generates moments that vary with angle of attack and contributions that are independent of angle of attack (constant). A negative total pitching moment slope represents positive static stability – the aircraft returning to the trimmed flight condition following a disturbance (e.g. sudden change of tail lift).

Figure 3, Contributions to Total Aircraft Pitching Moment about the CG

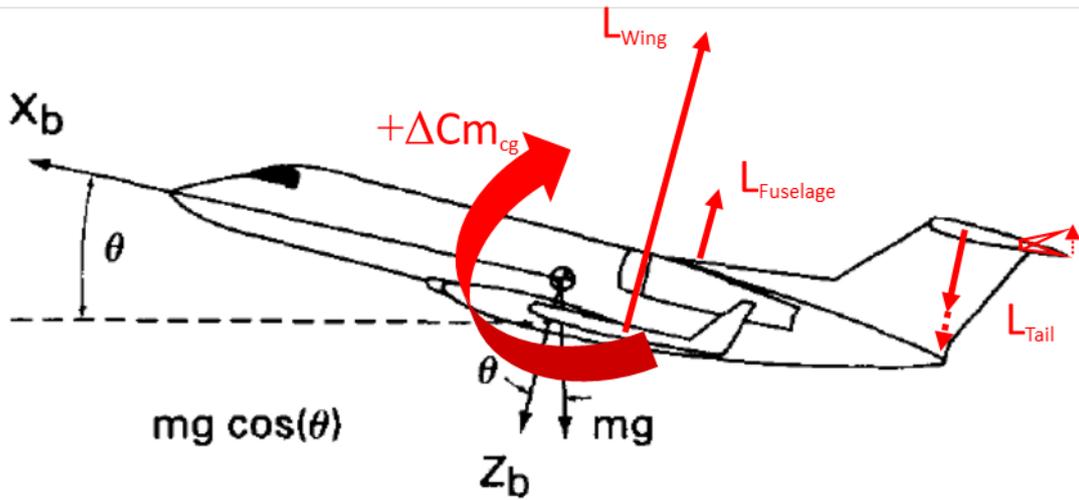
As ice builds up on the tail, it becomes less aerodynamically efficient, increased negative tail lift is needed to keep maintain the trimmed flight condition and, prevent the aircraft tending to nose down and overspeed with flaps extended. This is achieved by increasing elevator trailing edge up to compensate (Figure 4).

Figure 4, Forces and Moments on an Aircraft and Effect of Elevator Deflection

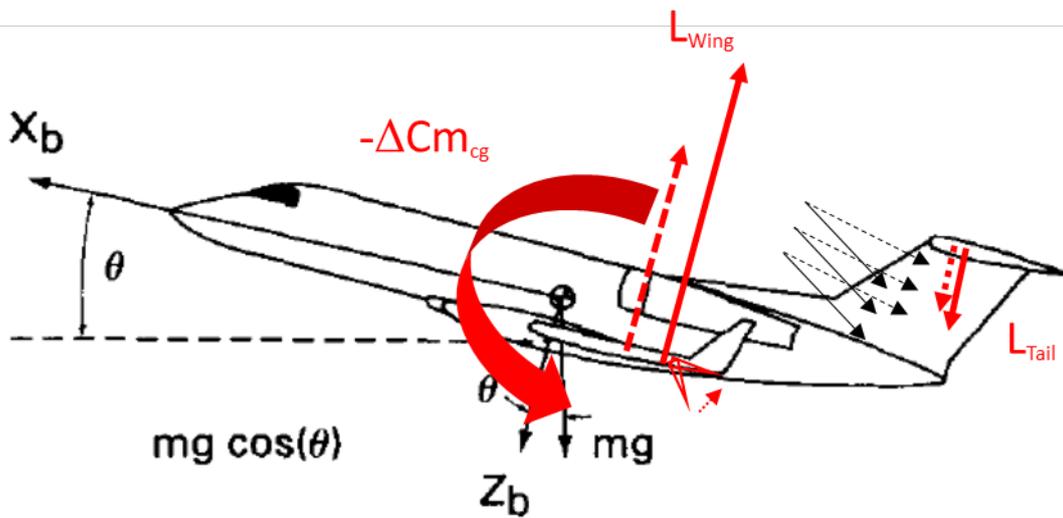
When flaps are retracted (Figure 4), the lift generated by the wing decreases and the point of lift moves forward. The aircraft tends to nose UP as the nose down pitching moment due to wing lift decreases. Increased trailing edge down (TED) elevator is required to compensate. At the tailplane, downwash angle decreases hence negative tail lift decreases. The aircraft tends to nose DOWN as the pitching moment due to negative tail lift decreases. This time, increased trailing edge UP (TEU) elevator is required to compensate. The resultant pitching moment about the CG is the net effect of these contributions. The effects due to tailplane are usually dominant (Figure 3).

Figure 5, Forces and Moments on an Aircraft and Effect of Flap Retraction

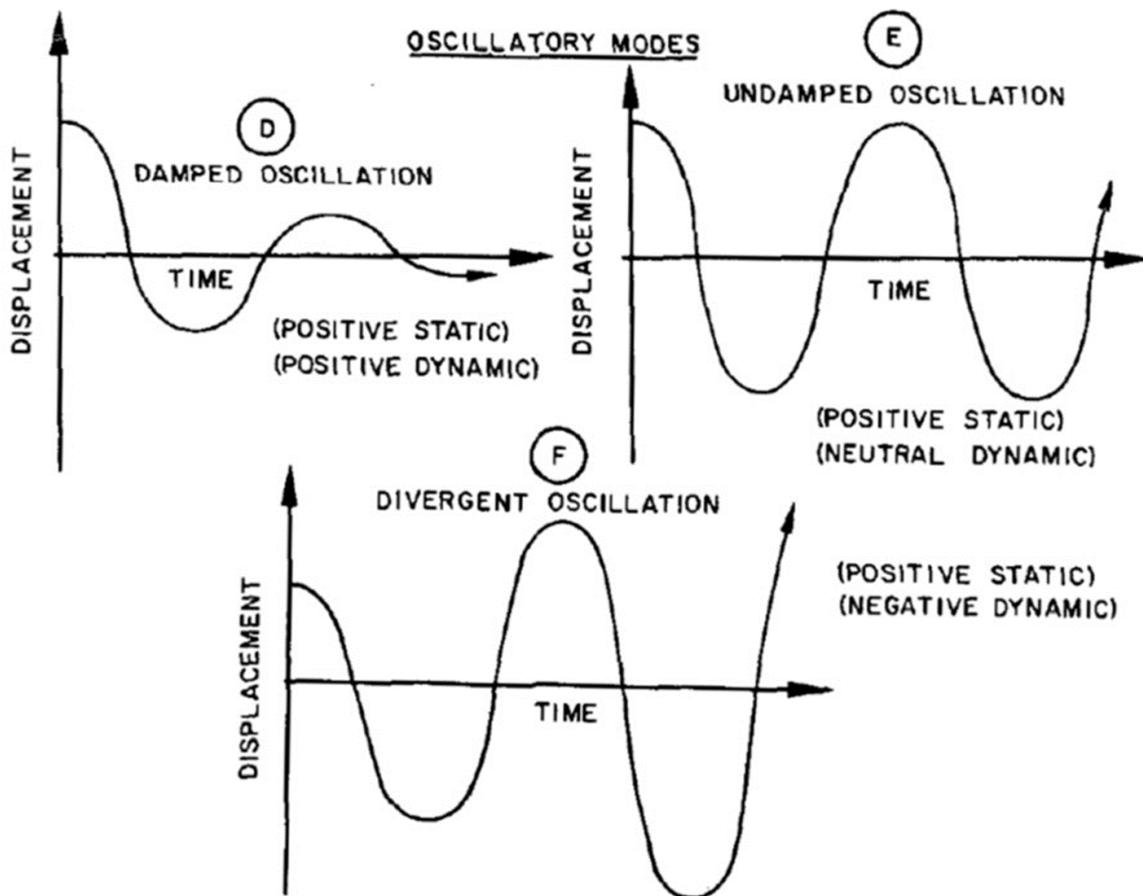
The longitudinal dynamic stability characteristics of the aircraft are dependent upon the airspeed, pitching moment variation with angle of attack, moment of inertia, lift to drag ratio and aerodynamic tail damping. The system may exhibit positive, neutral or negative dynamic stability (Figure 6).

Figure 6, Dynamic Stability (4)

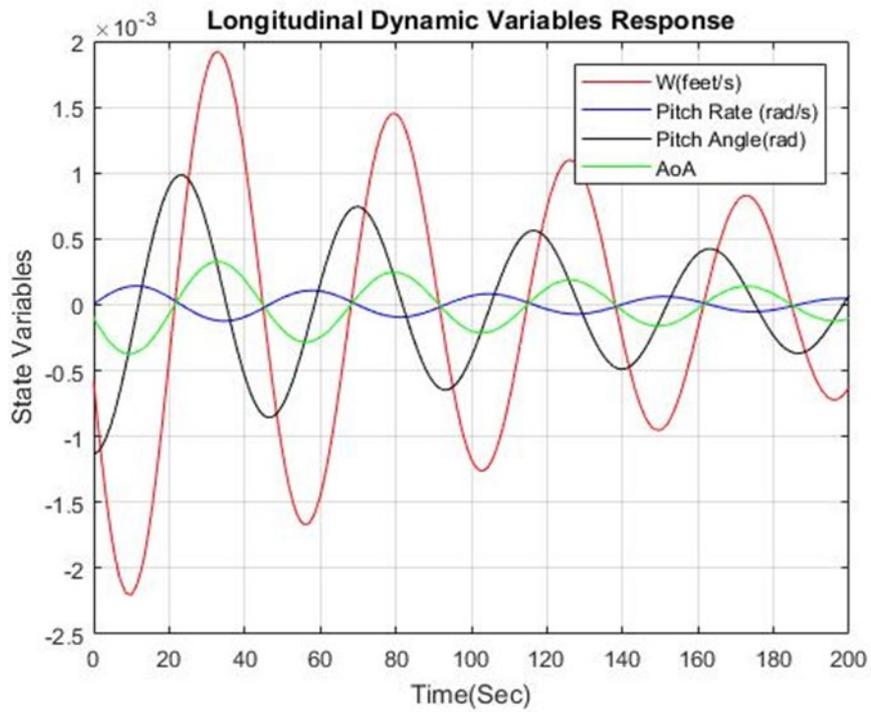
Figure 12, Long Period Oscillation (LPO) with 100% Horizontal Tailplane Efficiency

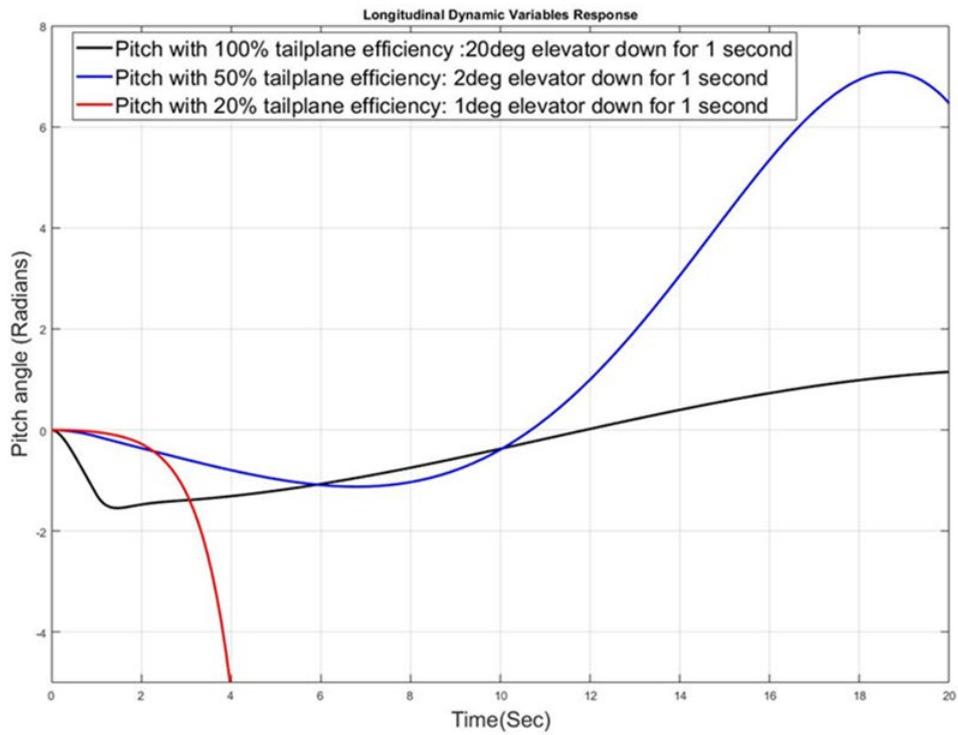
Figure 13, Dynamic Pitch Stability with varying Tailplane Efficiency

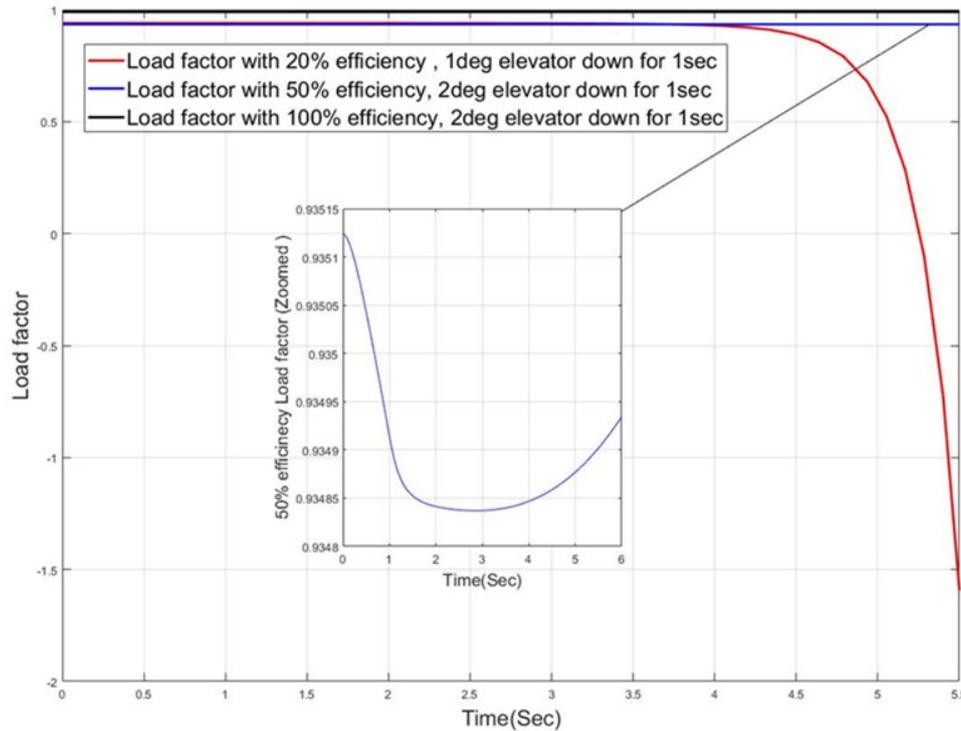
Figure 14, Load Factor with varying Tailplane Efficiency
