## **Virtual Wreckage Mapping Using Public Media Photos**

**Jacob Zeiger – Senior Air Safety Investigator, Boeing Commercial Airplanes**

# *Virtual Wreckage Mapping Using Public Media Photos*

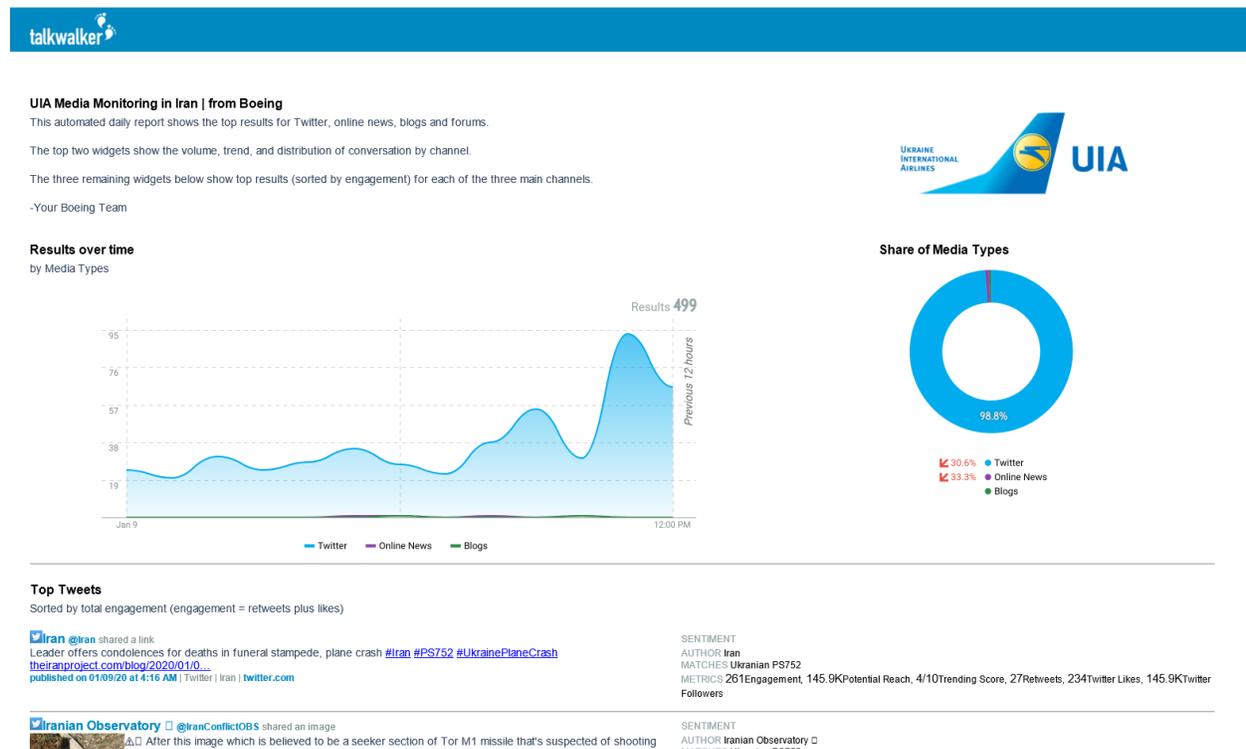
Figure 3: Talkwalker Media Monitoring Page. This application was able to locate photos that the team had not previously seen, and which contributed to the team's understanding of the wreckage field.

In this event, the team was able to leverage other areas of the corporate structure to find assistance in locating unique images and videos. The Boeing Communications department utilizes software called Talkwalker to monitor news and social media sites, gathering relevant news and social media material and displaying it in a user-friendly format. Talkwalker cut down on the total time involved in gathering data, and allowed the team to expand its coverage beyond the “typical” sources of information.

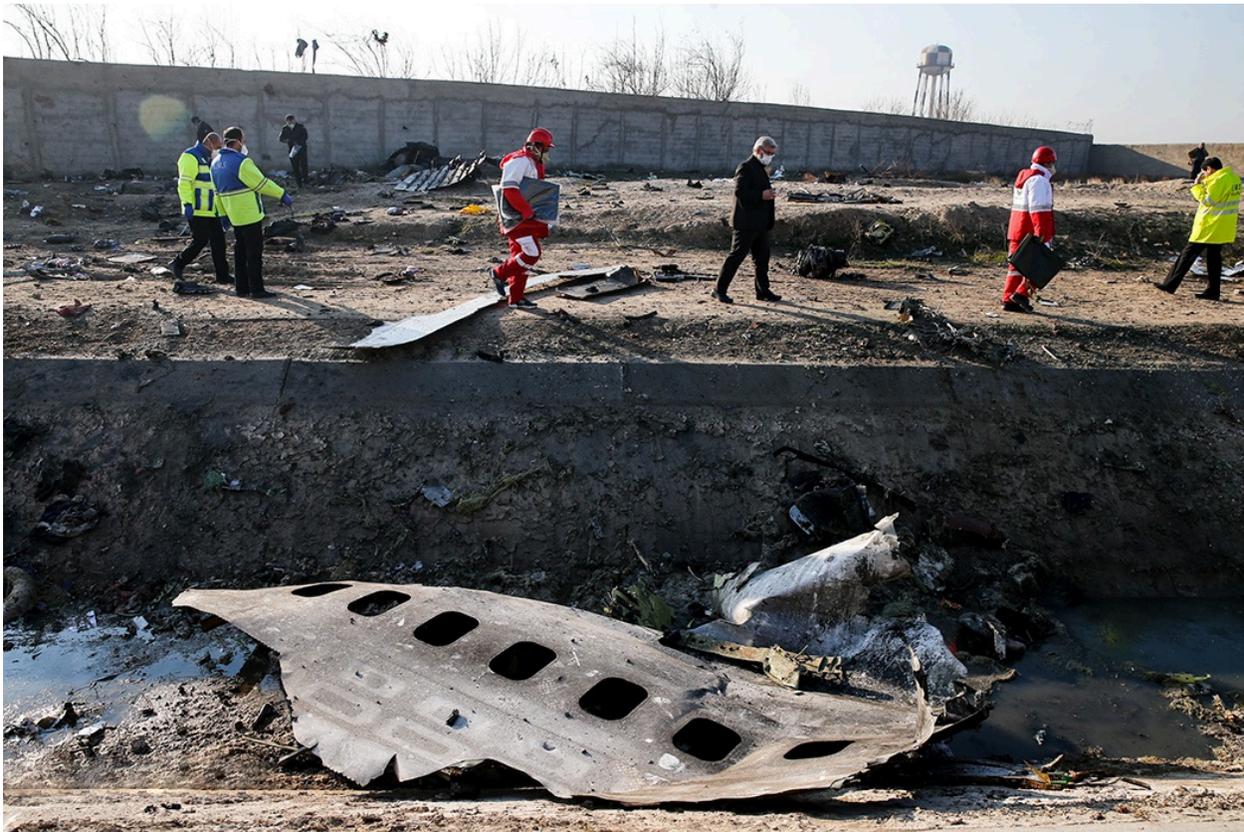
*Figure 5: Example photo with both airplane components and landmarks. Note the vertical concrete walls and water tower in the distance. Source: CC BY Fars News Agency via Wikimedia Commons.*

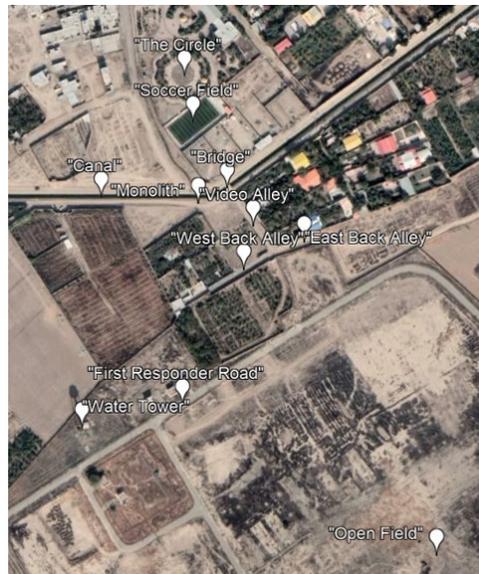
Figure 6: Wreckage map with landmarks labeled. Source: Google Earth

Labeling these landmarks explicitly in Google Earth proved to be highly beneficial when sharing the photo review with the larger investigative team and discussing observations over the phone. Both sides of the conversation were able to refer to areas of the wreckage field by these predetermined names.

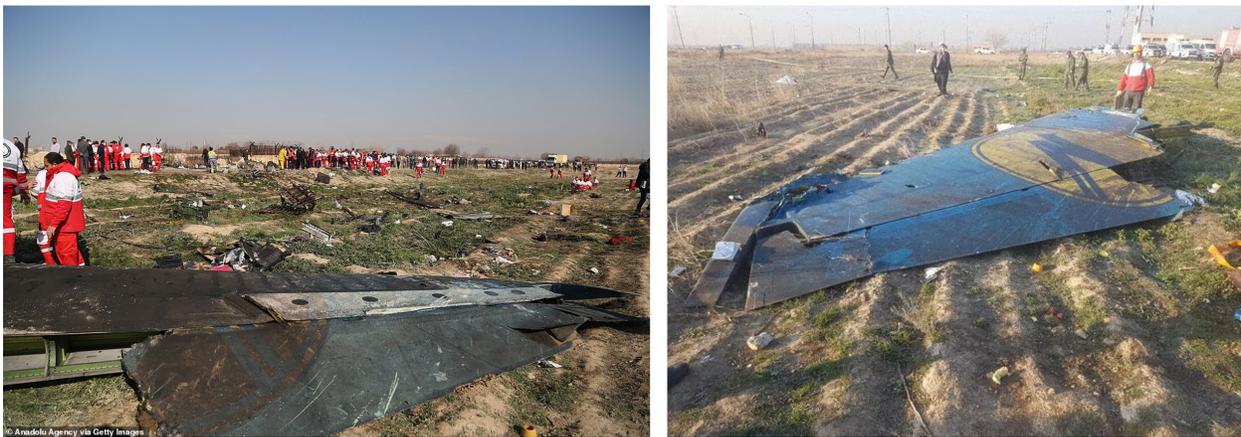
*Figure 8: The vertical tail included key fire evidence. The image on the left was posted in the first 24 hours after the accident but was not republished by many other news agencies. The image on the right, posted later, saw wide distribution. Sources: Anadolu Agency/Getty (left); Hossein Mersadi/FARS News Agency (right)*

As the team continued to monitor additional images and video in the days following the accident, items that were previously imaged and catalogued could sometimes be seen again in new locations and orientations. These changes to the wreckage field were variously detrimental and beneficial to the team: in some cases, the original location or orientation of a piece of wreckage could not be determined with certainty, but in others the movement provided additional and useful data about the state of a component after the accident.
